MR Magnets

Shu Nakamura, Ryuichi Ueki, Masashi Furusawa,
Yasunobu Ohsawa, Mika Masuzawa

Skew sextupole magnets for non-linear collimator

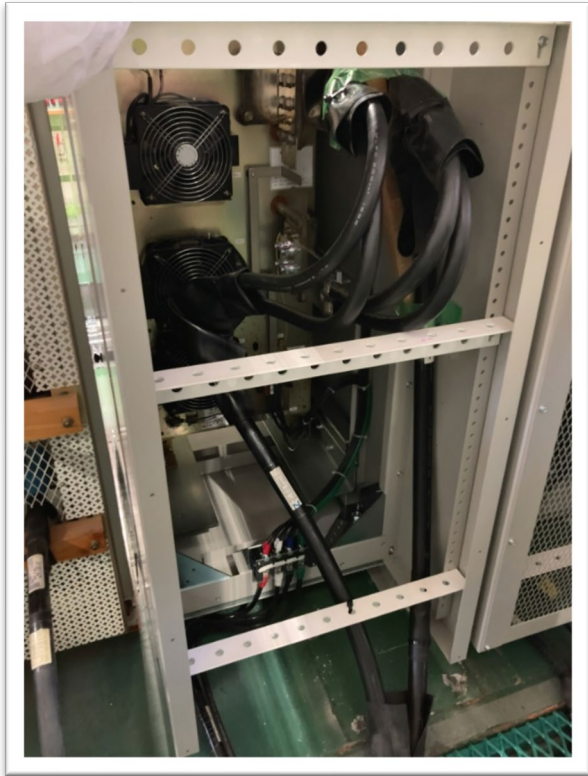
Skew sextupole magnets need to change the polarity. A power supply with a polarity changer has to be used. However, the alternative power supply does not have the polarity changer, so an extension cable is used.

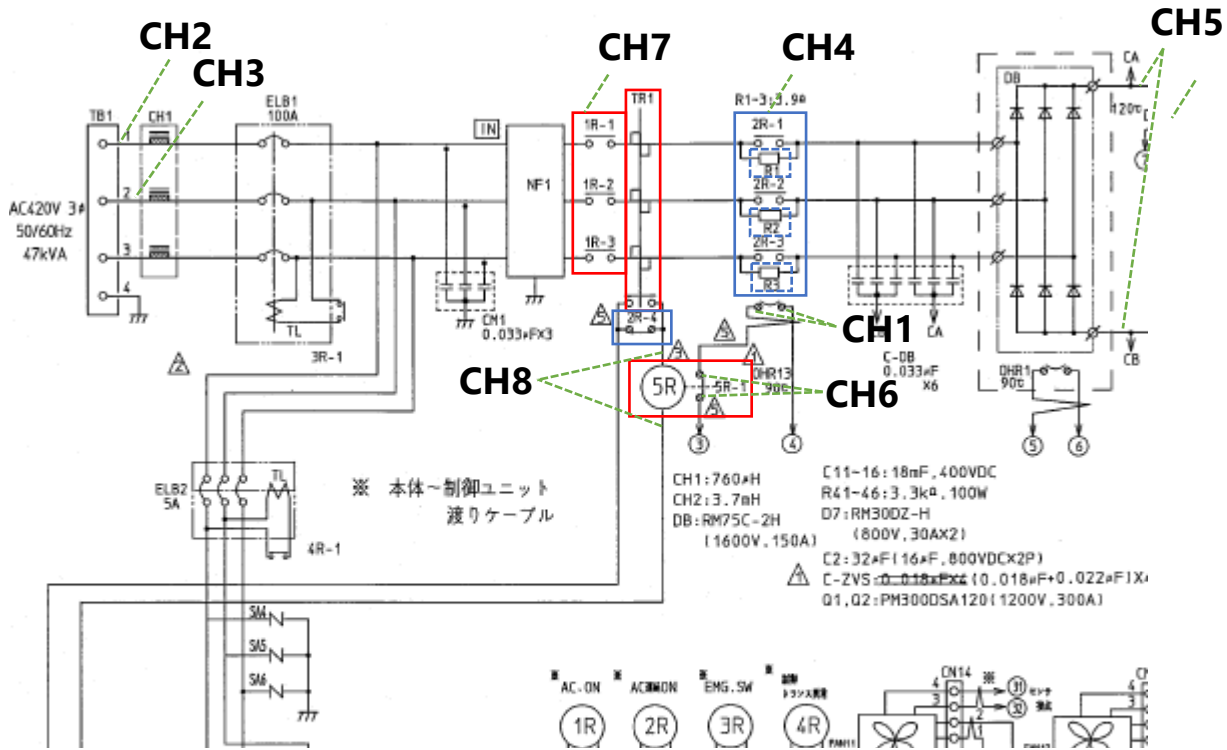
Unintended interlock triggering

- CH1 : Thermoswitch (Open at high temp.)
- CH2,3 : AC current (1A/1mV)
- CH4 : Drive voltage of Contactor#2(2R) (10V/1V, AC100V)
- CH5 : DC voltage (500V/1V)
- CH6 : Relay(5R) (Close when voltage is applied.)
- Ch7 : Drive voltage of Contactor#1(1R) (10V/1V, AC100V)
- CH8 : Drive voltage of the relay(5R) (10V/1V, AC100V)

The power supply(SD3ORE_2) frequently mis-detected interlocks(AC Over Current) and stopped. The beam operation was also stopped several times.

After these parts were replaced, this phenomenon no longer occurs.

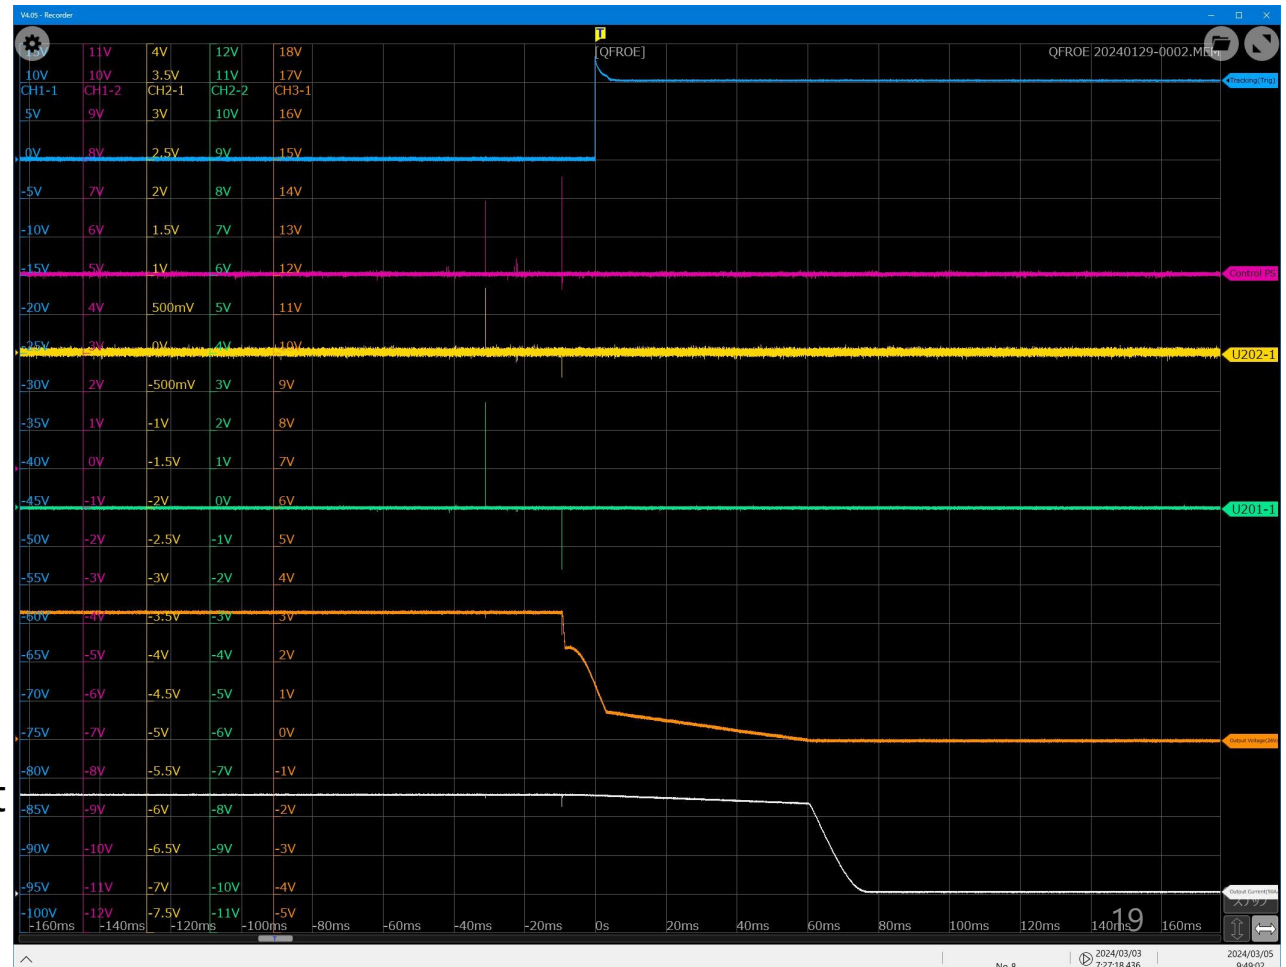
Unintended current reduction

The power supply(QFROE_4) sometimes unintentionally reduces the output current.
 The only interlock the power supply displays is "Tracking", but the output current is zero A.
 A malfunction due to noise in the control circuit is suspected.
 The control power supply was replaced, but the problem recurred.
 Other measures are under consideration.
