The 27th KEKB Accelerator Review Committee
26th March 2024

Kyo Shibata
On behalf of KEKB Vacuum Group

Major vacuum works during LS1 (MR) #1

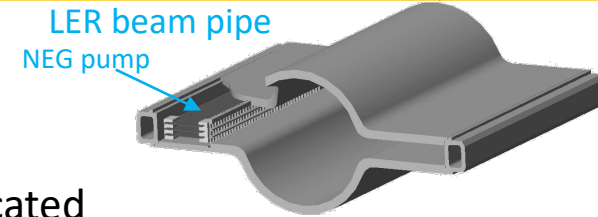
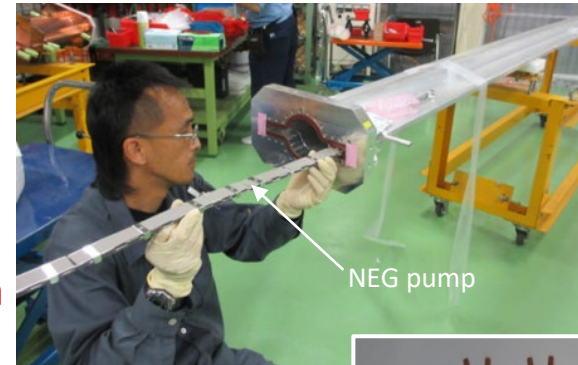
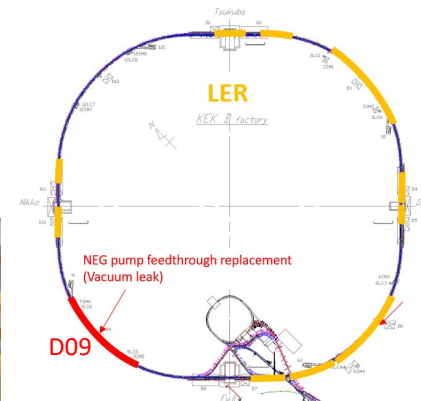
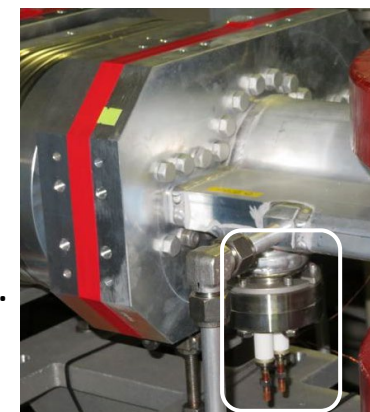
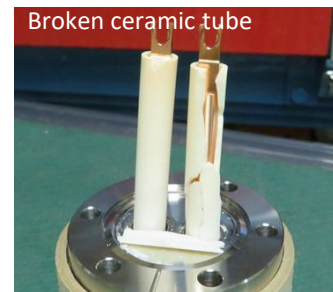
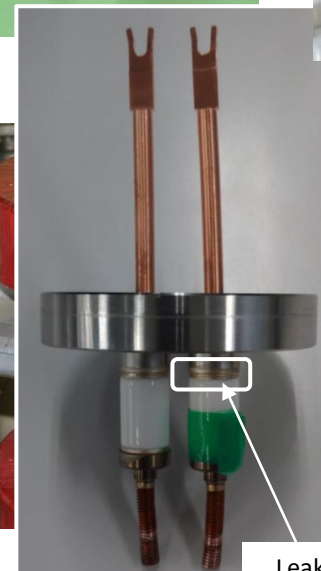
- NEG pump feedthrough replacement (LER)
 - Countermeasure against vacuum leak during LS1
 - It was found that a vacuum switch at D09 Arc Section in LER indicated abnormally high pressure. (2022/12/28)

- Vacuum leak from NEG pump feedthrough was detected by vacuum leak test.
- Replacement and investigation of NEG pump feedthrough
 - Faulty feedthrough was replaced with new one.

- It was found that vacuum leak was occurred at the brazed part between the ceramic and stainless steel.
 - Investigation with X-rays revealed a crack in the ceramic part.

- Ceramic tube inside vacuum was also broken.
 - It is still unclear why the ceramic parts were damaged at this time.
 - No work near this feedthrough & no NEG activation at this time.

- Remaining excessive force during installation?
 - No further countermeasure against this issue

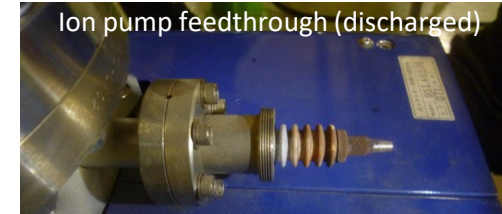
- It was found that abnormal discharge occurred in HV connector of an ion pump.
 - There was abnormal sound from it and abnormal high temperature on it.

- **Discharge in the connector resulted in vacuum leak.**
 - Replacement of HV feedthrough and investigation of other feedthroughs
 - Faulty feedthrough was replaced with new one. (Vacuum work)

- They may be due to an increase in humidity due to the air conditioner stopping.
 - Further countermeasures:
 - R&D of humidity-resistant HV feedthrough and connector was started.

Ion pump feedthrough (discharged)

- **Three feedthroughs in D09 & D12 Arc Sections were replaced with new ones. (Vacuum work)**
 - **Others were reused after cleaning. (Not vacuum work)**

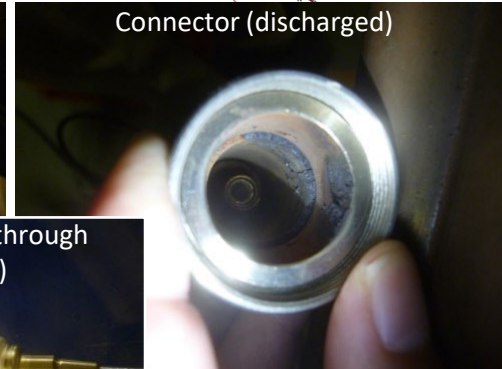
- Feedthroughs and connectors of other ion pumps were checked.
 - **It was found that abnormal discharge occurred in some connectors at D09 & D12 Arc Sections.**

Connector (discharged)

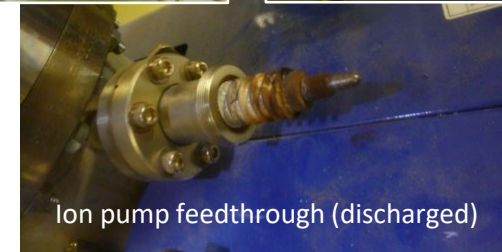
Ion pump feedthrough (discharged)

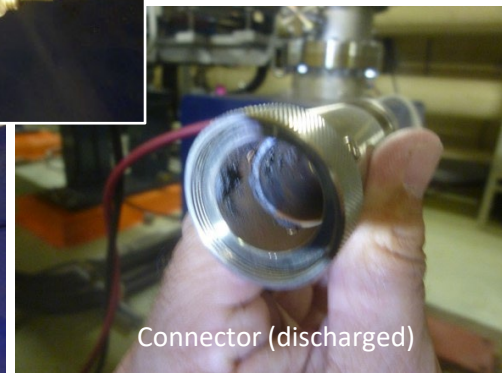
Connector (discharged)

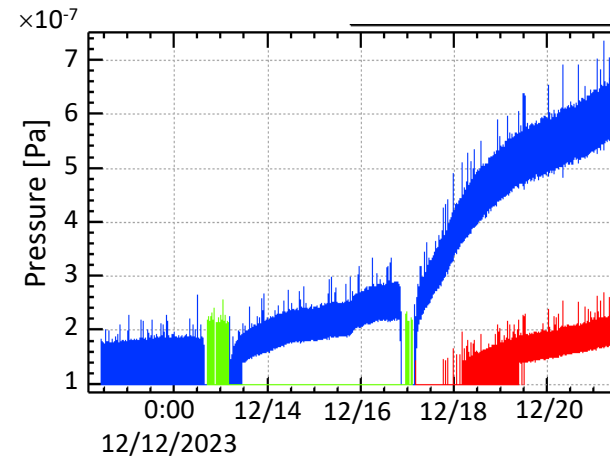
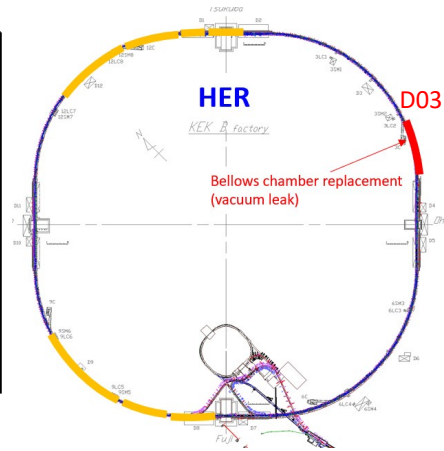
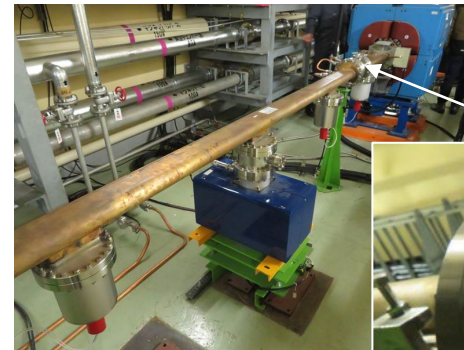
- Bellows chamber replacement (HER)
 - Countermeasure against vacuum leak during LS1
 - Pressure at D03 Arc Section of HER gradually increased to $\sim 7 \times 10^{-7}$ Pa. (from 2023/12/13)
 - Leak test revealed that a vacuum leak occurred at the brazing line of a bellows chamber.
 - Faulty bellows chamber was replaced with new one.
 - It was installed into KEKB in 1997.
 - Still unclear why the vacuum leak occurred at this bellows chamber at this time
 - If vacuum leak occurs at other bellows chamber, it will be replaced with spare bellows chambers.
 - There are spare bellows chambers.

Leaked bellows chamber

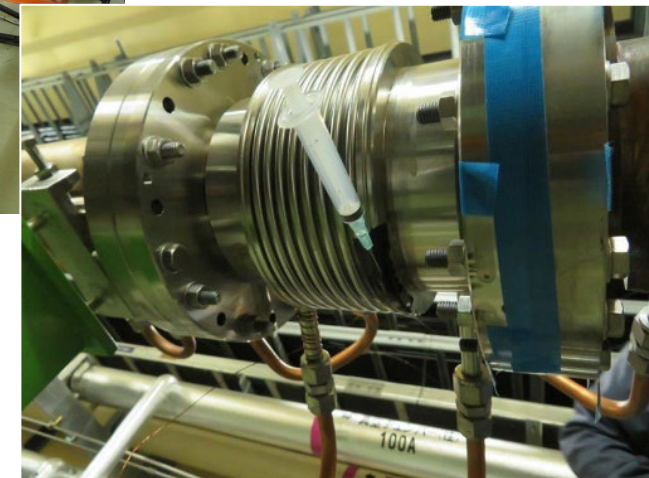
He gas was sprayed with a syringe to locate the leak point

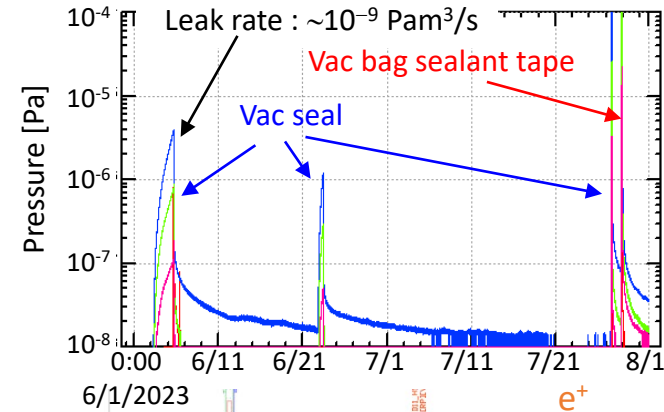
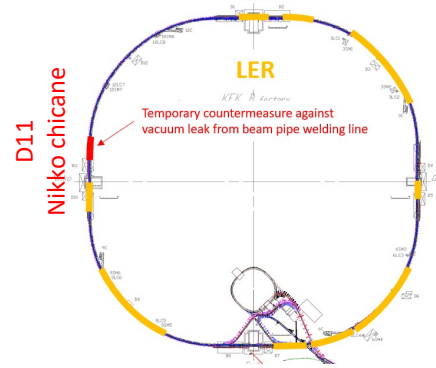
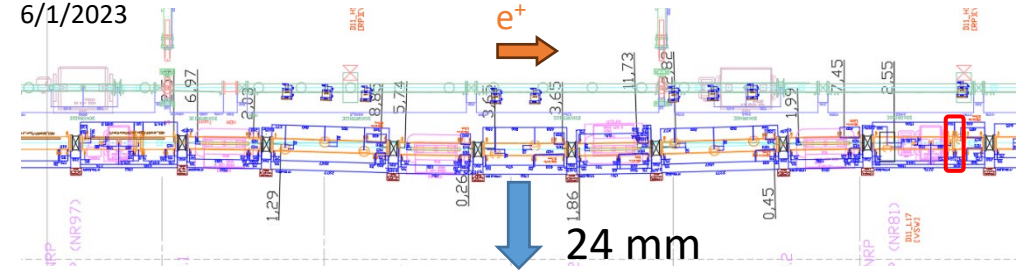
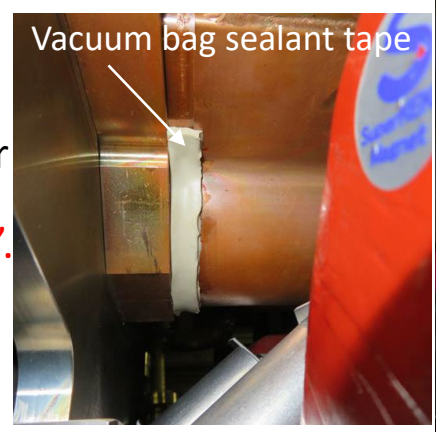
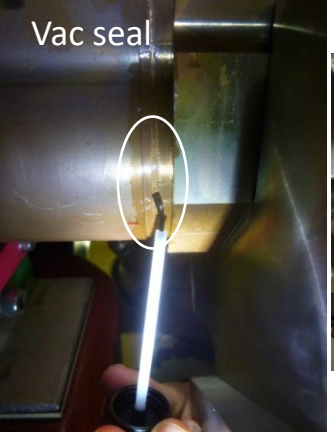
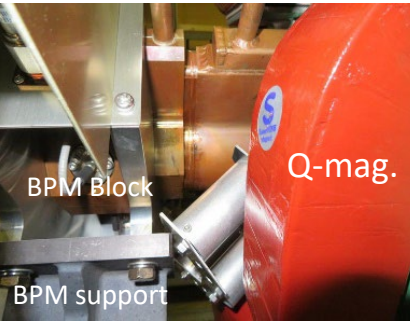
- The BPM block of the Q-chamber, which had not been fixed for unknown reason, was fixed to the Q-magnet. (2023/4/28)
 - Vacuum leak occurred from the welding line of the BPM block. (2023/6/3)

- Leak rate was $\sim 10^{-9}$ Pam³/s at this point.
 - This chamber was deformed during TiN coating process and repaired before installation into the SuperKEKB.

- Stress due to repair work might be a cause of the vacuum leak.
 - Countermeasure against vacuum leak:
 - At first, the vacuum leak was stopped by “Vac seal”, however it could not be stopped by “Vac seal” in the end.

- The vacuum leak was stopped by “Vacuum bag sealant tape”.
 - Further countermeasure
 - New beam pipe is currently being fabricated and is scheduled to be delivered on 27th March (tomorrow).

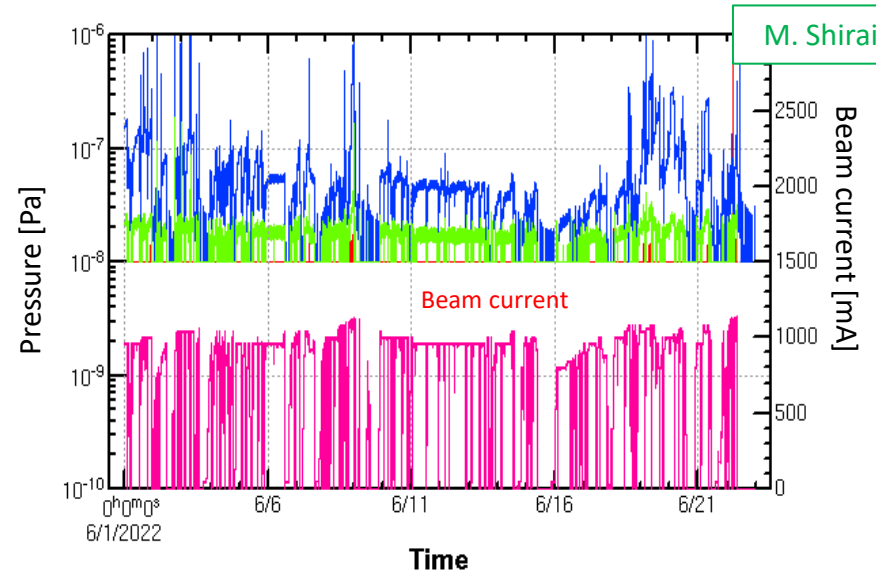
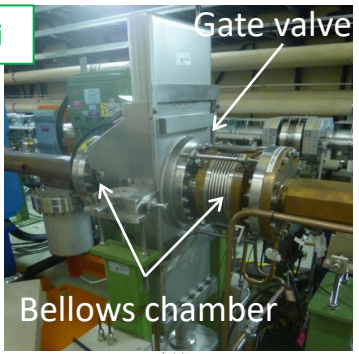
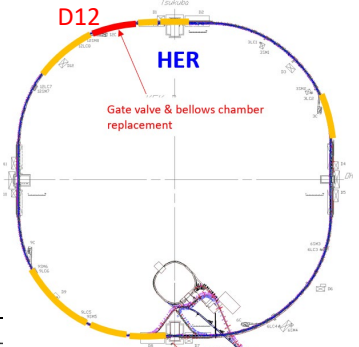
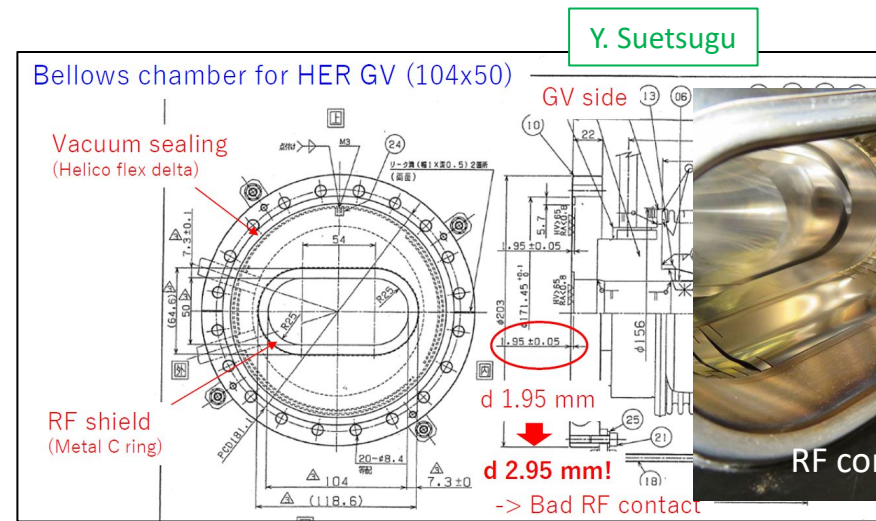
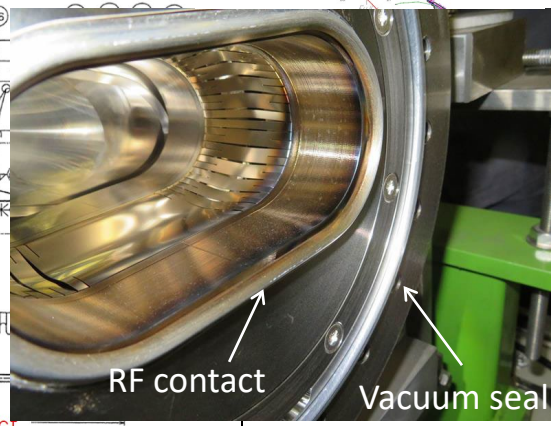
- Countermeasure against abnormal pressure spike
 - Abnormal pressure spikes near a gate valve were observed at HER D12 Arc Section (2022ab).
 - Abnormal temperature rise of the gate valve was also observed.
 - Internal visual check revealed that the groove for the RF contact of the bellows chamber connected to the gate valve was 1 mm deeper than designed. (Vacuum work)**
 - Possible cause is discharge at small gap due to poor contact between gate valve and bellows chamber.
- Gate valve and bellows chamber were replaced with new ones.
 - It was confirmed that the depth of the groove for the RF contact of installed bellows chamber was designed value.
 - It was also confirmed that the pressures and temperatures of other HER gate valves were normal.
 - The depth of the other bellows chamber grooves seems to be as designed.

- Replacement of gate valve and bellows chamber (HER) Already reported in last KEKB Review

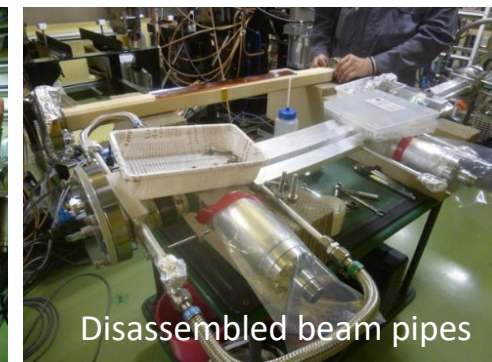
- Two beam pipes were disassembled and reinstalled for Ext. Kicker PS work.
 - First vacuum work after DR construction
 - West Arc Section was filled with dry nitrogen.
 - Ceramic beam pipe for Ext. kicker and a beam pipe next to it were disassembled to remove Kicker PS.
 - These two beam pipes were filled with dry nitrogen and reinstalled into DR about 10 months later.
 - Remaining area of West Arc Section was also filled with dry nitrogen for about 10 months.
 - Other sections covered by Vacuum Group were kept in vacuum.
 - East Arc Section
 - North Straight Section
 - Sought Straight Section
 - RF Group also performed vacuum work at RF section during LS1
 - Vacuum system of RF section is covered by RF Group.
 - Pressure of RF section was improved by this work.
 - Pressures of West Arc Section and Sought Straight Section were also improved by this work.

Disassembled beam pipes
