Safety

The 27th KEKB Accelerator Review Committee

2024.3.26

Toshihiro Mimashi

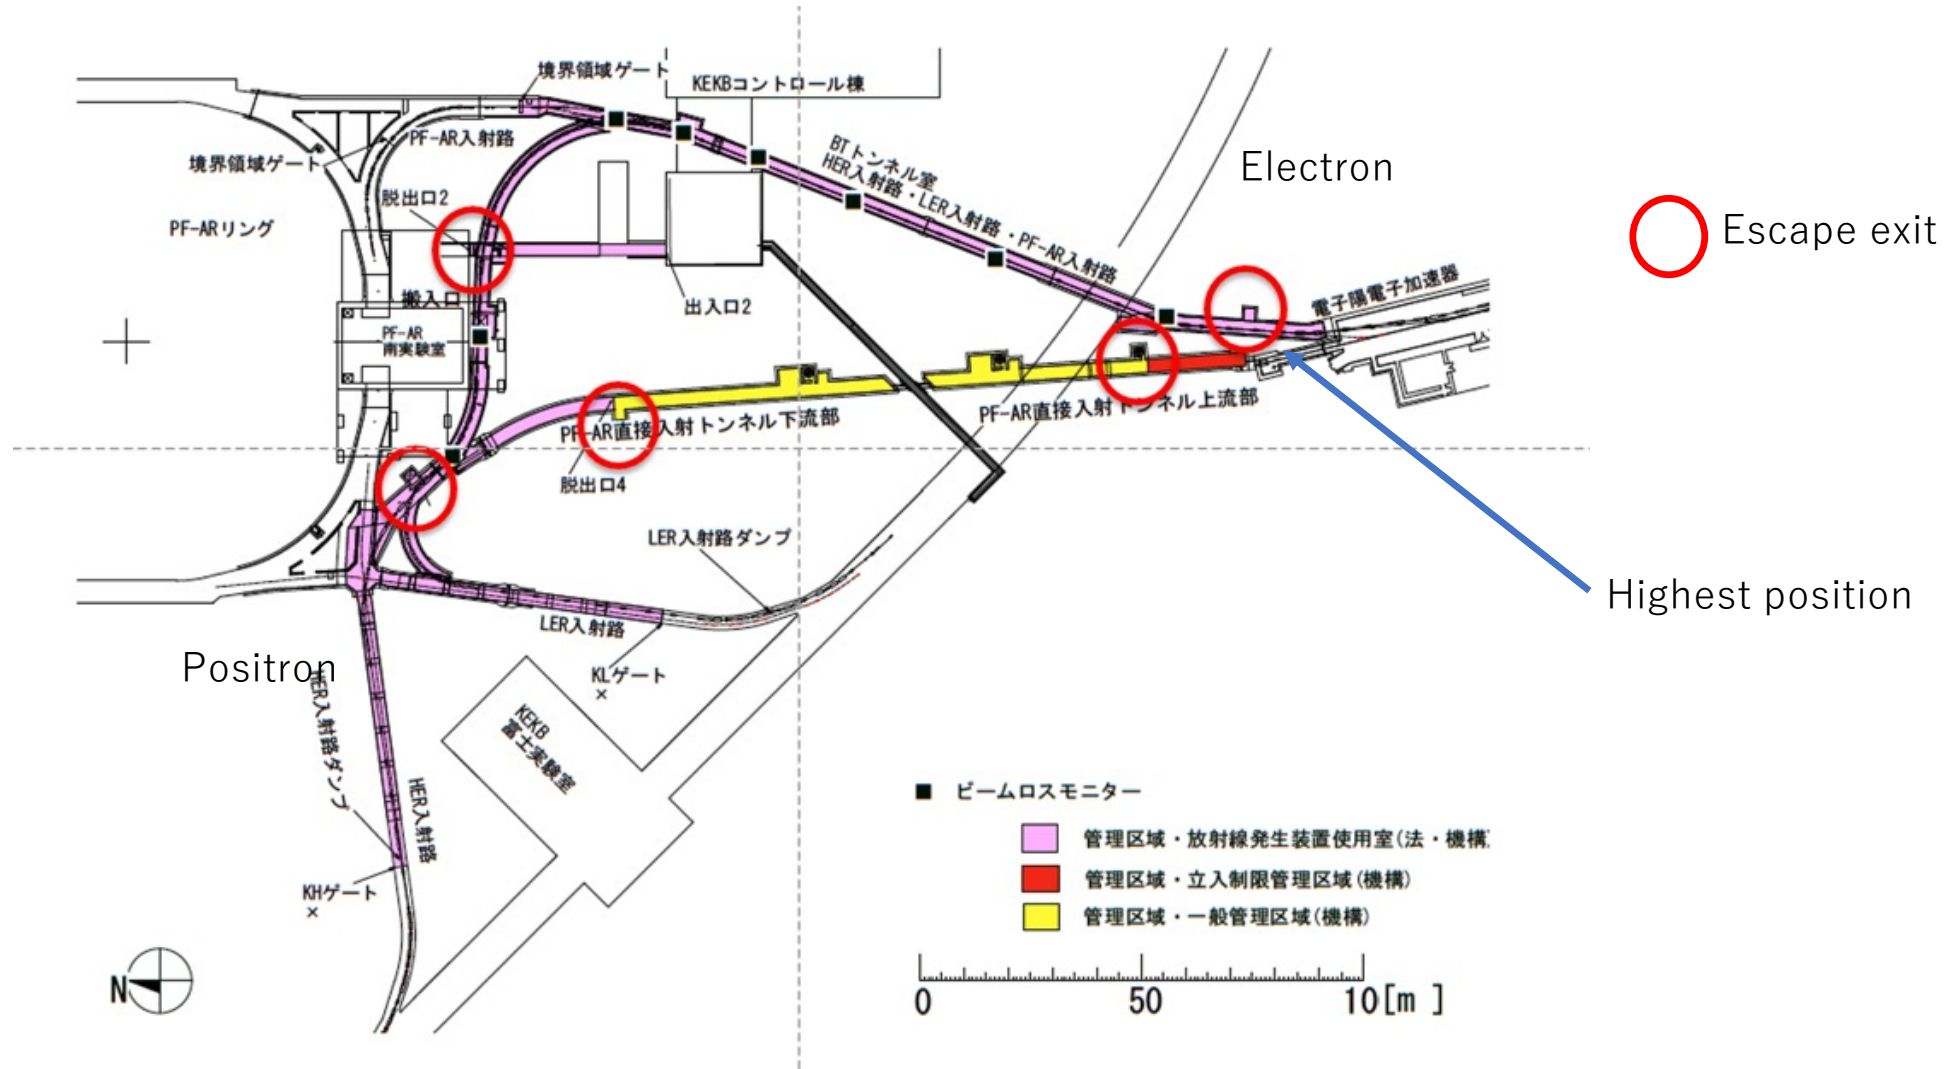
Radiation level in front of the most upstream BT escape exit is high

Before tuning: $0.8\mu\text{Sv/h}$ (must be $0.2\mu\text{Sv/h}$ or less)

→Mainly it comes from electron beam

After tuning: $0.13\mu\text{Sv/h}$

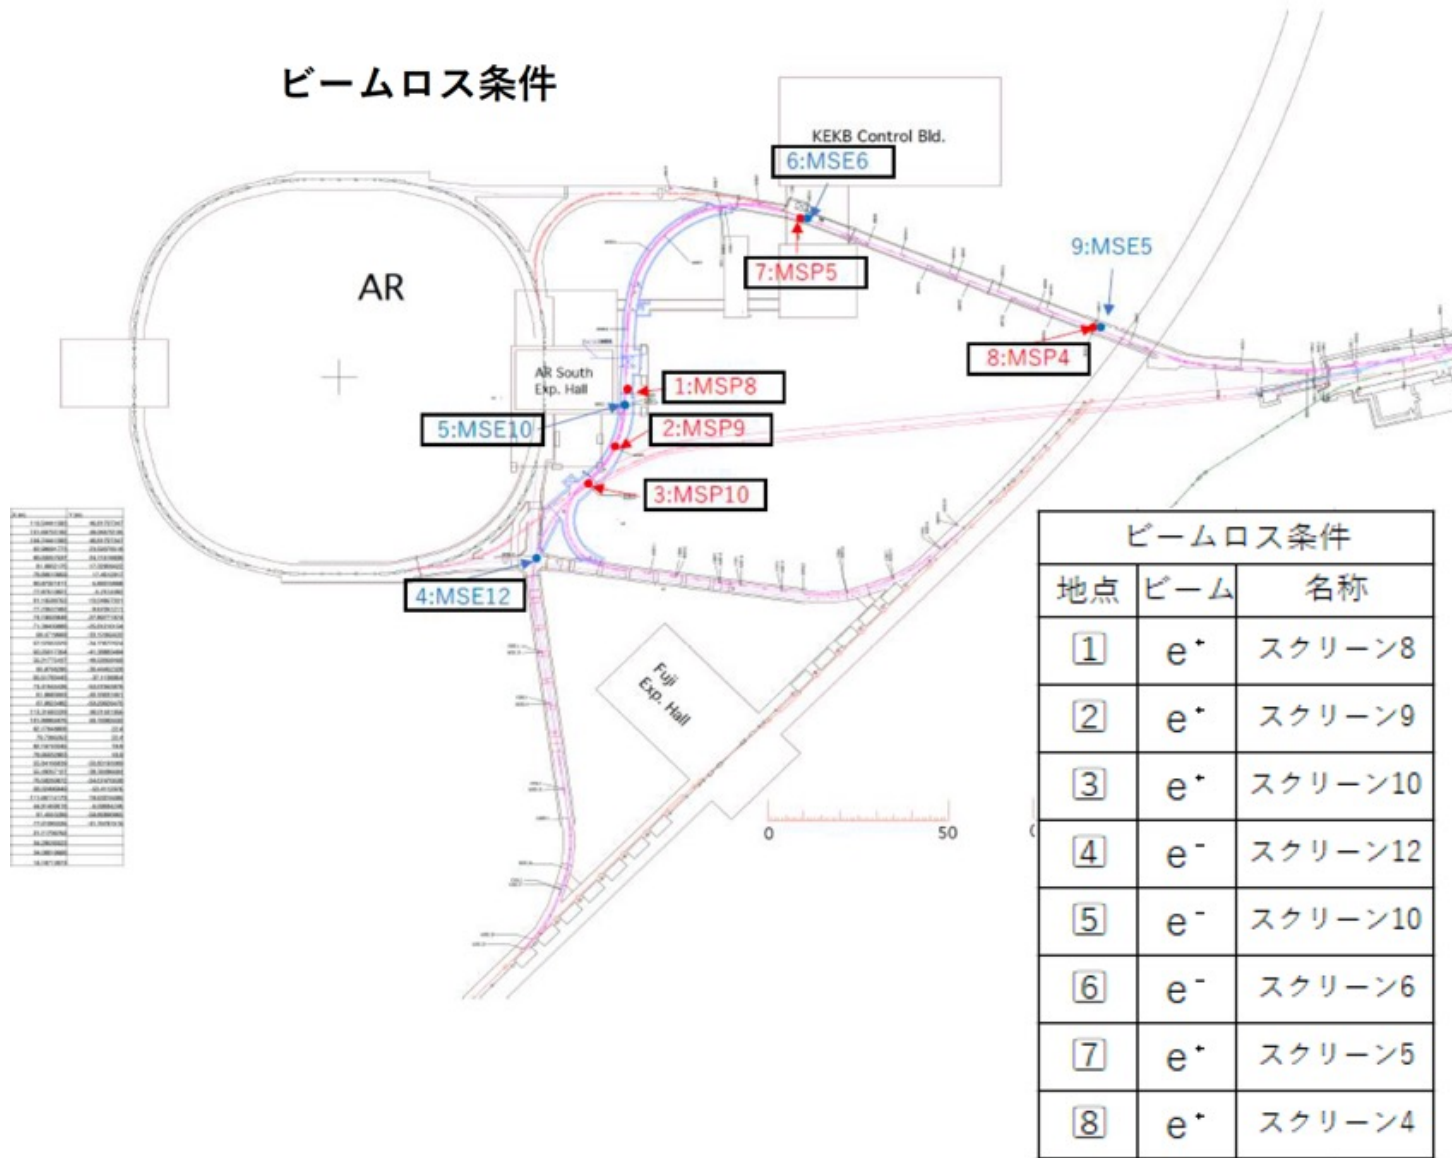
Screen Monitor inserted in the beam line

Radiation Level outside of tunnel becomes high

->Repetition Rate is limited to 1 Hz

Average Repetition Rate < 0.3 Hz /Hour

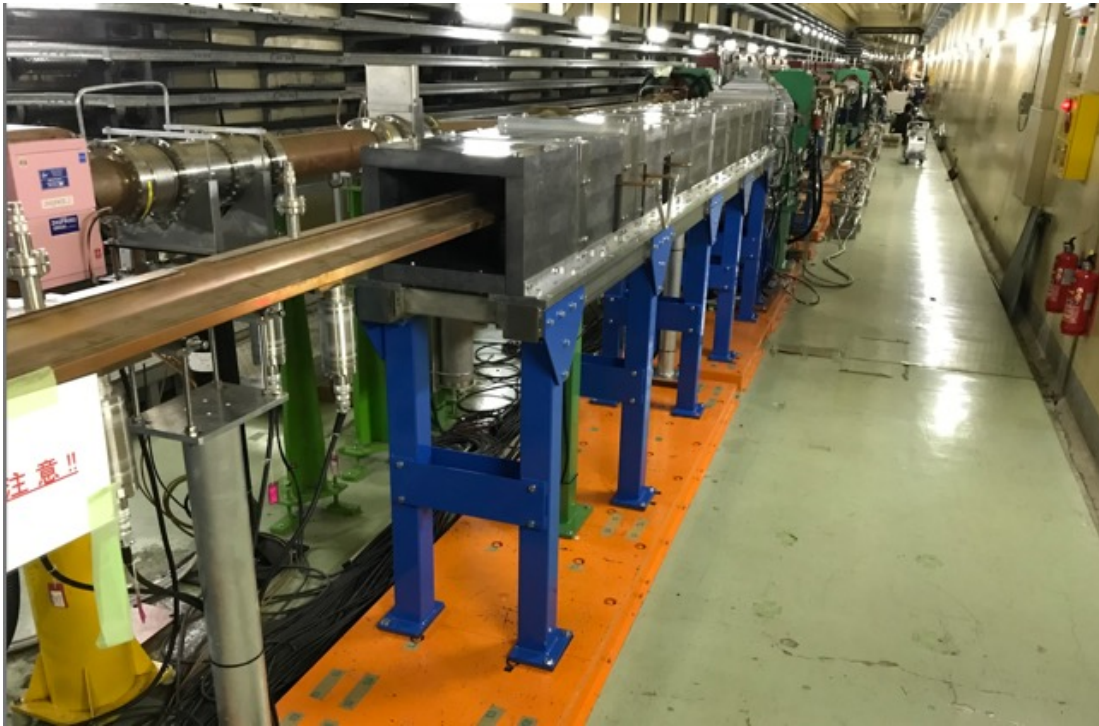
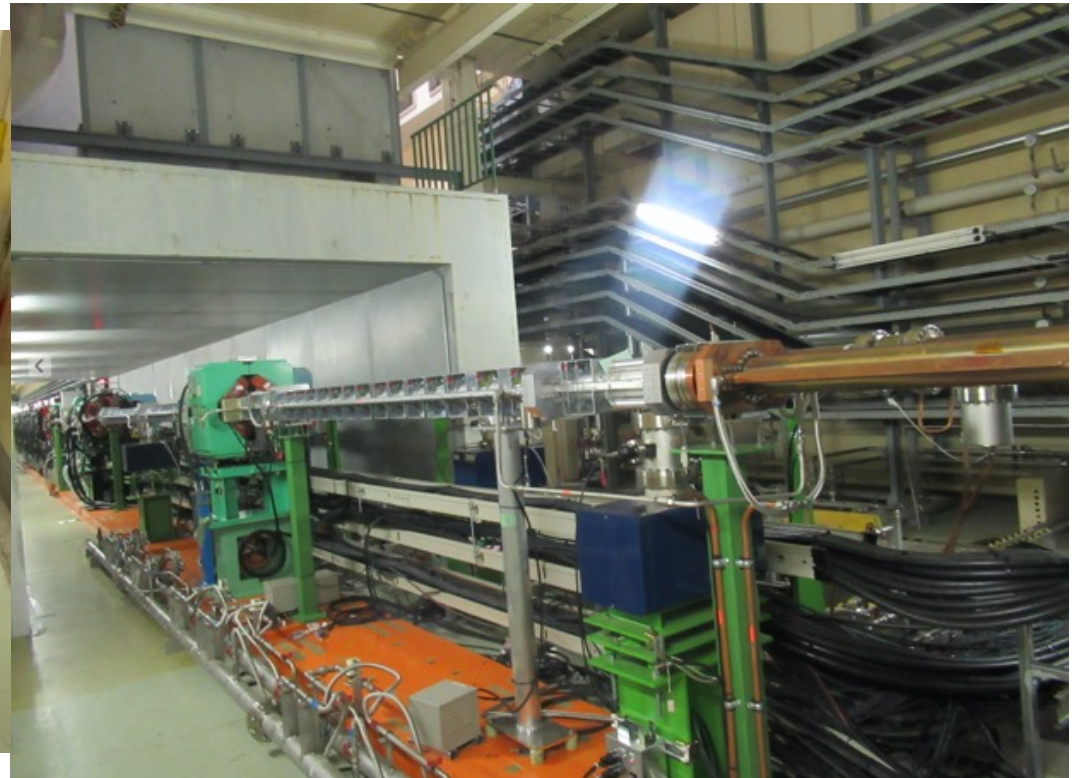
Non-Linear Collimator (NLC) is installed Oho straight section

Surround the beam pipe with 5cm of lead. (5m long)

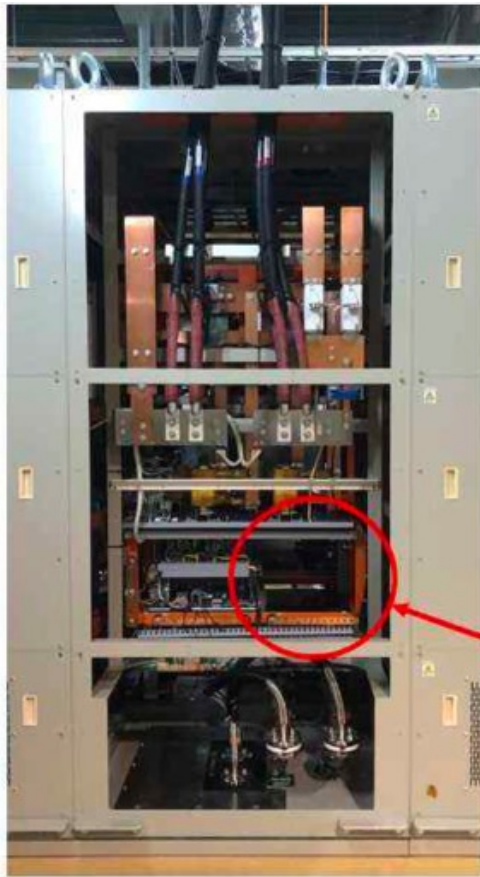
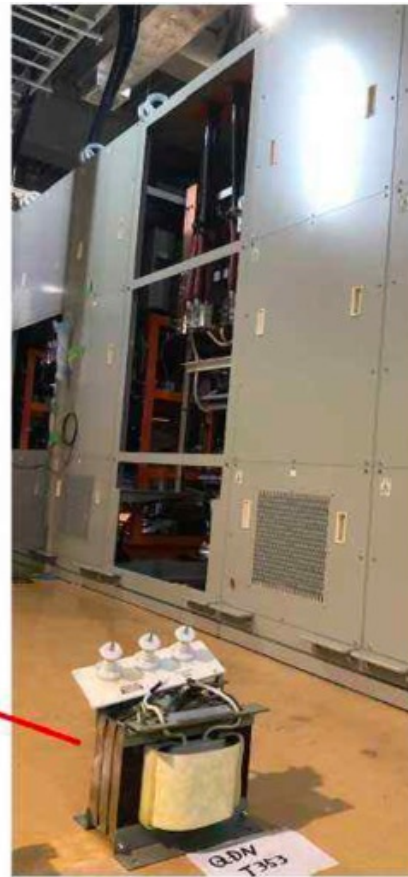
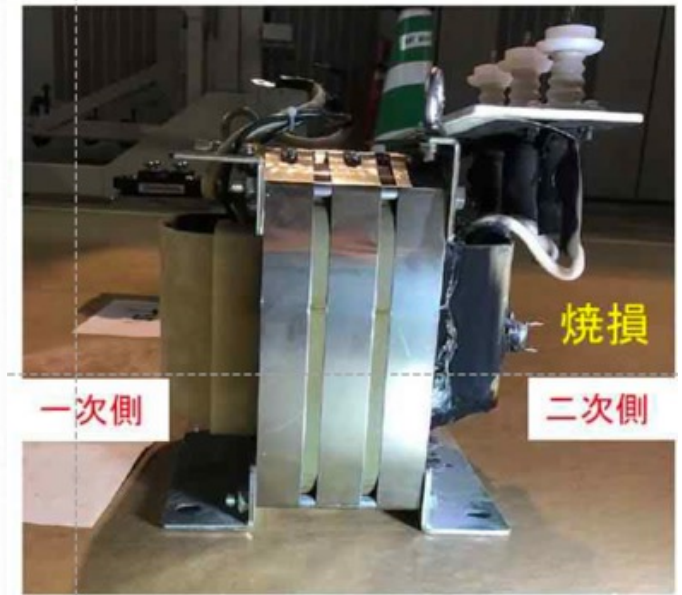
MR Power Supply Fire (April 25th):

Occurred in transformer of a magnet power supply.

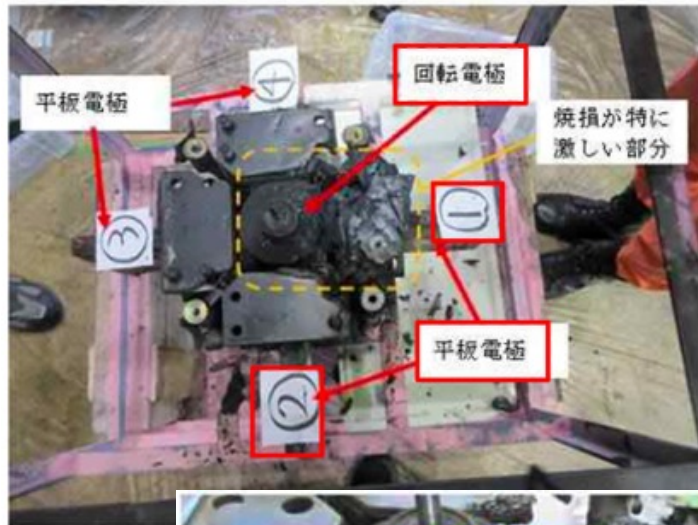
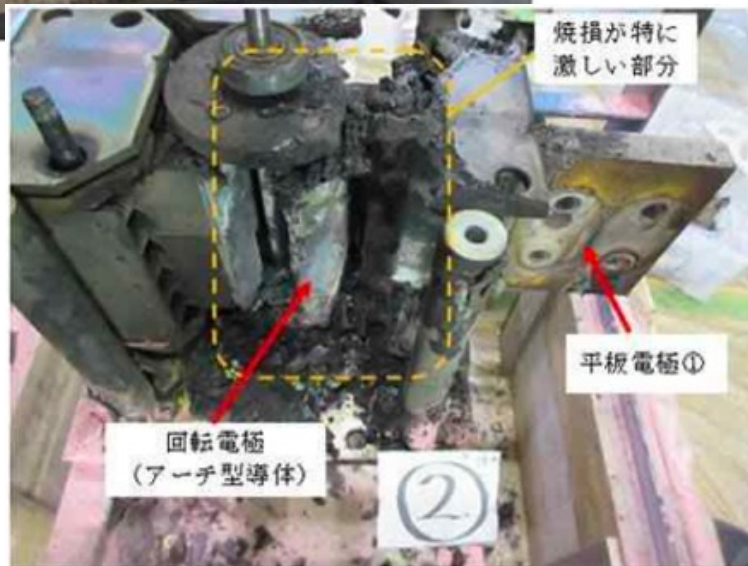
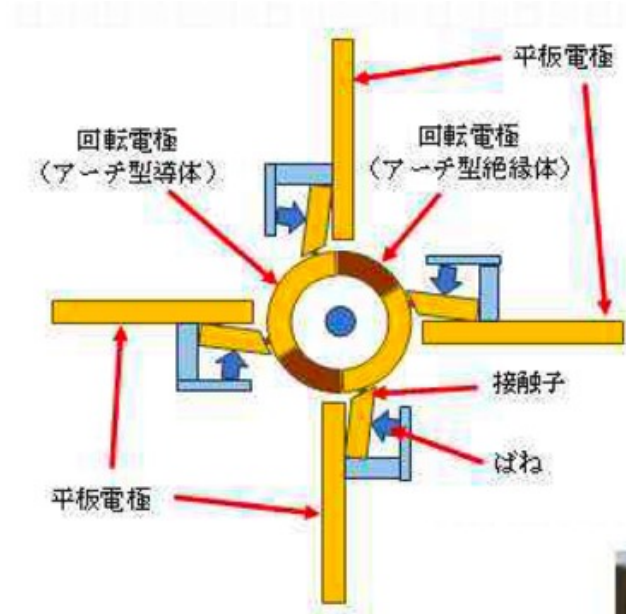
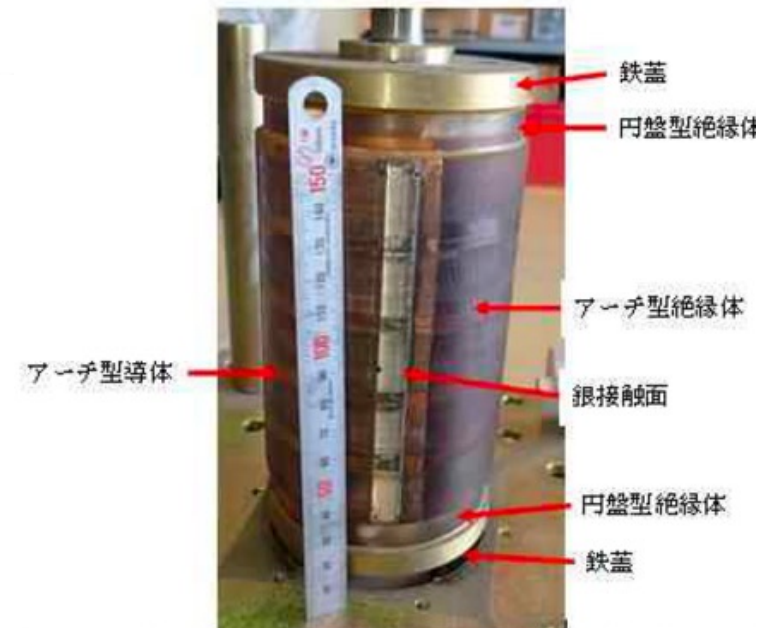
Contact resistance of Polarity Changer
 $< 0.1\text{m}\Omega \rightarrow 90\text{m}\Omega$
 It caused 100kW power Loss

- Polarity Changer
 - For power supplies that have the same type of polarizer that caught fire at J-PARC, remove the polarizer or replace it with a more commonly used device.
- Confirm the status of periodic inspections of equipment.
 - Equipment in operation that has not yet been inspected will be inspected immediately and a report will be made to the supervising engineer.
 - Reconfirm that there are no blind spots or deteriorated parts.
 - In areas subject to thermal stress, check for deterioration of components and loosening of bolts.
 - The status of fever will be confirmed using radiation thermometers, thermo-cameras, and pasting of thermo labels.
- When restarting stored old equipment, be sure to conduct a pre-use inspection.

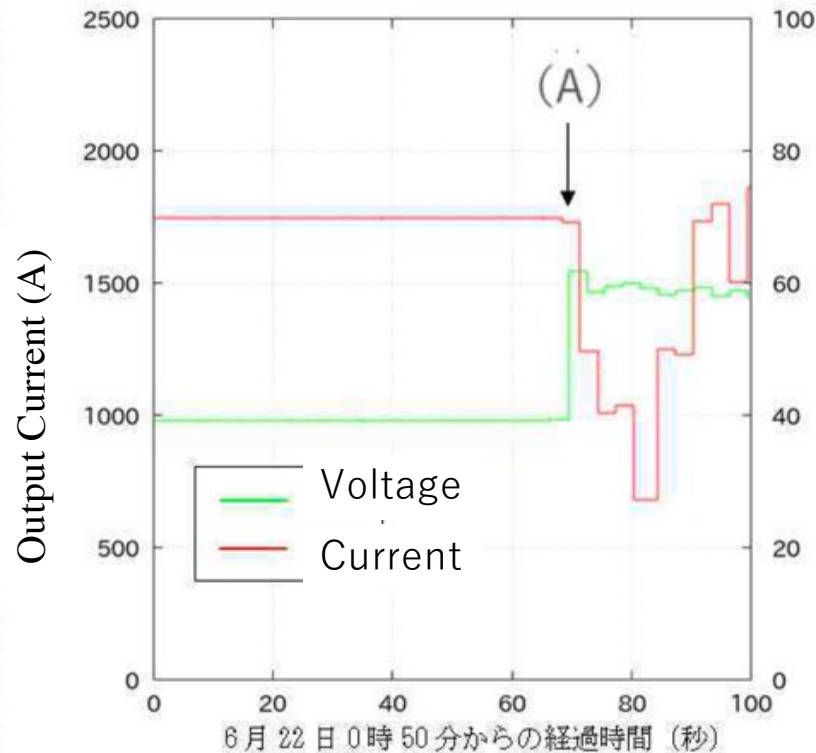
Increased resistance
 Output Current decreased
 Output Voltage increased to Maximum value (60V)

Trouble suddenly Occured
 No signs could be observed
