# Magnet

MR and BT/DR

Shu Nakamura  
On behalf of the Magnet Group

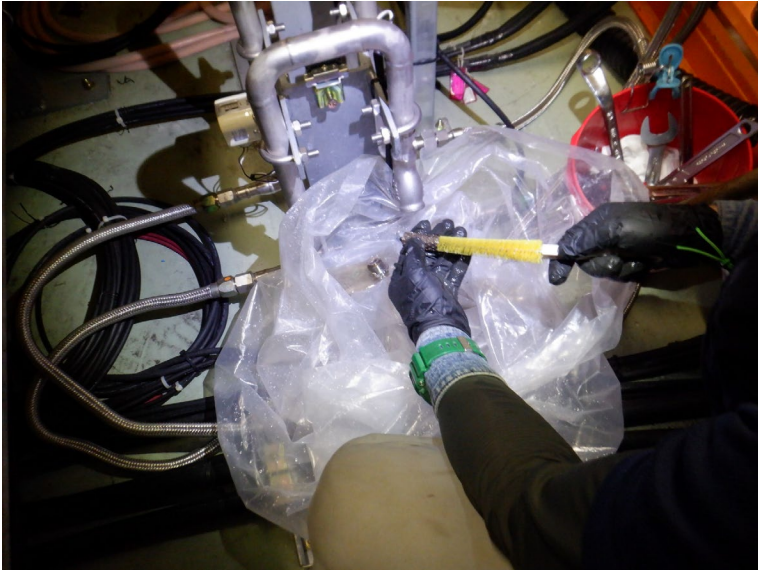
Strainer maintenance

- Cleaned the strainers and checked the flow rates of all water-cooled magnets.
- Cleaned the hoses of magnets showing a significant decrease in flow rate compared with last year.

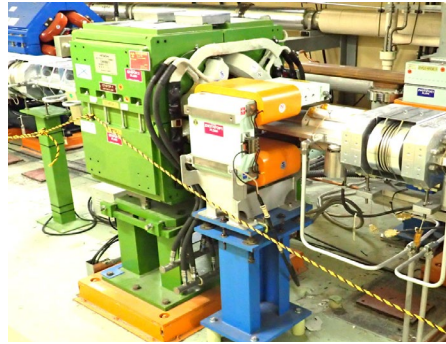
Magnet and surrounding equipment

The radiation group measured 1,200  $\mu\text{Sv/h}$  on 30 June 2026.

New EPDM hardened.  
Hardening alone cannot quantify the dose.

Flow-switch resin parts broke.

The main concern is loss of dielectric strength, leading to shorts between coils or ground faults.

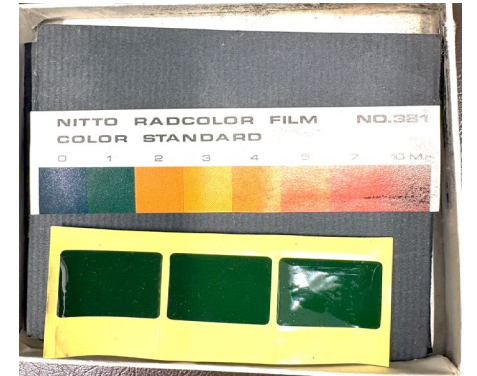
RADCOLOR film turned dark red, indicating at least  $10^7$  rad over about one year.

RADCOLOR film  
Dark red:  $10^7$  rad =  $10^5$  Gy  
Dark blue-green: Unused

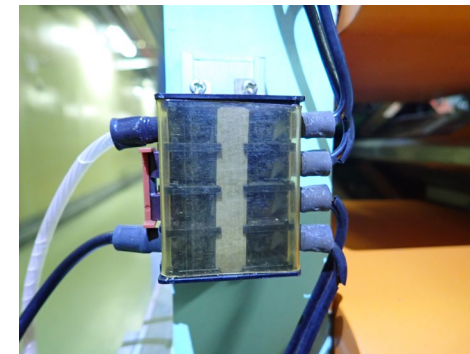
Discoloration  
St connectors and wiring

At the upstream magnet ZHQT4FOP.1, the connector showed discoloration and the cable sheath had cracked.

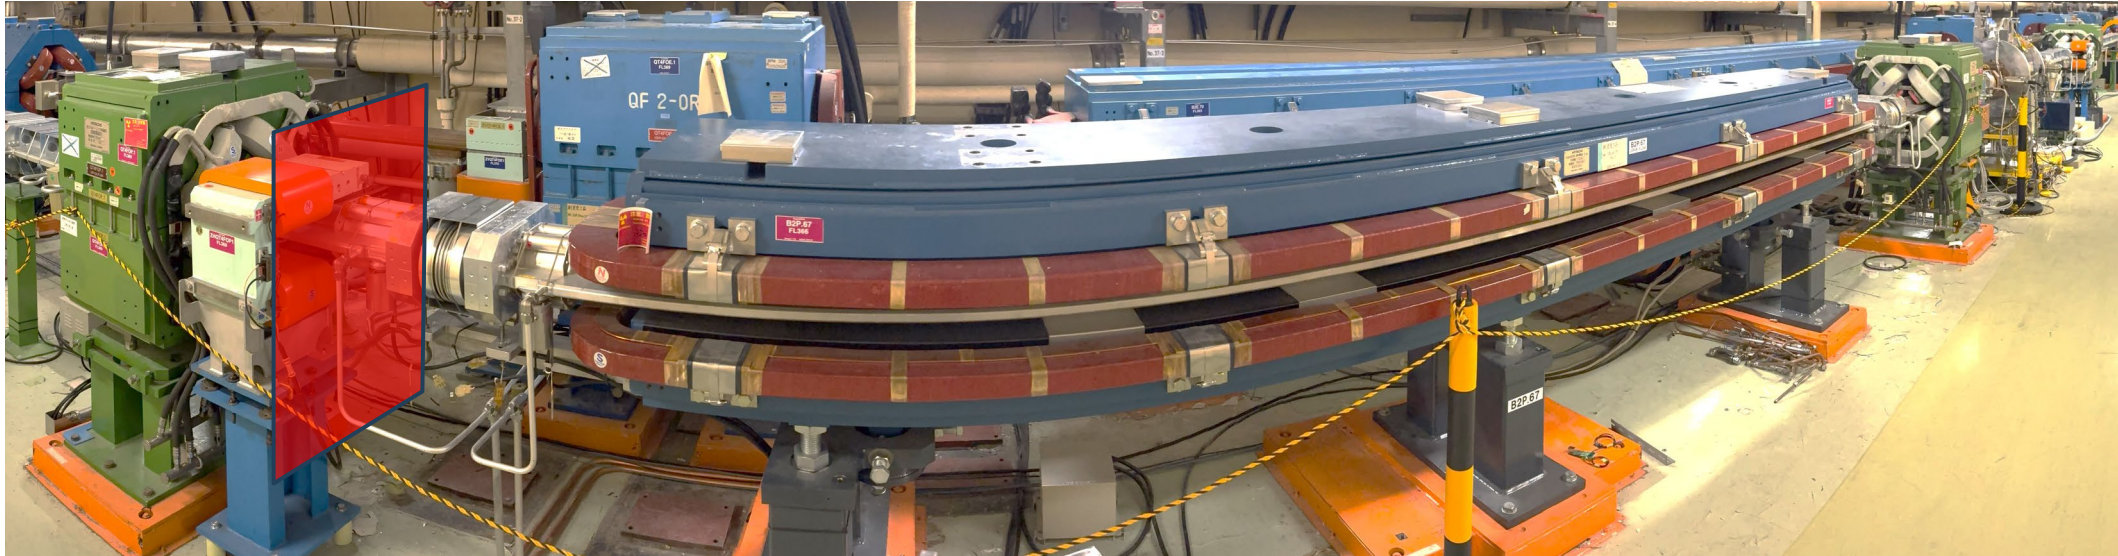
We are considering a detailed radiation survey and lead shielding at one affected location. In the future, it may be necessary to install localized shielding at approximately four additional locations.

Preliminary concept.  
Shield geometry and installation remain under study.

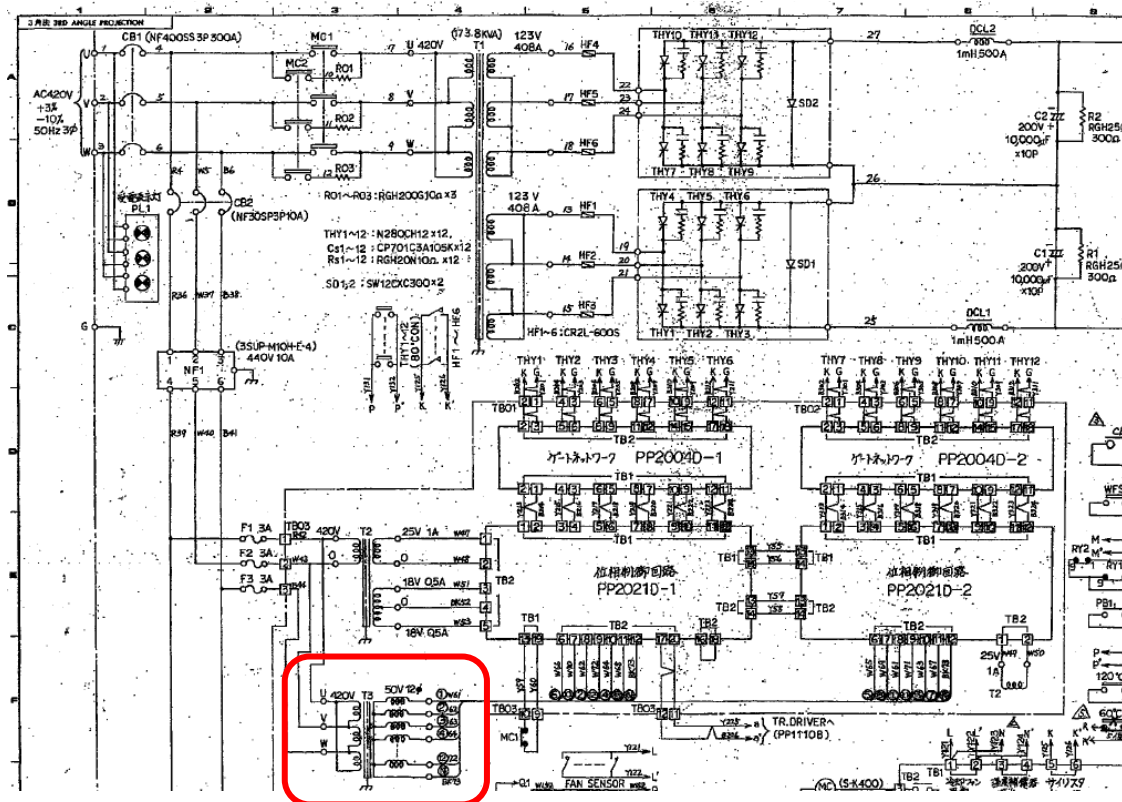
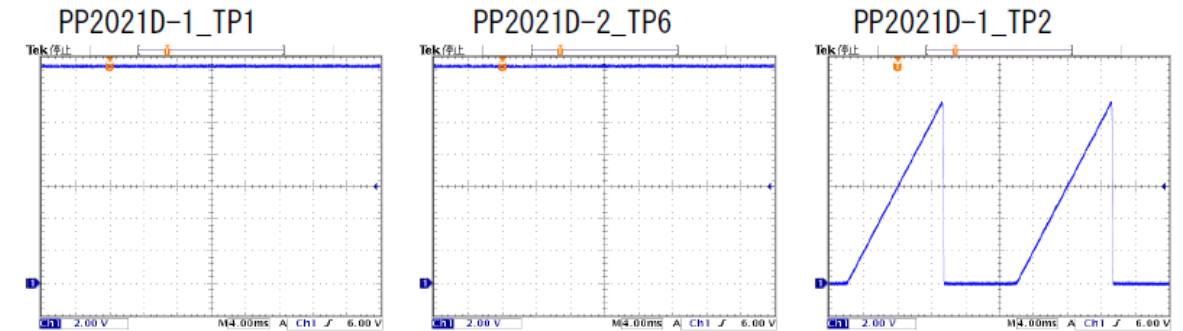
Since 2025c, the maximum current has been limited. Magnet initialization had therefore used a current below the rated value.

Two failed phases of the transformer used to synchronize thyristor gate pulses with the AC supply caused the fault.

Abnormal signals (left and center), normal reference (right)

The replacement transformer has arrived. We will replace it on November maintenance period.

We will also replace the control power supply, as the converter is approaching 30 years of service.

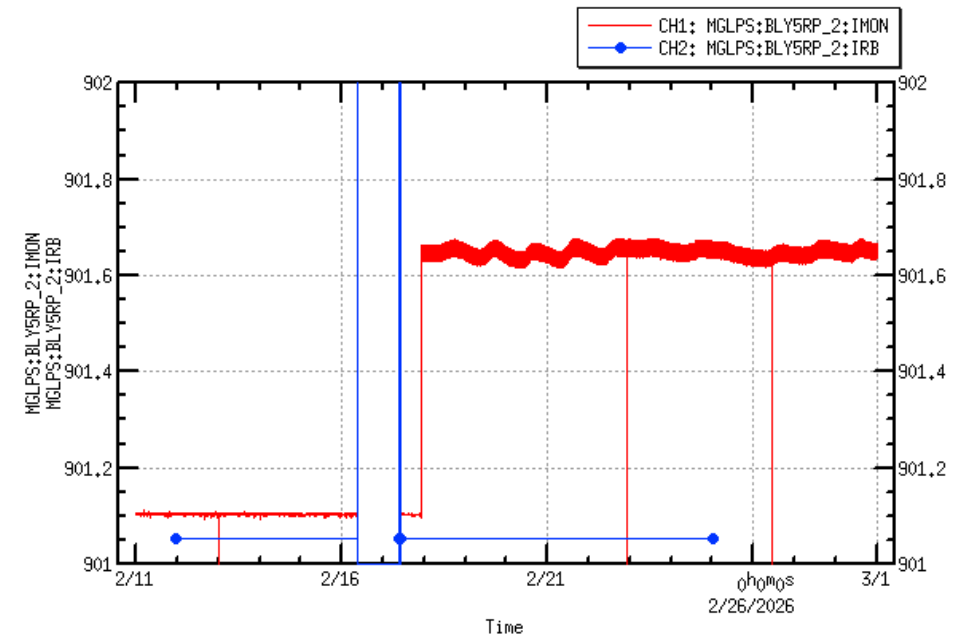
An offset and fluctuations appeared in the output current during 2026a.

- Currently investigating the cause of the issue.
- The suspected faulty converter operated normally when connected to a load and powered on.
- The condition may have changed during inspection of connection points, such as connectors.

- Continue investigating the cause.
- If the issue does not recur, return the unit to operation with a backup unit ready for immediate deployment.

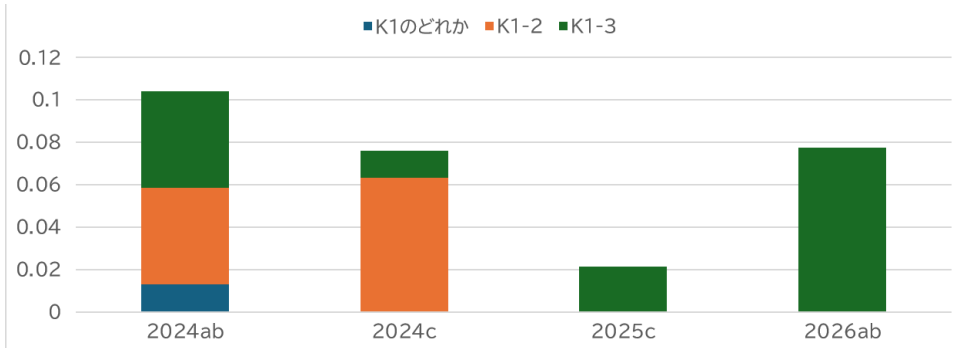
The daily rate decreased after 2024ab, then increased again in 2026ab.

Events per day by kicker  
Blue: any K1(not identified)  
Orange: K1-2  
Green: K1-3

**We decided to replace the thyatron in the LER kicker power supply K1-3, CX1174, with the type used in the HER kicker power supply, CX1826A.**

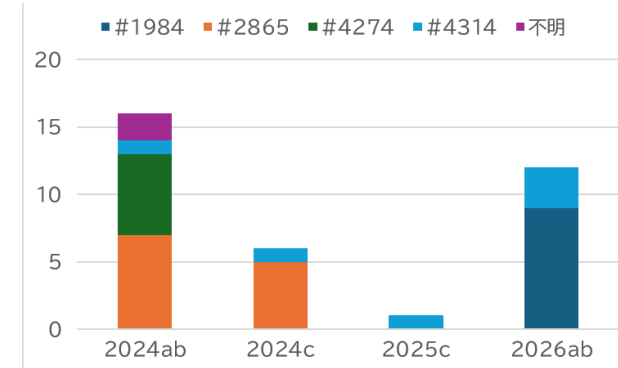
Events by tube S/N  
Dark blue: #1984  
Orange: #2865  
Green: #4274  
Light blue: #4314  
Purple: no record

K1-2 self-firing stopped after a thyatron replacement.  
(#2865 → other)

K1-3 events continued after some replacements.  
(#4274 → #4314 → #1984)

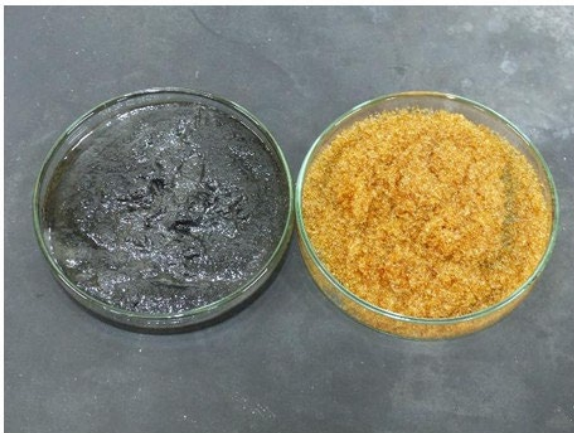
Demineralizer resin samples, 2026. (Left) Used resin, (Right) New resin.

- Increased from 1 event (2021-2024) to 2 (2025c) and 12 (2026ab).
- No events since demineralizer resin replacement on May 7.

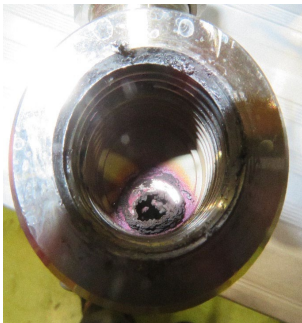
(Left) Needle valve, (Right) Strainer clogged with copper oxide.

- Flushed cooling water circuits, removed needle valves, and cleaned strainers.
- Observed copper oxide deposits in strainers.
- Cleaning BT cooling tower strainers is expected to reduce deposits.

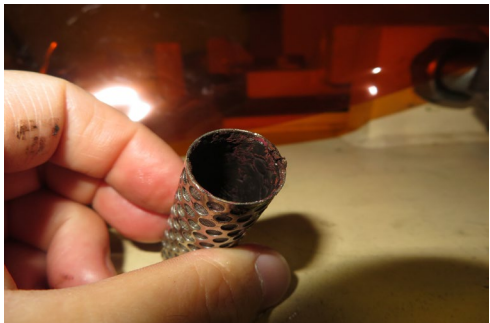
Strainer undergoing maintenance. It is clogged with copper oxide.

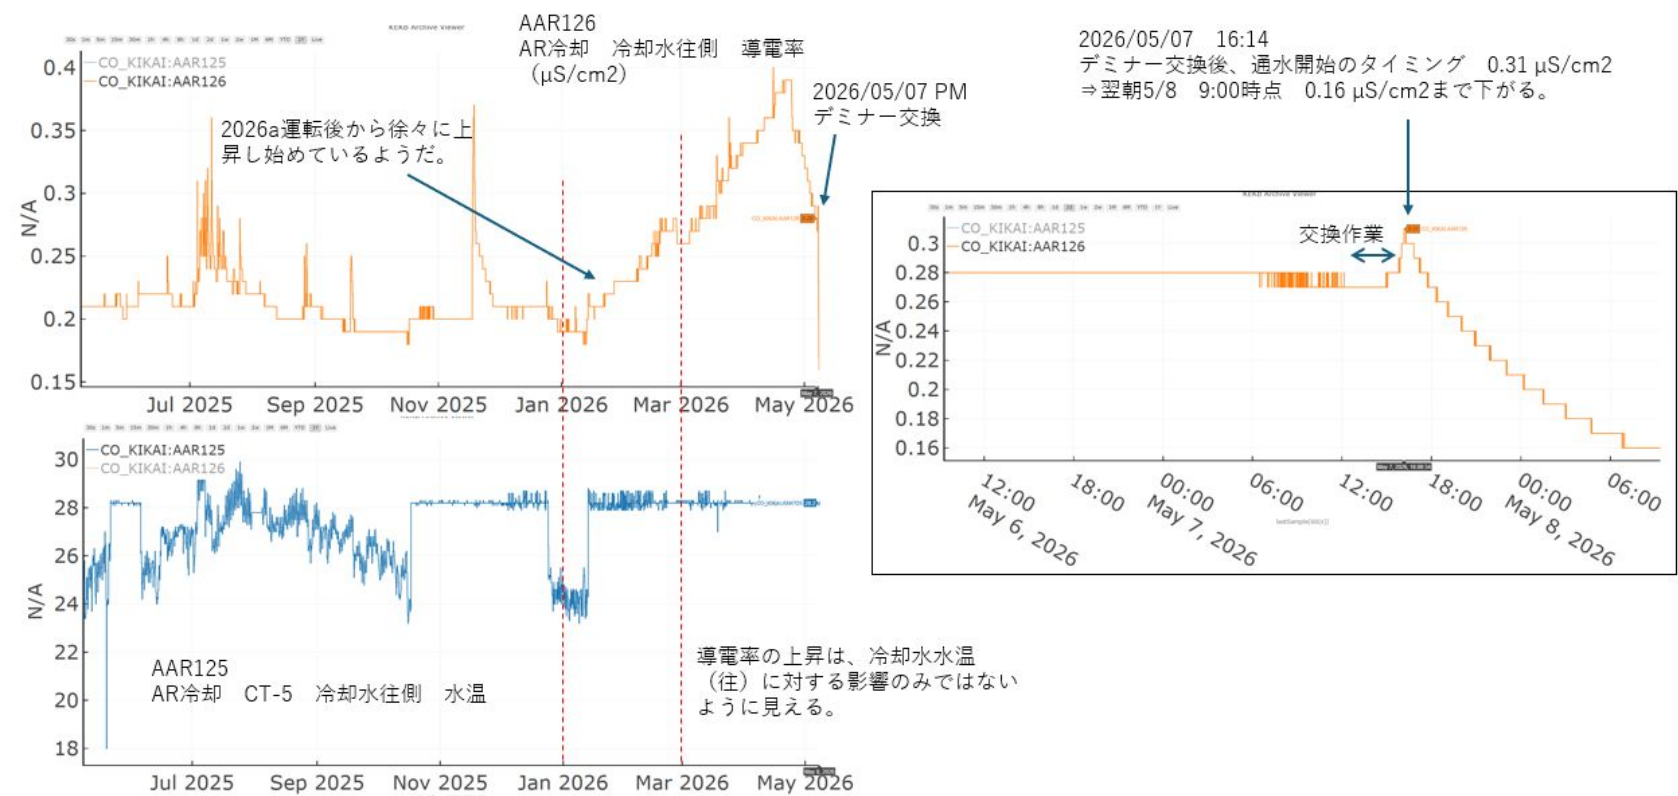
BT magnet cooling-water measurements, 8 May 2026

Conductivity fell from 0.31 after replacement to 0.16 by the next morning (source units).

The earlier rise does not appear to follow temperature alone.

Conductivity-unit label requires confirmation. All plotted data are unchanged.
