# Vacuum

The 29<sup>th</sup> KEKB Accelerator Review Committee  
26<sup>th</sup> October 2026

Mu-Lee Yao  
On behalf of KEKB Vacuum Group

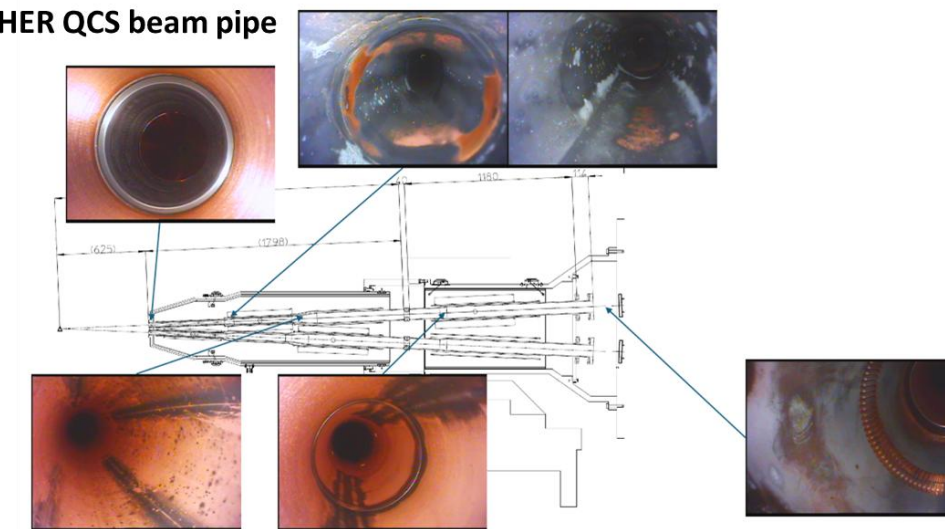
D02 HER QCS beam pipe

- An inspection of the inside of the QCS beam pipes using a fiber scope were performed. In particular, the surface on the HER D02 side showed discoloration—areas that were supposed to be copper-plated had turned black.

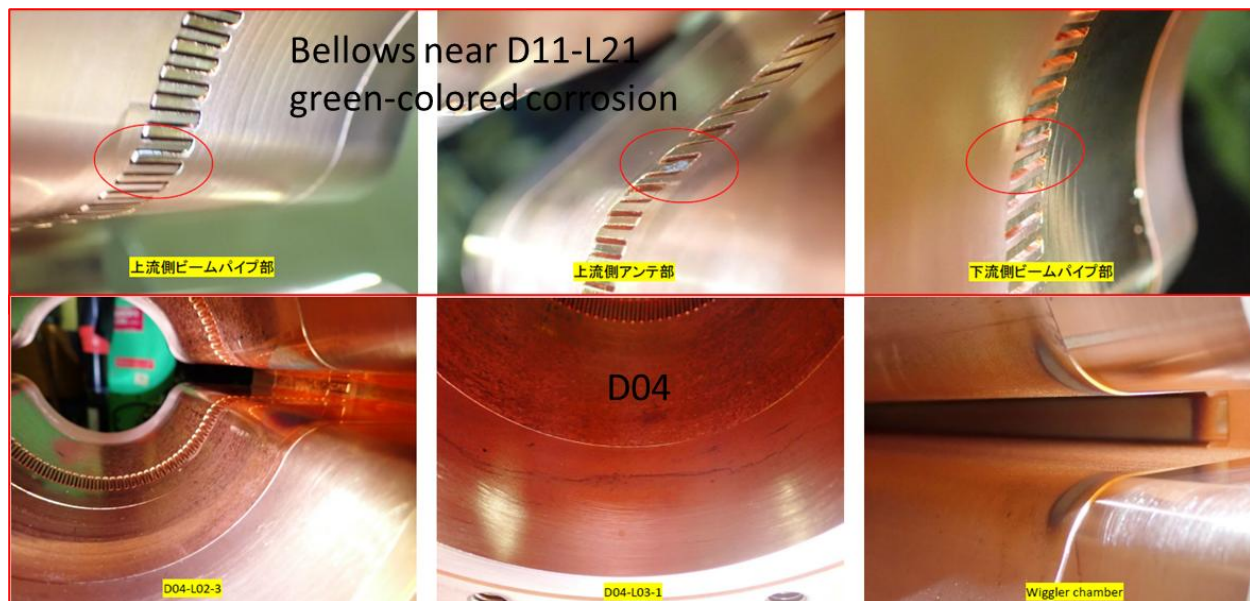
- Pressure bursts during SBL were still observed at D11 and D04
  - The interior of the bellows was checked, and both bellows were replaced — 4 units in total.
- Verification during 2026ab run: Pressure bursts frequency reduced (see following pages)
  - Bellows replacements?
  - Natural conditioning? Not sure
- The event frequency remains higher than before LS1, although the beam current is also higher.
- Beam losses accompanied by pressure bursts also occur in regions where Vacuum Sealant has not been used, suggesting that factors other than Vacuum Sealant also contribute to beam losses.

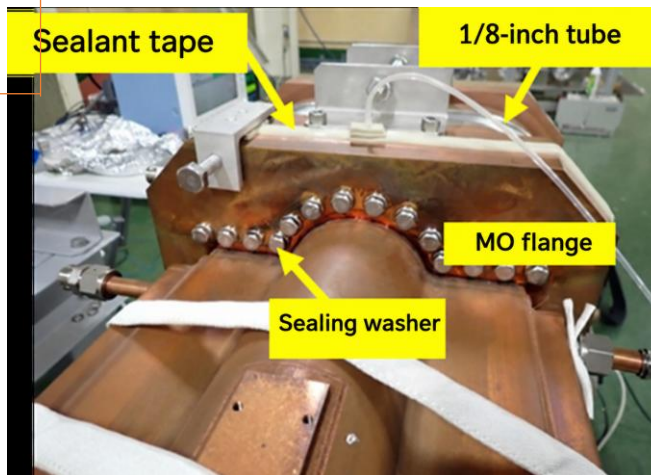
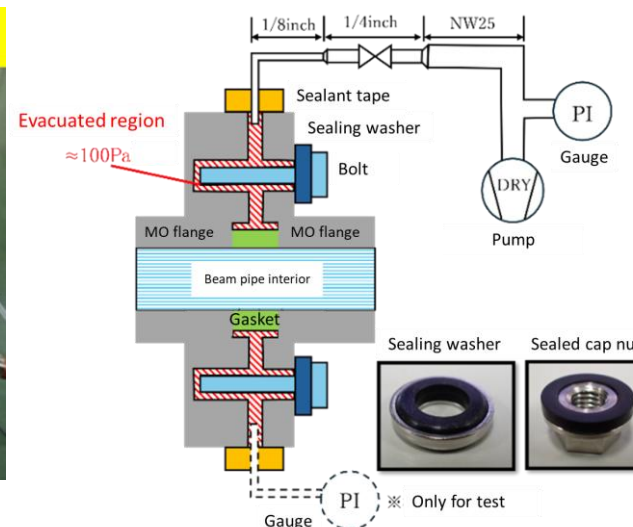
#### 1. Nikko CCG D10\_L07

- 2025/11 (2025c): Installed a **clamshell** upstream of D10\_L07
- 2026/02: Repeated leaks at CCG D10\_L07 (Feb. 4, 9, and 12) were resolved by retightening and gasket replacement
- 2026/02: Installed another clamshell upstream of D10\_L08, **clamped** the antechambers at four locations (two on the inner side and two on the outer side), and aligned the bellows
- Results: Improved temperature and pressure behavior in the surrounding area

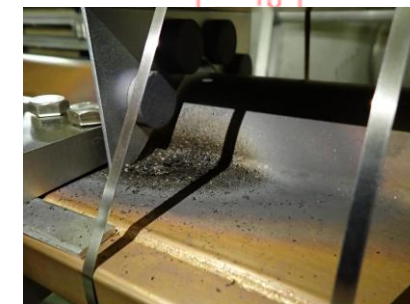
IP/CCG  
D10\_L09

- Pressure rise at CCG D10\_L09 - associated with upstream beam pipe heating
  - Black copper oxide was observed (#169: 280°C/ #27:180 °C @1600 mA)
  - Before 2027ab: 1. Replace the upstream bellows with an SR-mask-equipped unit, 2. reverse the chamber orientation, and 3. fabricate a spare
  - Clamping is effective, but the amount of deformation must be controlled

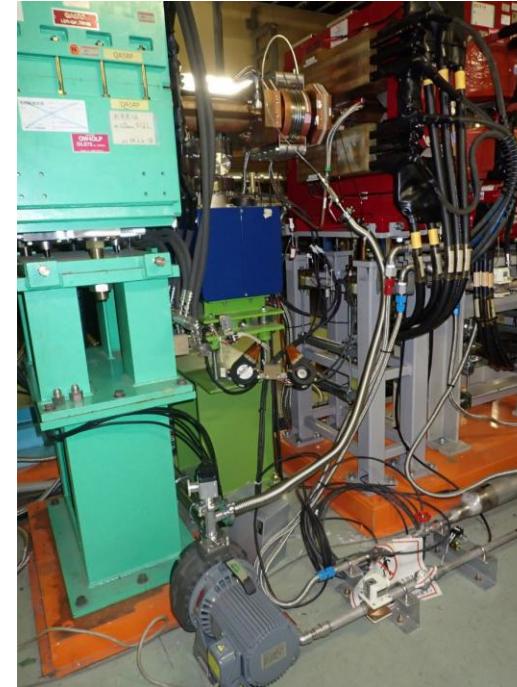
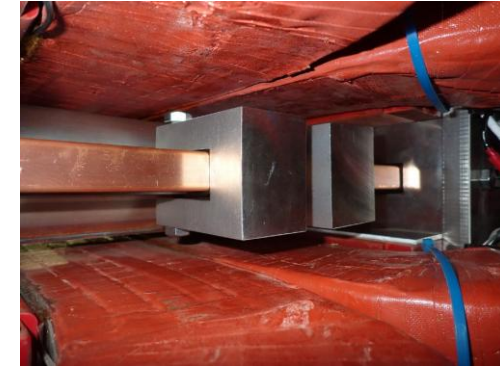
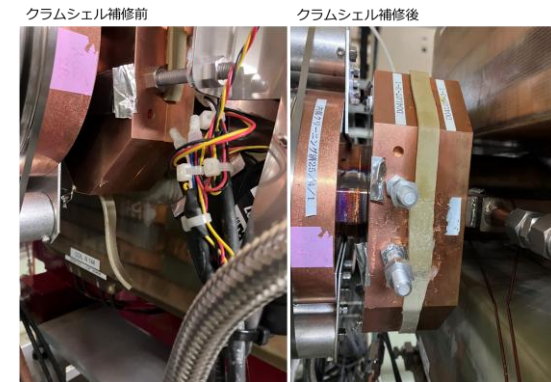
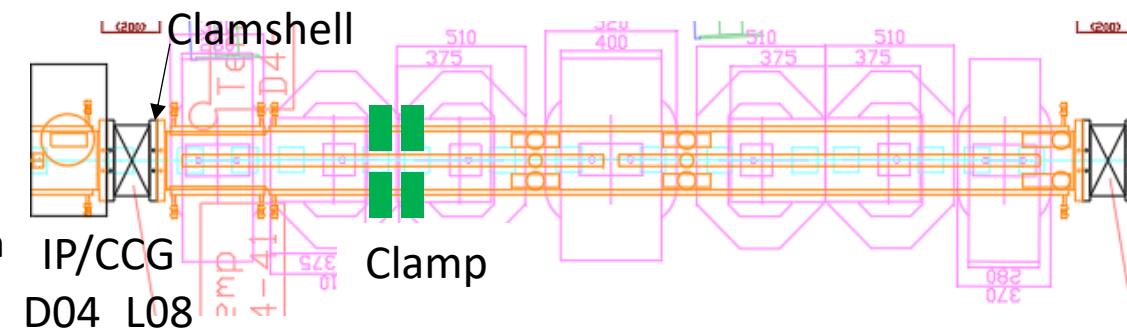
### 2. LER wiggler: Leaks, Clamshell, and Clamp 2. Oho CCG D04\_L08

- 2026/02/15 A leak developed at the upstream flange of CCG D04\_L08 after a beam abort
  - Retightening
  - 2/16 Installed a clamshell at the D04\_L08 bellows connection and antechamber clamps on the upstream chamber (two each on the inner and outer sides).
- 05/06 The same flange leaked again after a beam abort
  - Some sealant had detached from the clamshell side. Retightened the flange and repaired the clamshell
- 06/06 Another leak occurred after a beam abort
  - Retightening 3 times
  - Following orbit adjustment in the wiggler section CCG pressure reduced  $1.1 \times 10^{-7} \text{ Pa} \rightarrow 0.8 \times 10^{-7} \text{ Pa}$

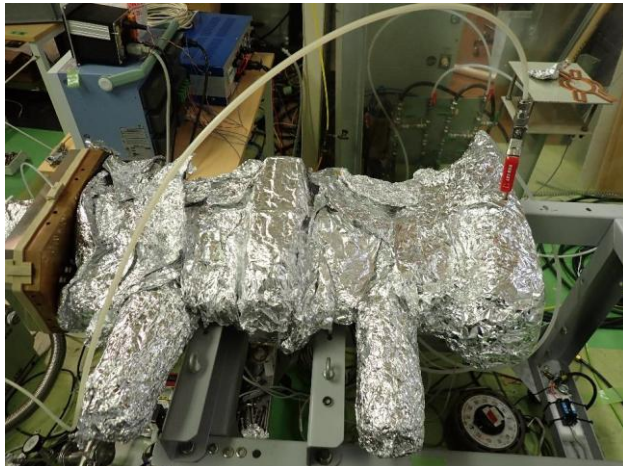
#### 2. Enhanced water-cooled bellows

- Temperature differences between the top and bottom of the flange have been confirmed to cause vacuum leaks
- Structural simulations indicate no significant reduction in flange stiffness
- Thermal simulations:  
63°C without water cooling  
45°C at 1.5 L/min / 35°C at 3.5 L/min
- Heating-tape tests also confirmed effective temperature reduction (2026/06)

- Prioritize locations with high leak risk (clamshell sites)
  - D04: 3 units/ D10: 13 units/ D11: 10 units (All Completed)

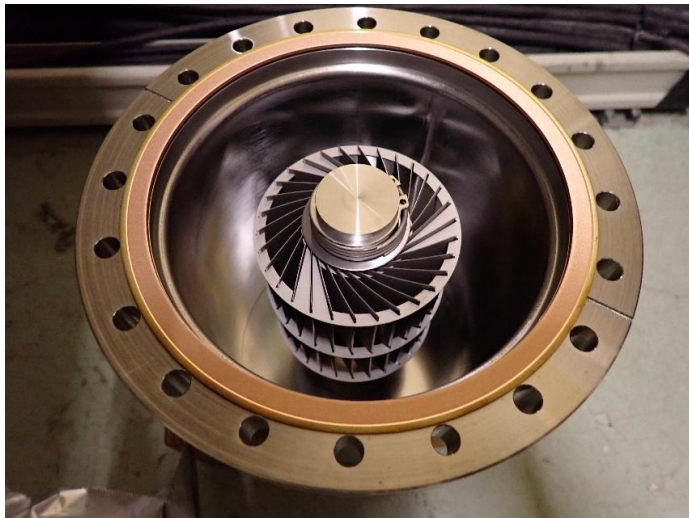
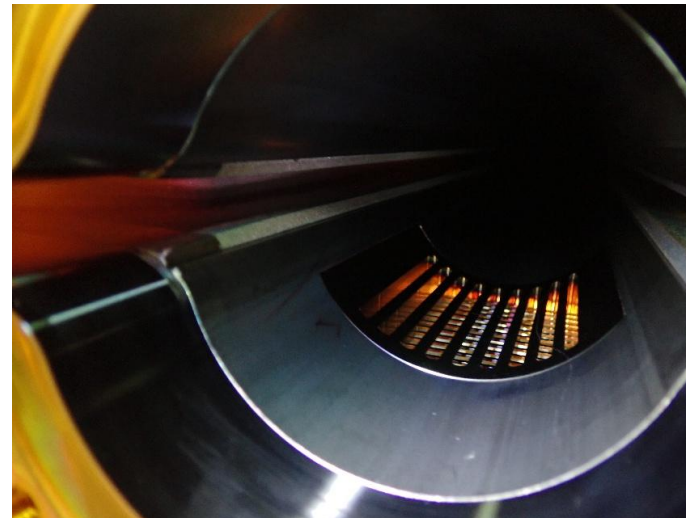
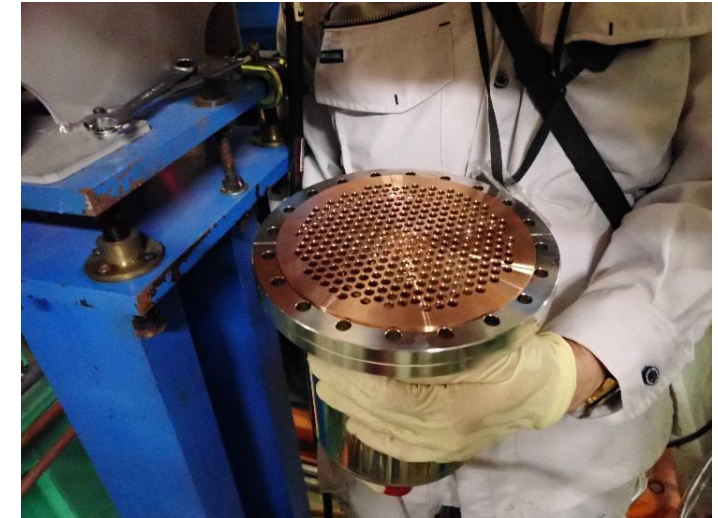
NEG Pump near CCG D10\_L09C

- Pressure rise was observed at CCG D10\_L09C in LER wiggler section
- Chamber opened for inspection on 7/3; only slight gasket discoloration was observed
- RF-screen gaskets were installed at the NEG pumps near CCG D10\_L09C and also CCG D04\_L09C

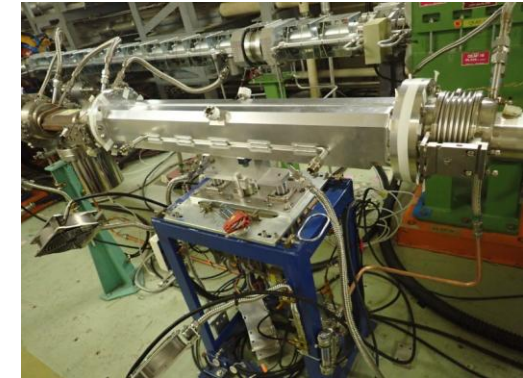
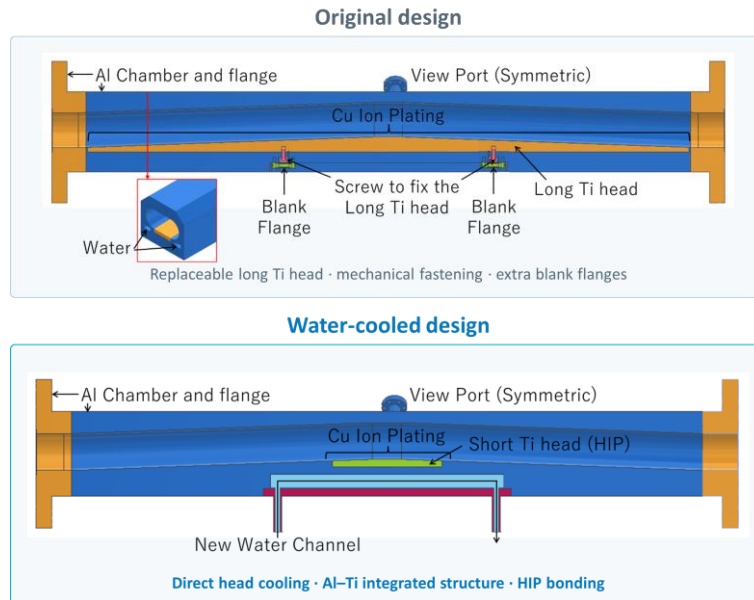
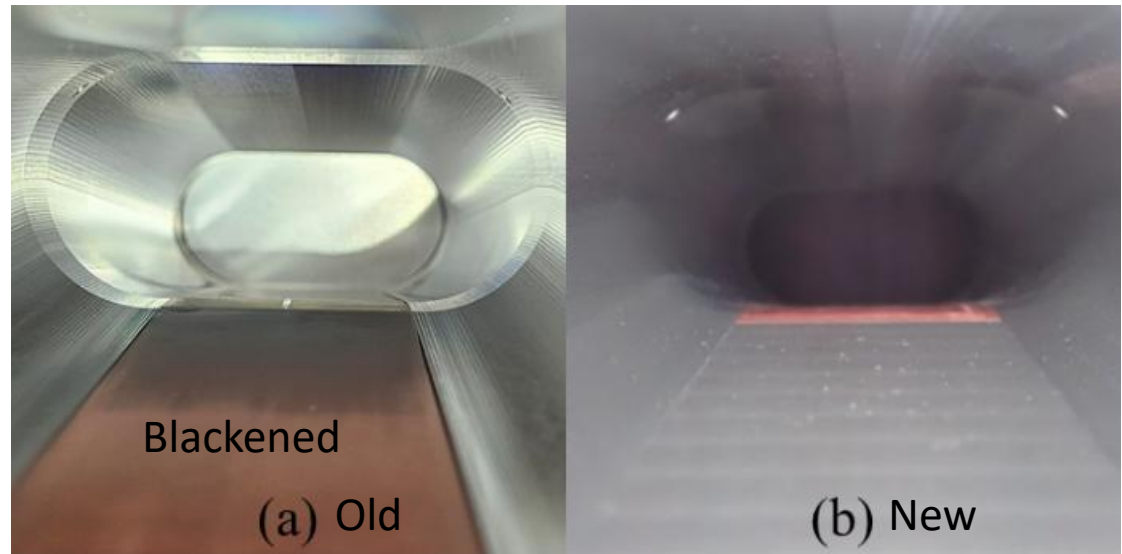
- Nonlinear pressure rises were observed at several HER collimators
- Suspected mechanism: SR heating causes head deformation, reducing thermal contact with the chamber and cooling efficiency, leading to sharp temperature and pressure rises
- A water-cooled KEKB-type collimator was installed at D09V3 before the 2025c run to suppress nonlinear pressure rise
- The removed head showed pronounced blackening, suggesting possible overheating to 200–300°C, although discoloration alone cannot establish the temperature

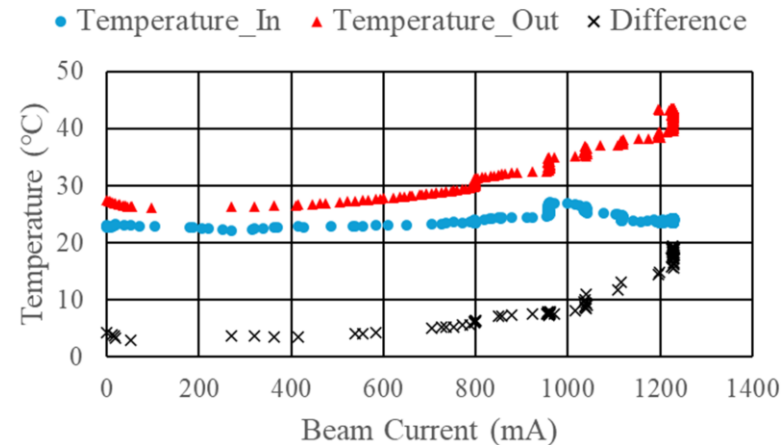
After: water-cooled collimator (2025–2026)

Stable up to ~1300 mA  
(jaw positions 1.35–1.38 mm)

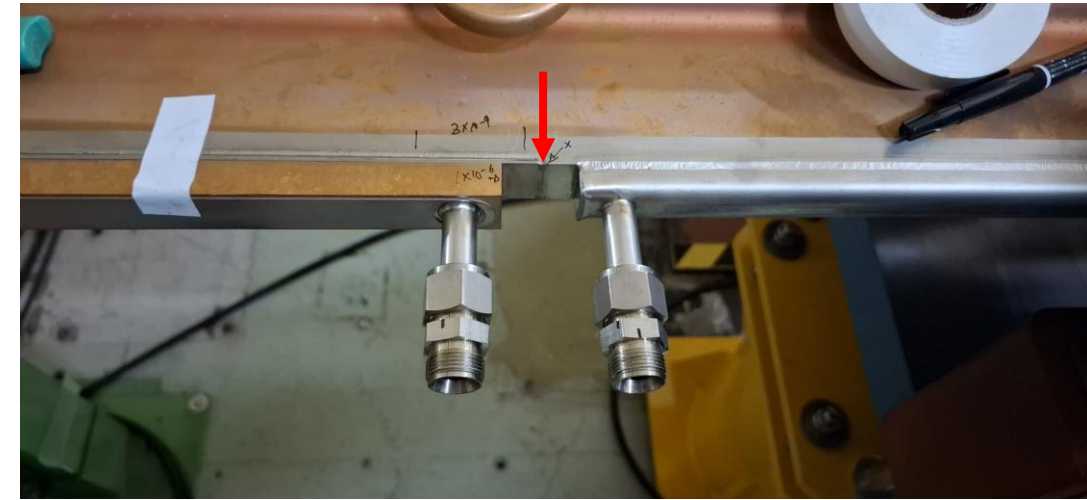
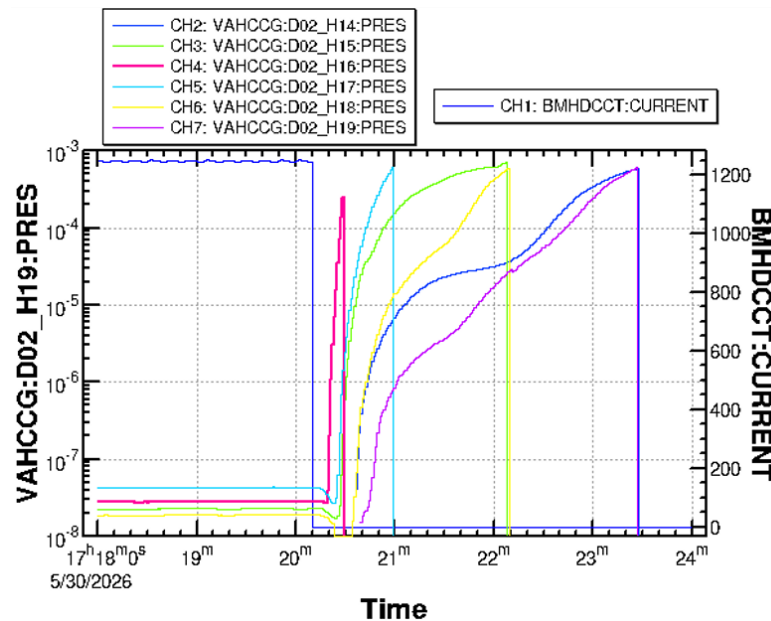
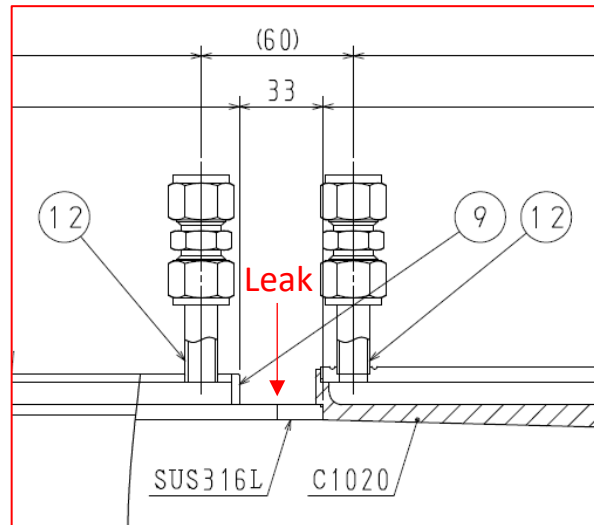
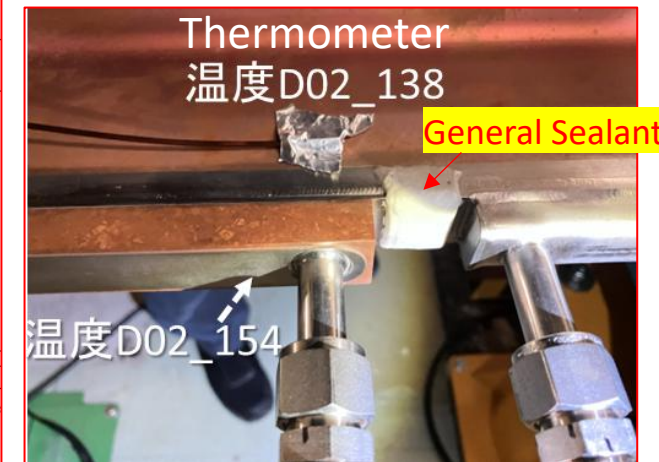
- 2026/05/30 A leak developed at a weld in the stainless-steel beam pipe for ZVF4RE (iBump steering), near CCG D02\_H16.
- Temporarily sealed with General Sealants and Vacuum Sealant during operation
- Suspected cause: Thermal fatigue cracking due to SR from BLA2RE striking the weld

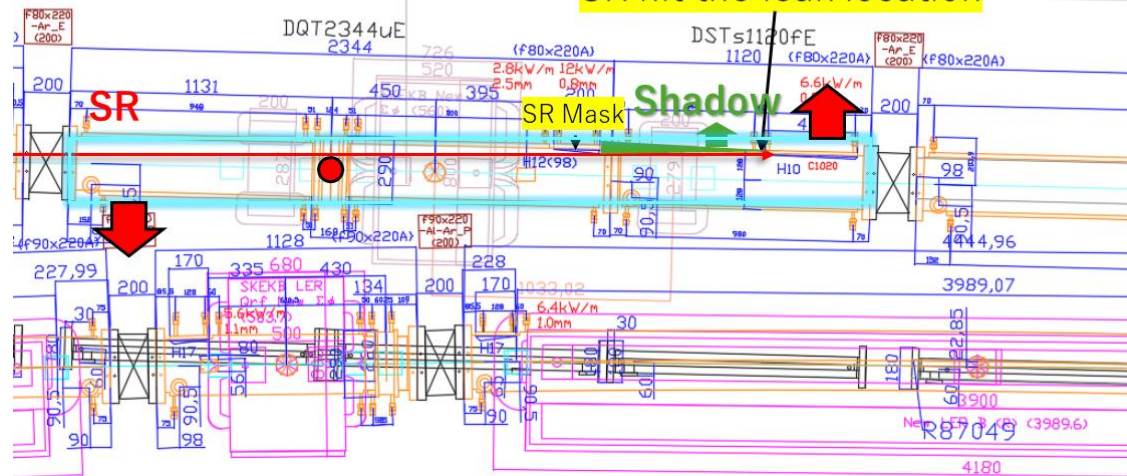
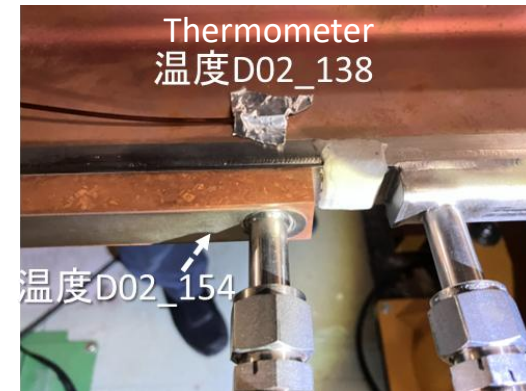
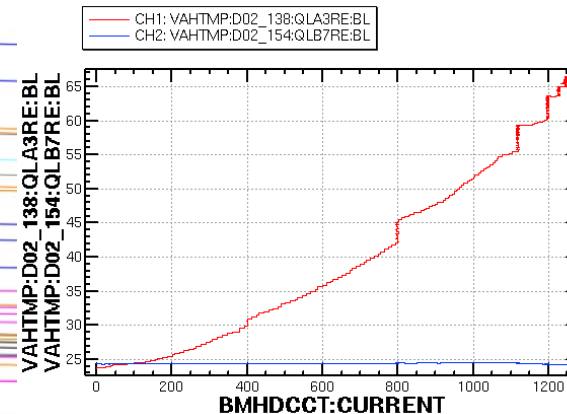
SUS welding line:  
SR hit the leak location

6/11 Before rotation: The D02\_154 thermometer had detached

6/11 After rotation: The D02\_154 thermometer was resecured

- 6/11 As an emergency measure, rotated the upstream QLA3RE beam pipe 0.5° counterclockwise about the BPM
  - The rotation reduced the temperature by approximately 15 °C at 1200 mA
- Occasional pressure spikes and fluctuations persisted at CCG D02\_H16, but remained within the acceptable range.

Move the leak location into the shadow of the SR mask.

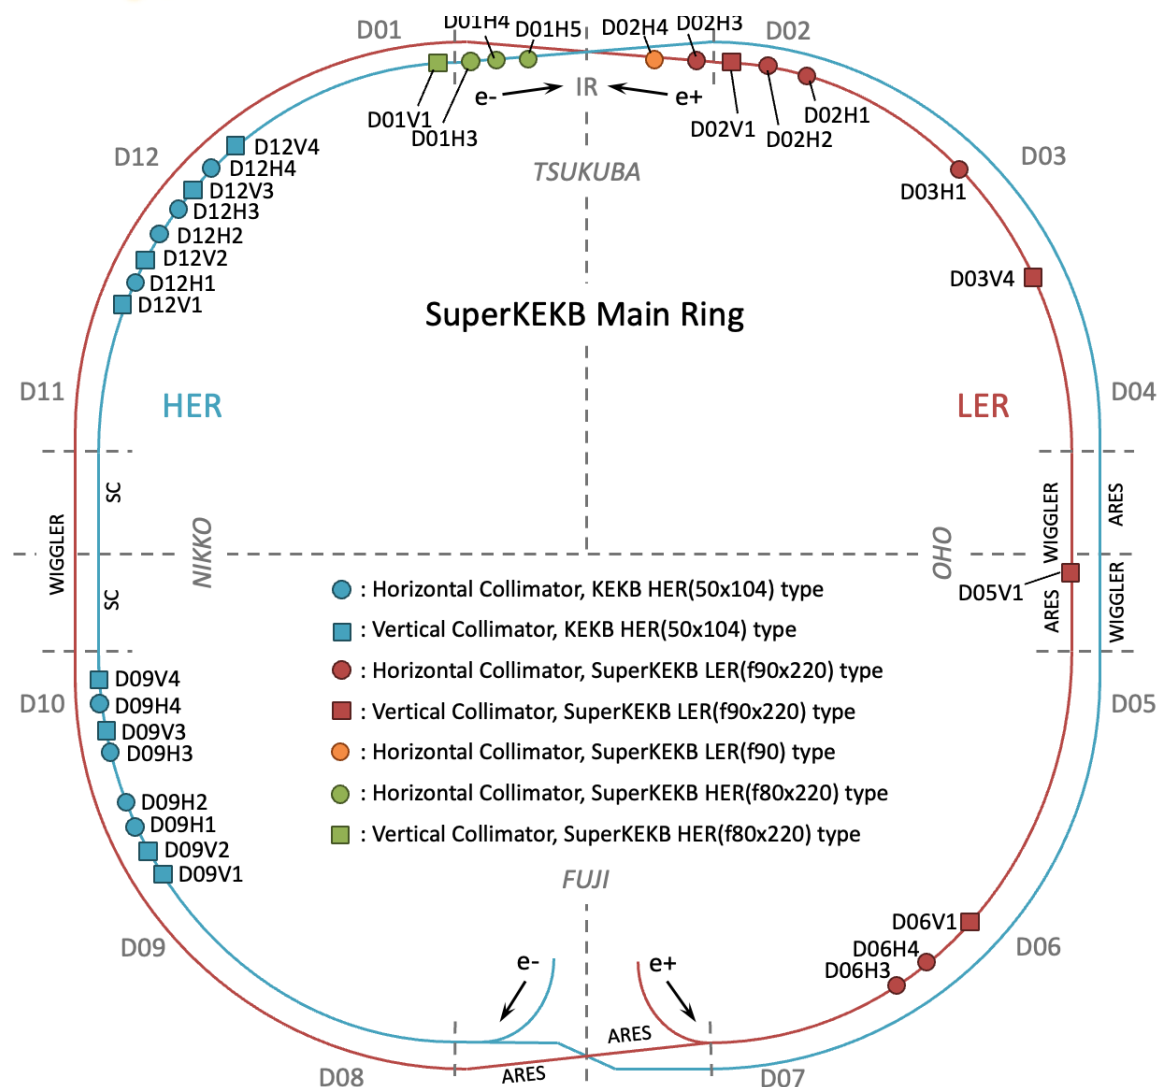
# 4-3-1. Status of LER collimator before 2027ab

- D02H1 may be damaged due to the injection kicker accidental firings.

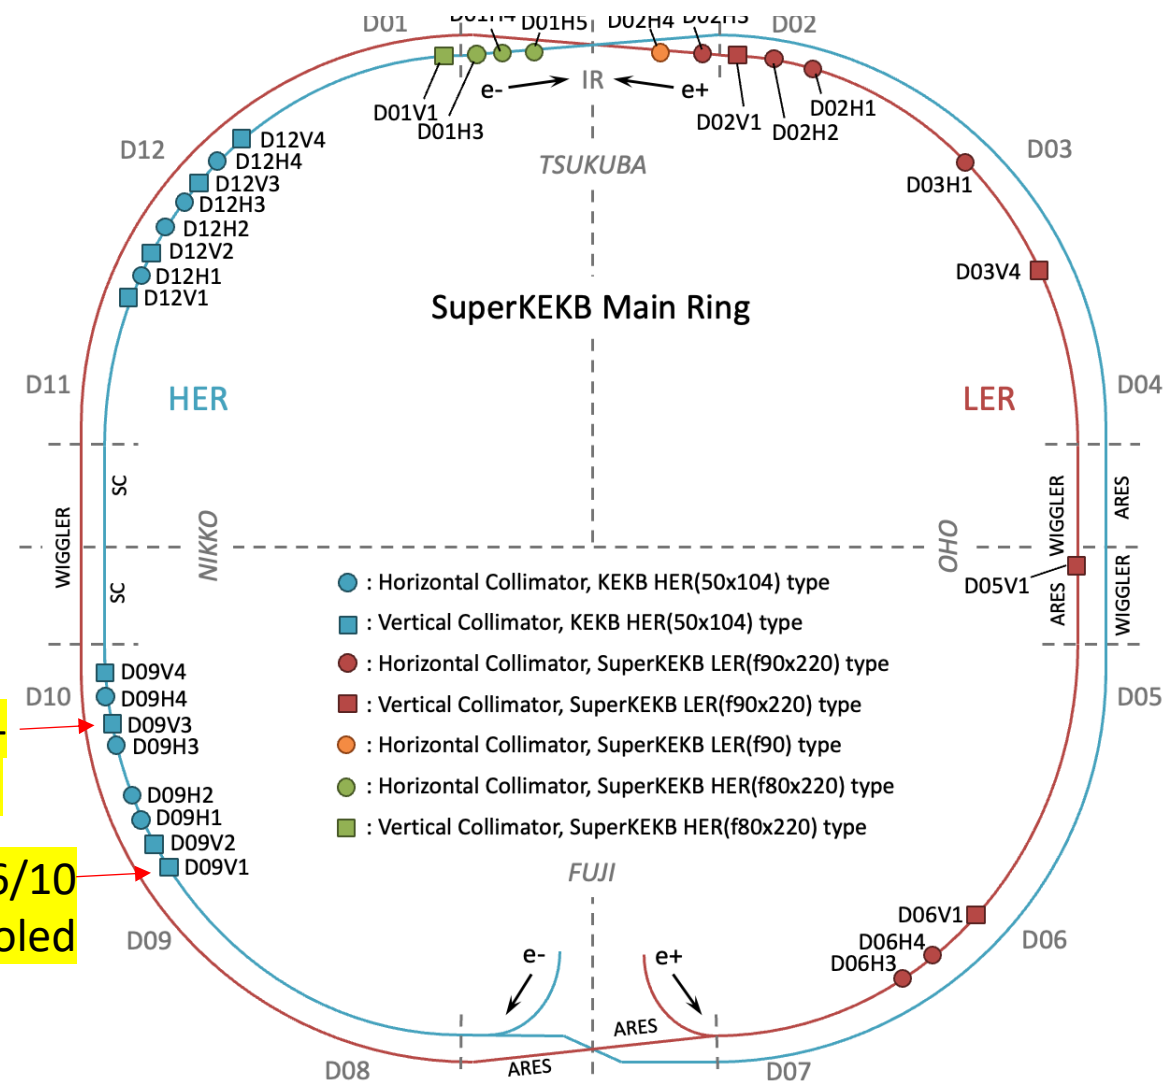
- D01V1 and D12V4 were damaged during 2026ab.
