# Facility and Safety

27 Oct 2026

The 29th KEKB Accelerator Review Committee

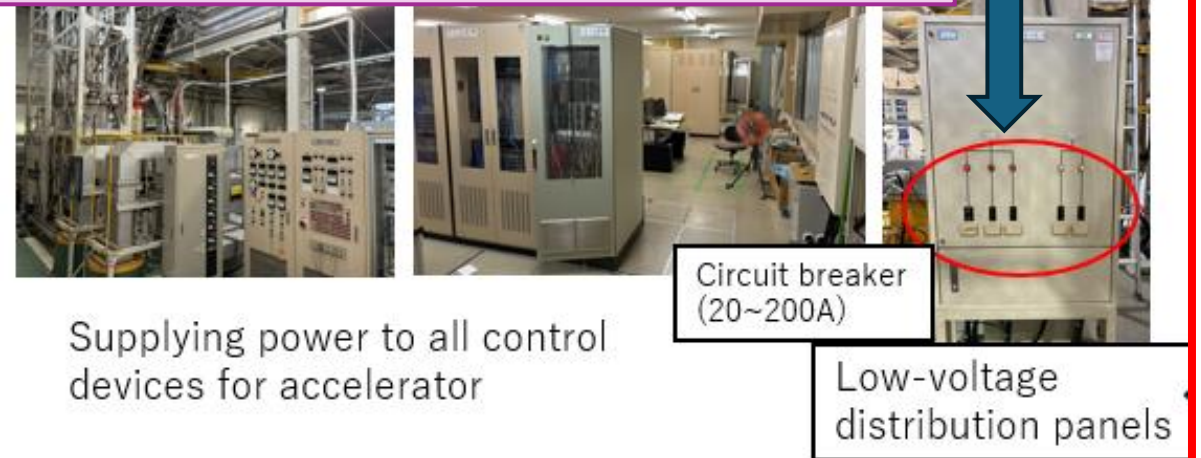
- Concerns
  - A point of concern is the potential for circuit breaker failures within low-voltage distribution panels. There are “exceed 1,000 such circuit breakers in use, **and there is almost no inventory of spares for circuits with a current capacity exceeding 50A.**
  - Establishing backup circuits is an urgent priority to prepare for unexpected failures (Under proposal).**

Circuit breakers for distribution panels (1982) -> not replaced.

Risk of losing power supply to essential control equipment, then Operation stops).

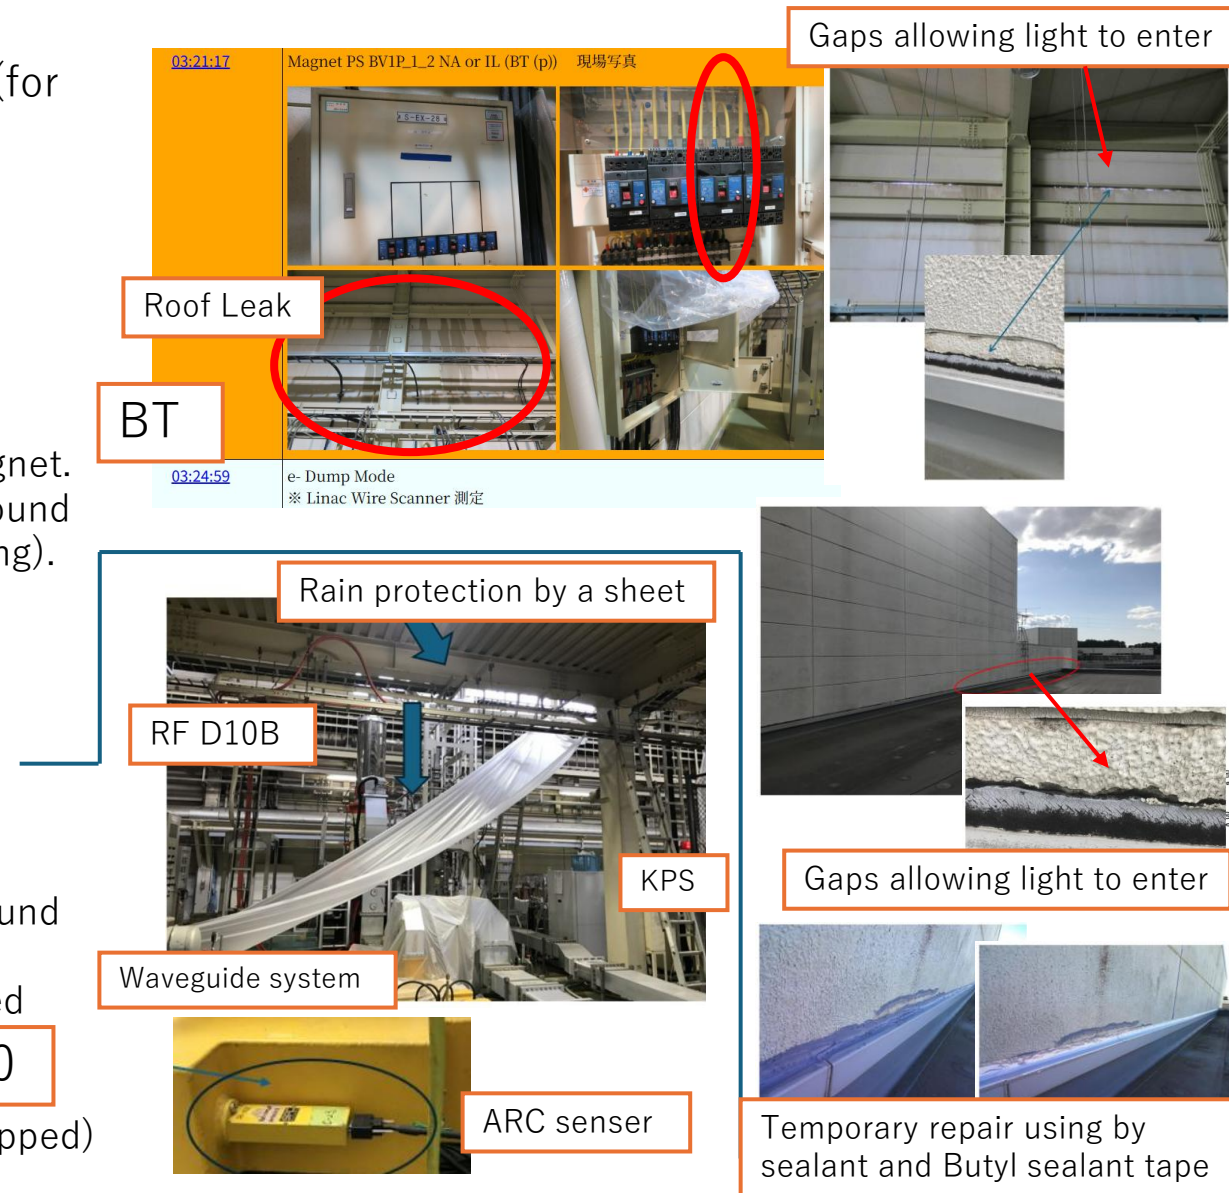
- Issues related to the aging of the building(s)
  - Unsurprisingly, roof leaks rank first.
- Run stop events occurred caused by roof leaks in 2026ab (2 times)

- March 4, 2026 (02:02:35) -> Injection stopped by I/L of BT magnet. It was determined that the interlock trigger was caused by a ground fault in a circuit breaker on the distribution board (BT PS building). Fortunately, we were able to resume operations after spending four hours drying out the breaker.

- > Injection restarted (07:03:30) with initialized BT magnet (1 abort happened and 5 hour stopped)
  - May 1, 2026 (10:54:00) -> HER beam aborted by I/L of MR-RF. It was determined that the interlock trigger was caused by a ground fault in an arc sensor on waveguide system at RF-D10B. We implemented measures to prevent water ingress and disabled this interlock.

Currently, we are carrying out repairs to the exterior walls of two buildings—the same buildings that previously caused operational shutdowns.

- BT power supply building: Completed in Oct 2026
- D10 building: Work is scheduled to begin sometime between January and March.

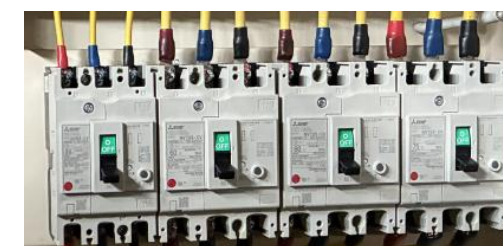
Replaced 4 circuit breakers (2026)

BT

Gaps allowing light to enter

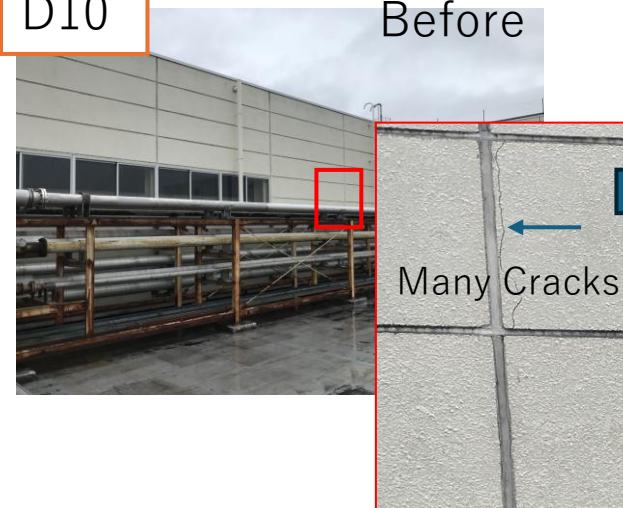
D10

Waiting until  
next year.

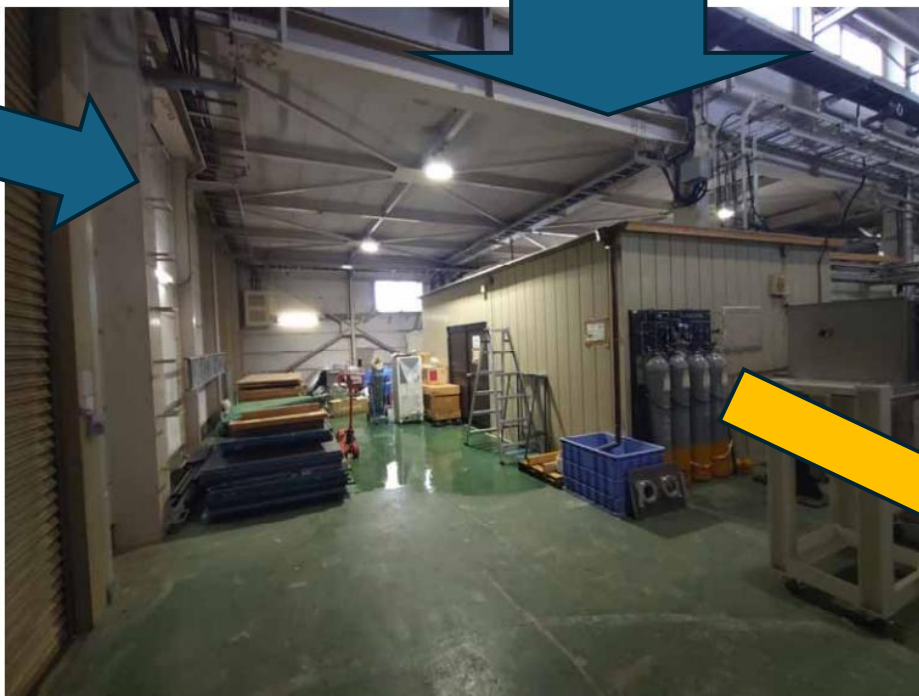
## D8電源棟SRMハット付近

天井段差のところからかなりの漏水

Increased risk of health issues due to mold growth  
(**Inhaling mold** can cause health problems.)

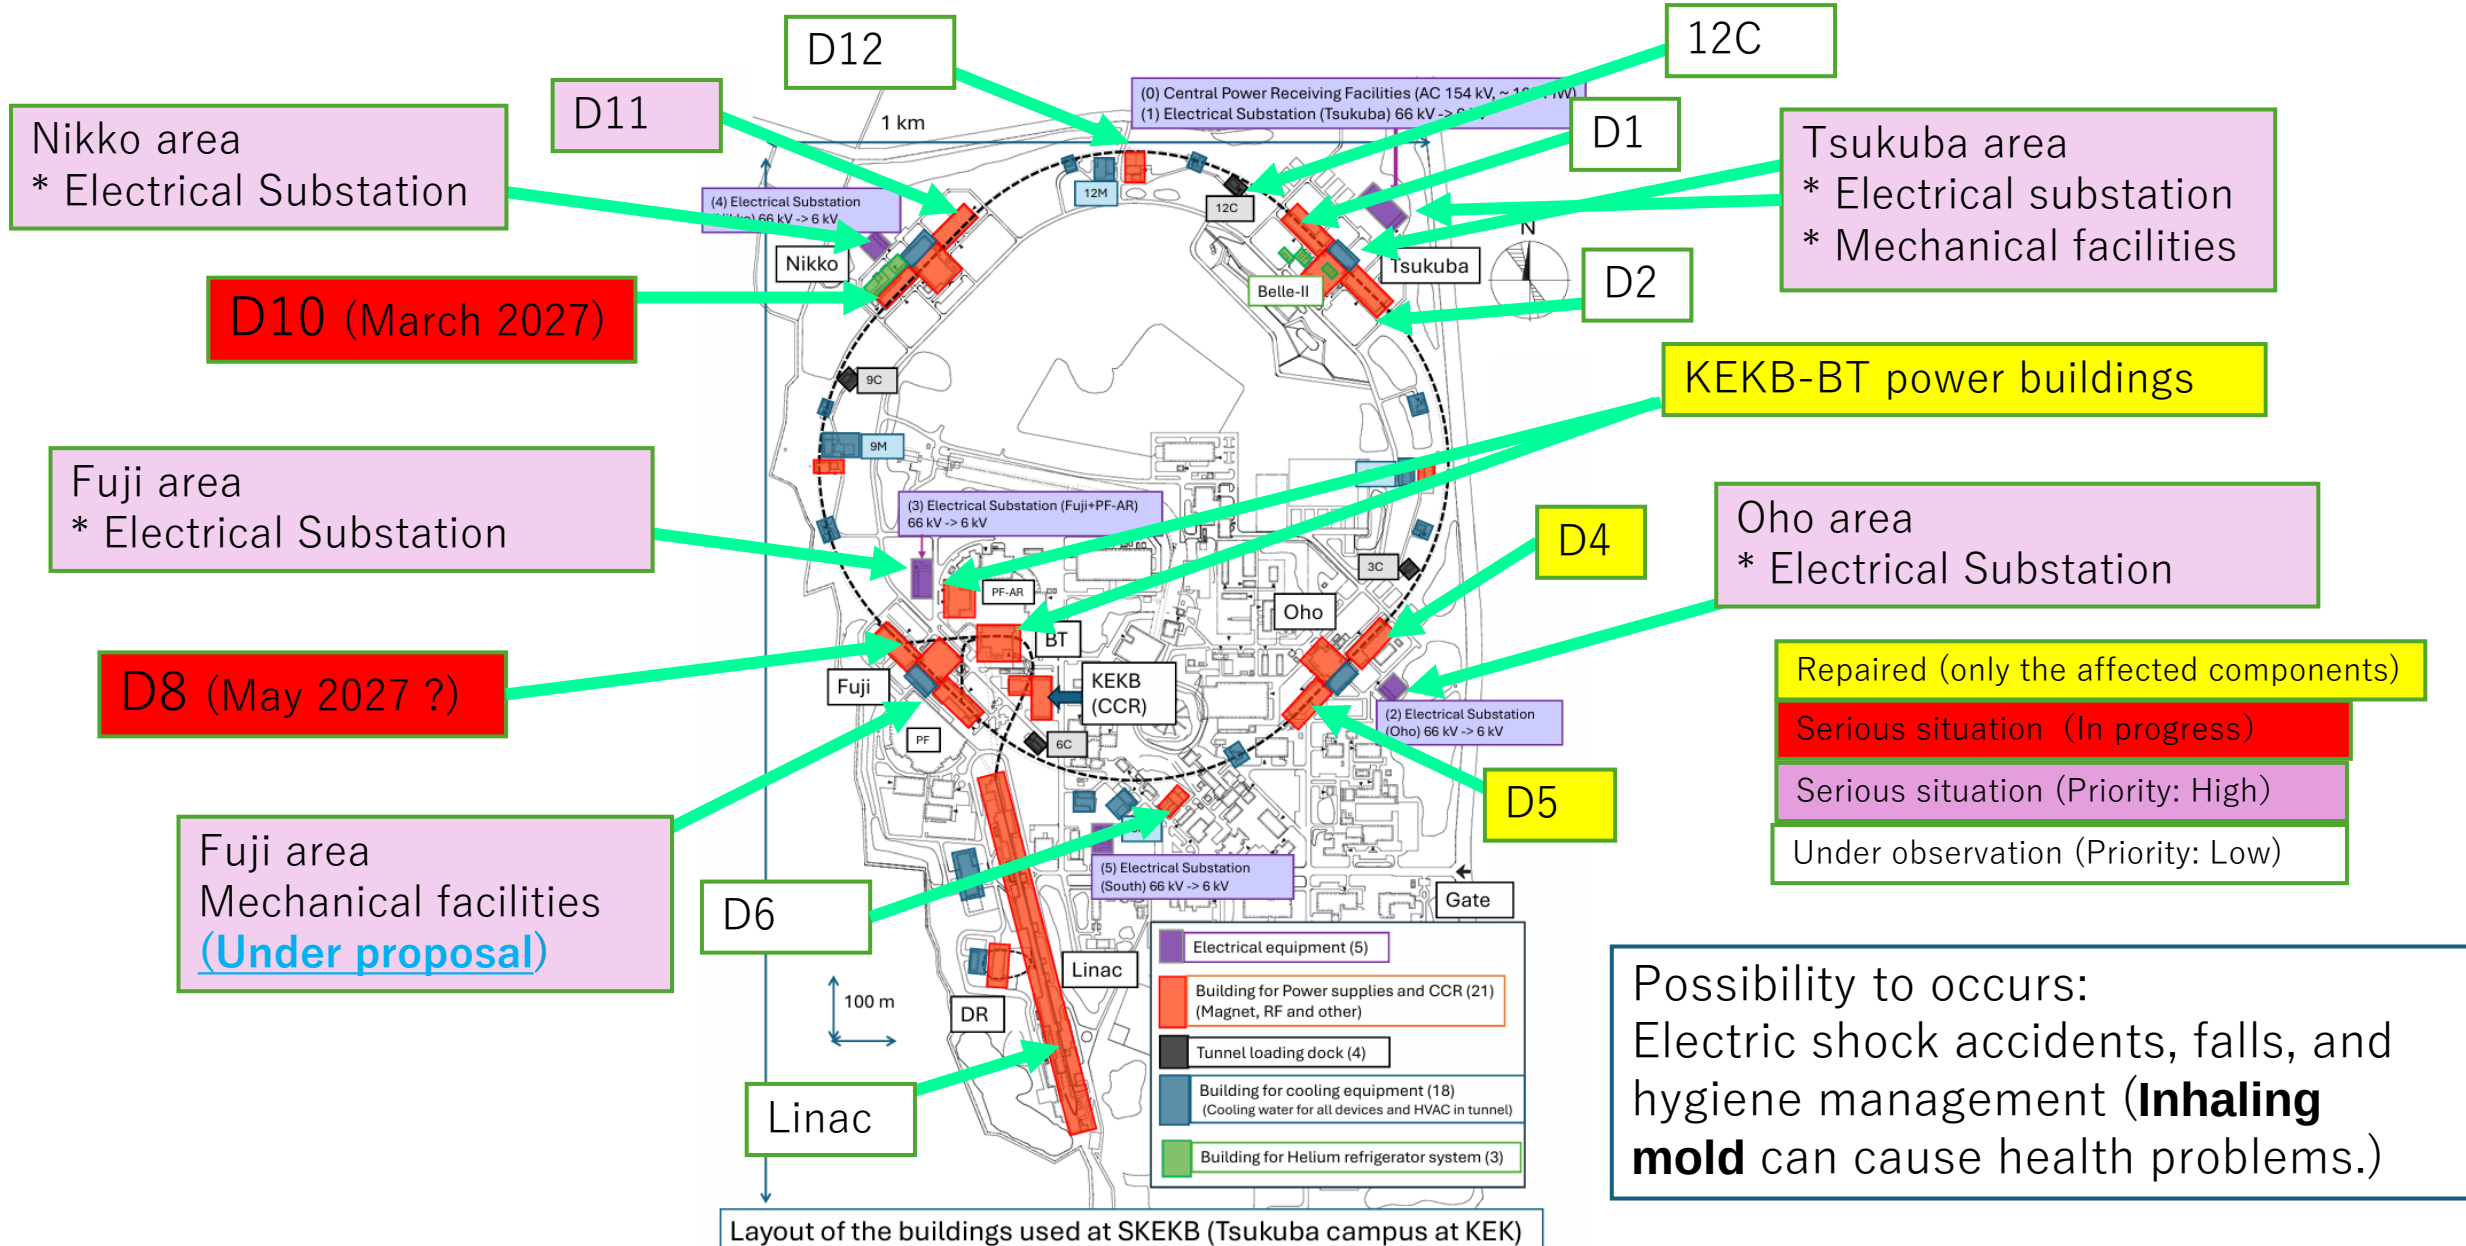
Building (51) -> a roof leak appeared more than 17 buildings.

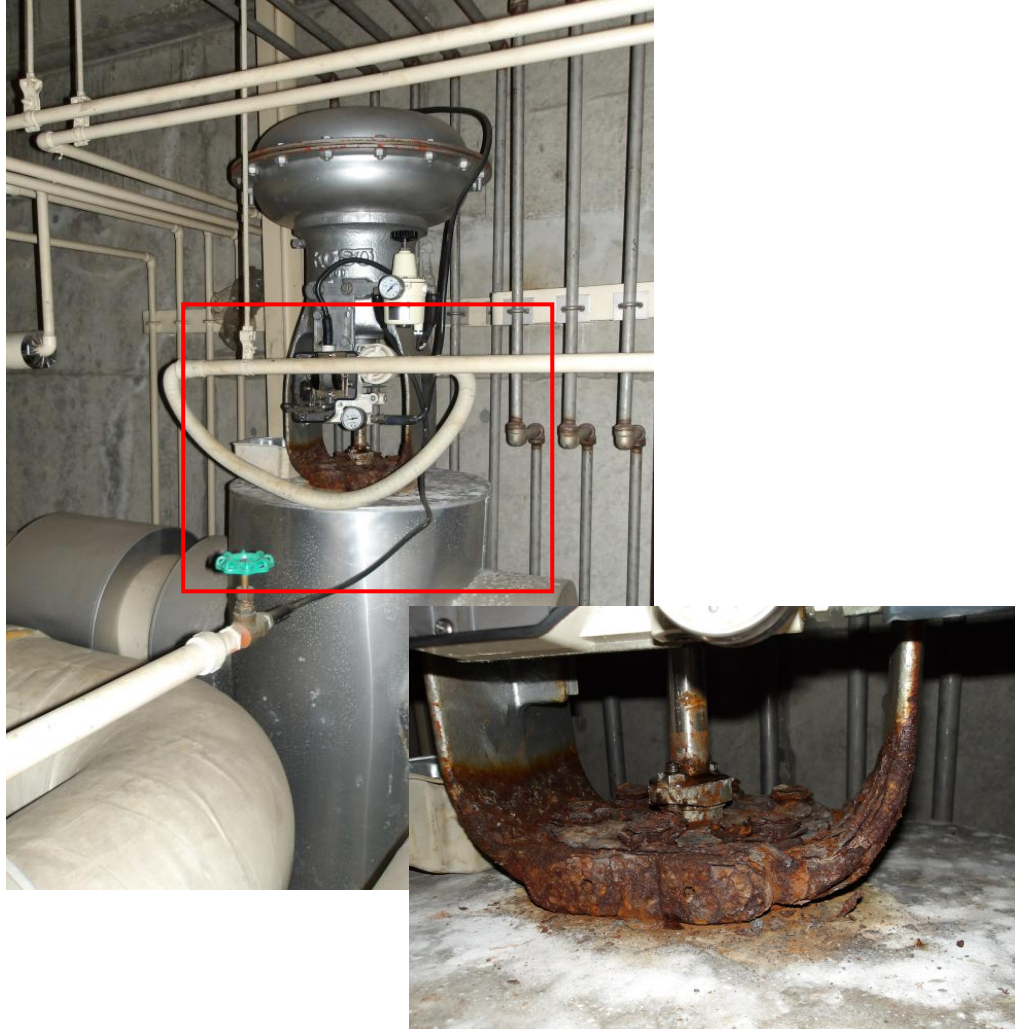
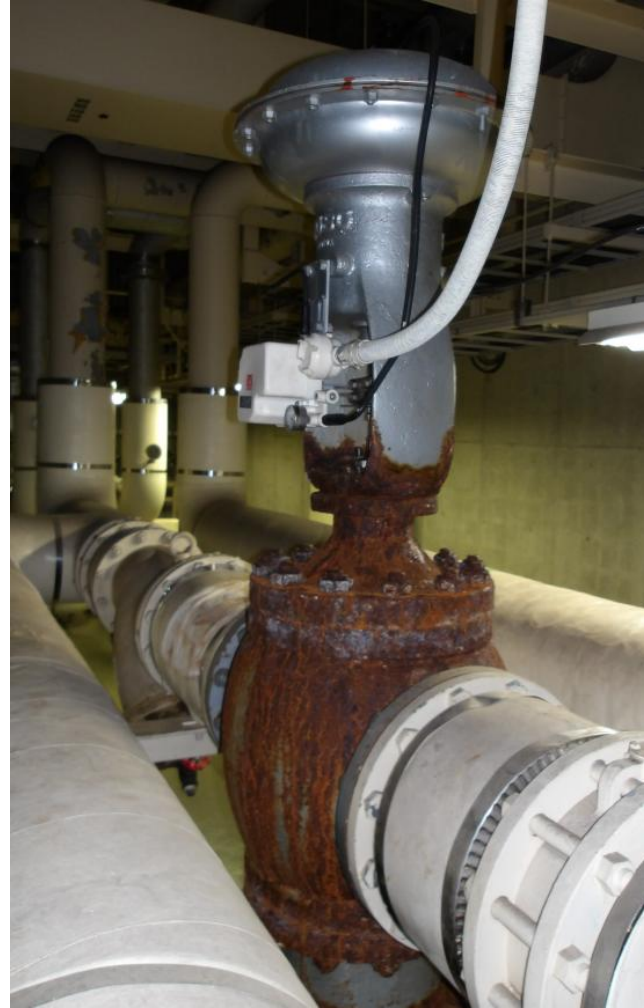
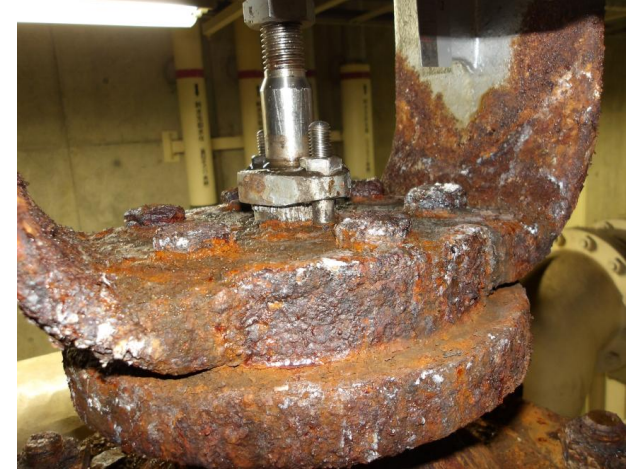
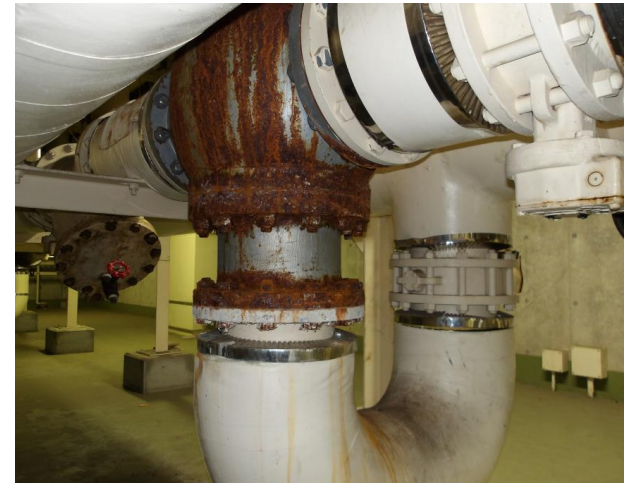
## Aigen of three-way-valve, damaged caused by water leak on movable shaft

- ・ 1980年代に設置された三方弁：軸受けのシール性が劣化したことによる水漏れが原因で各所が腐食。  
軸の固着による動作不良、漏水拡大による冷却系の停止が懸念される状況。

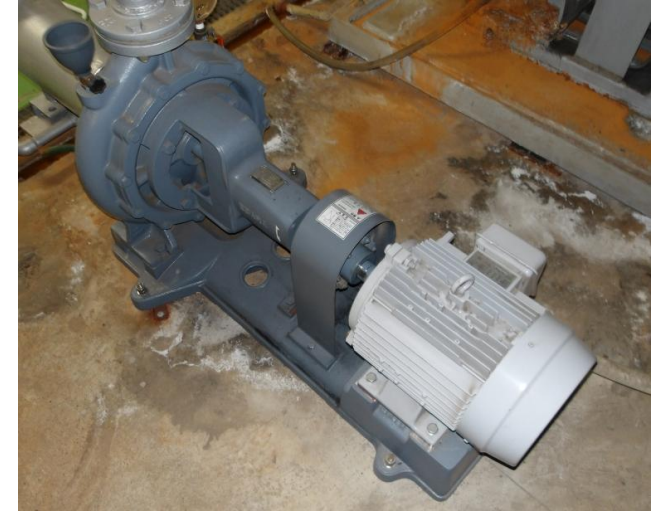
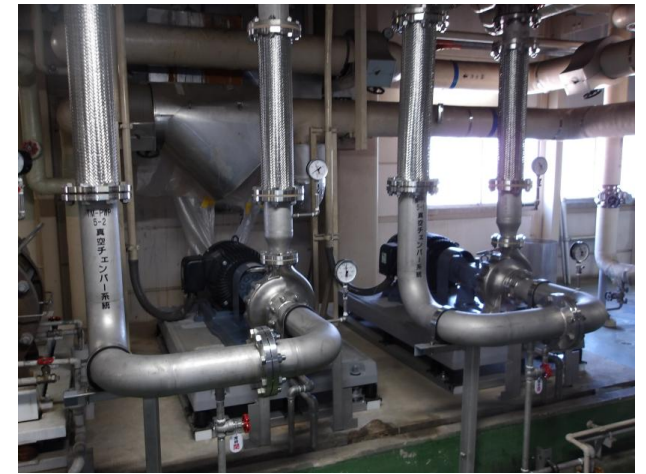
更新されているポンプはごくわずかな状況である。1~2割ほど。

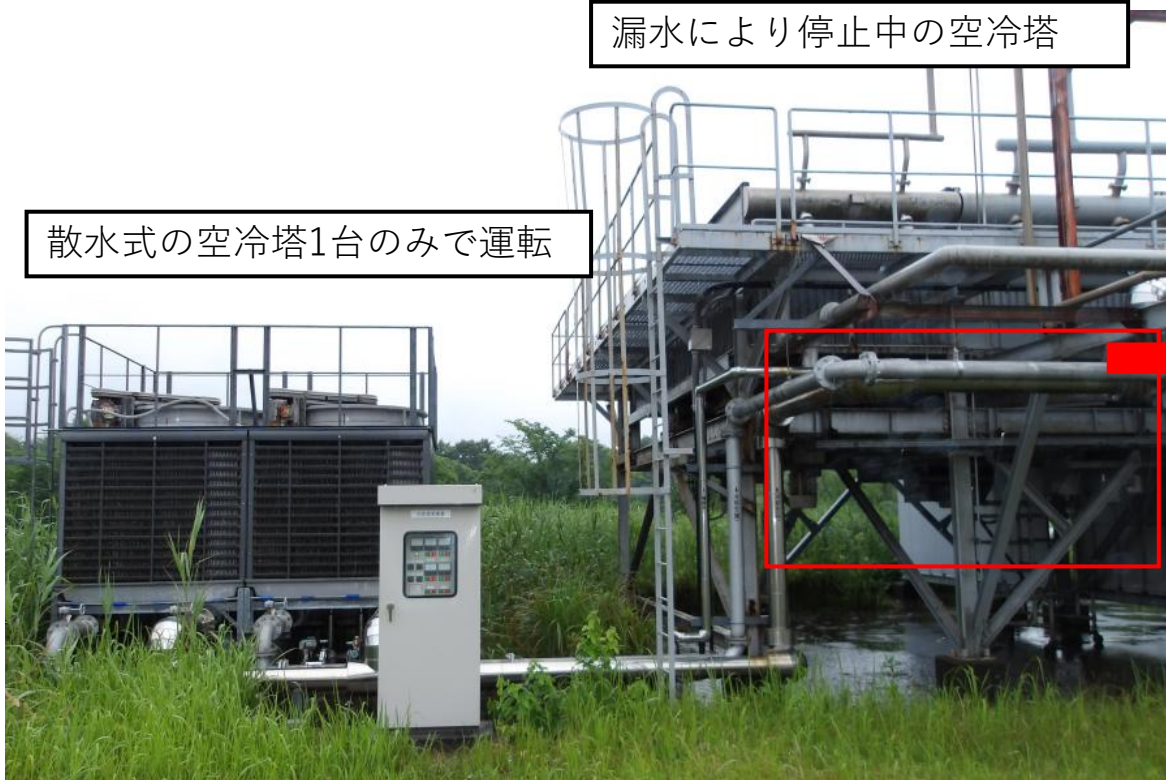
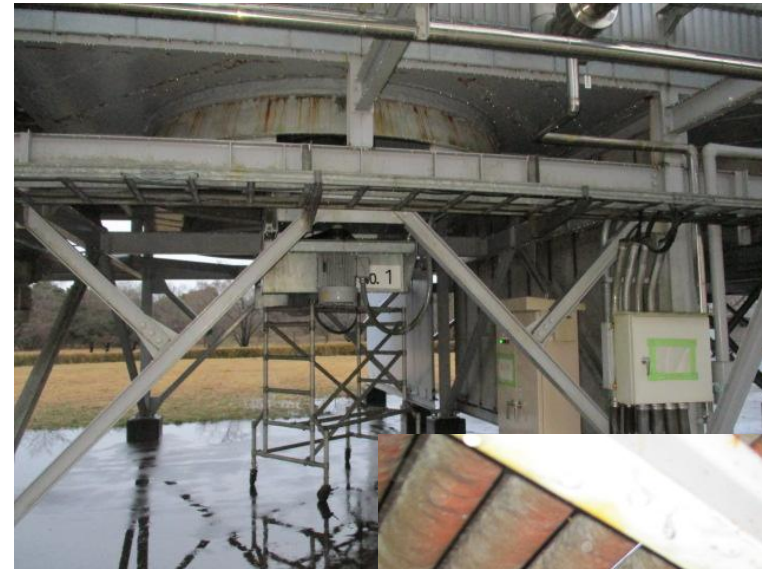
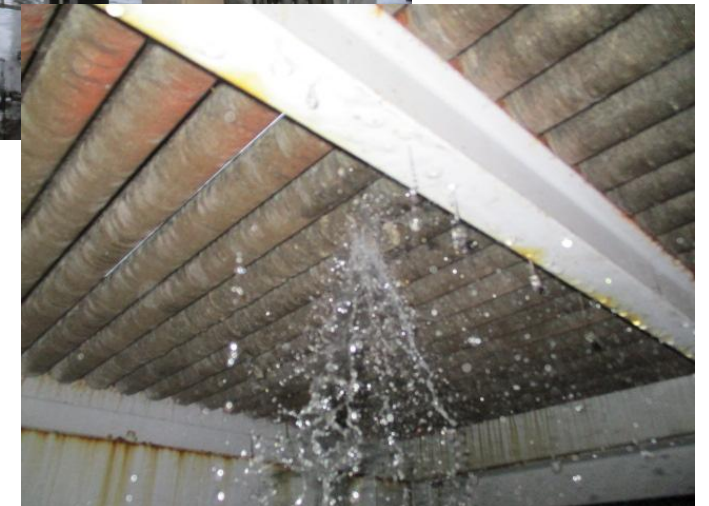
漏水により停止中の空冷塔

散水式の空冷塔1台のみで運転

・ 冷却水コイルからの漏水（だいぶ前に故障）  
修理不可能と判断。空冷塔自体の更新が必要。

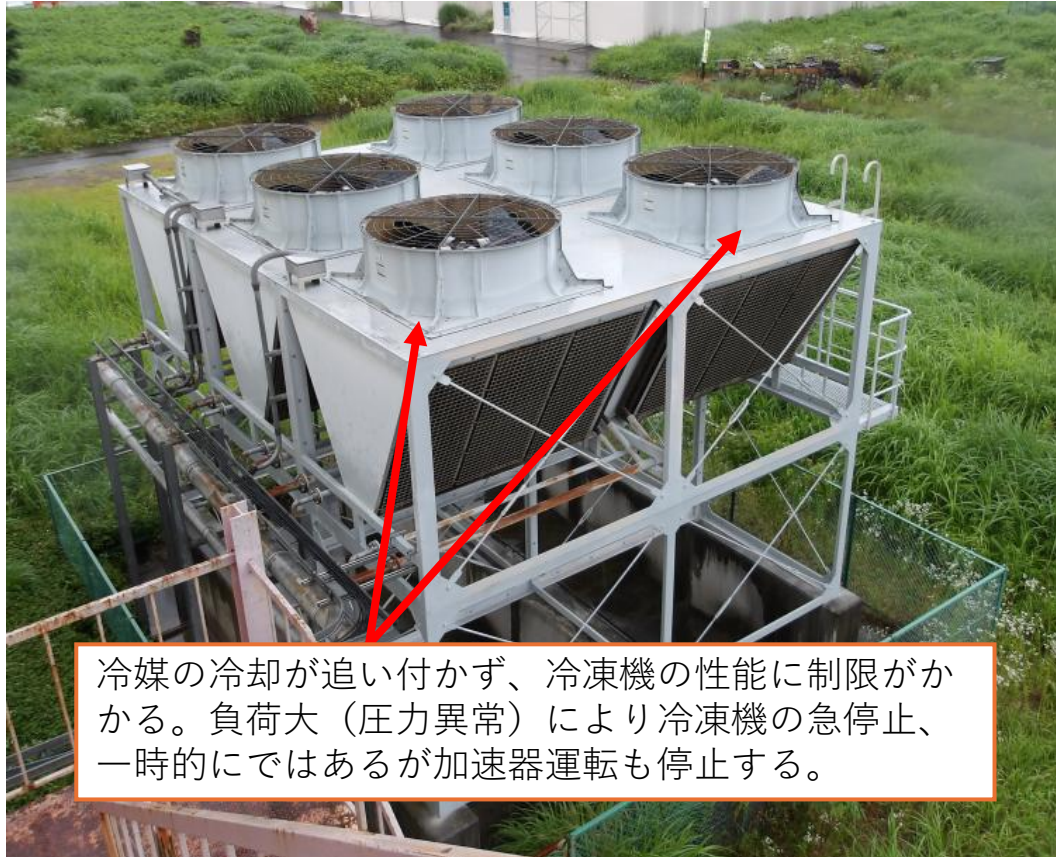
## Air cooled fans for the screw chiller

冷媒の冷却が追いつかず、冷凍機の性能に制限がかかる。負荷大（圧力異常）により冷凍機の急停止、一時的にはあるが加速器運転も停止する。

冷媒冷却用の空冷塔（粗熱取り）  
老朽化により6台中2台のファンが停止している。  
（電動機の地絡が原因）

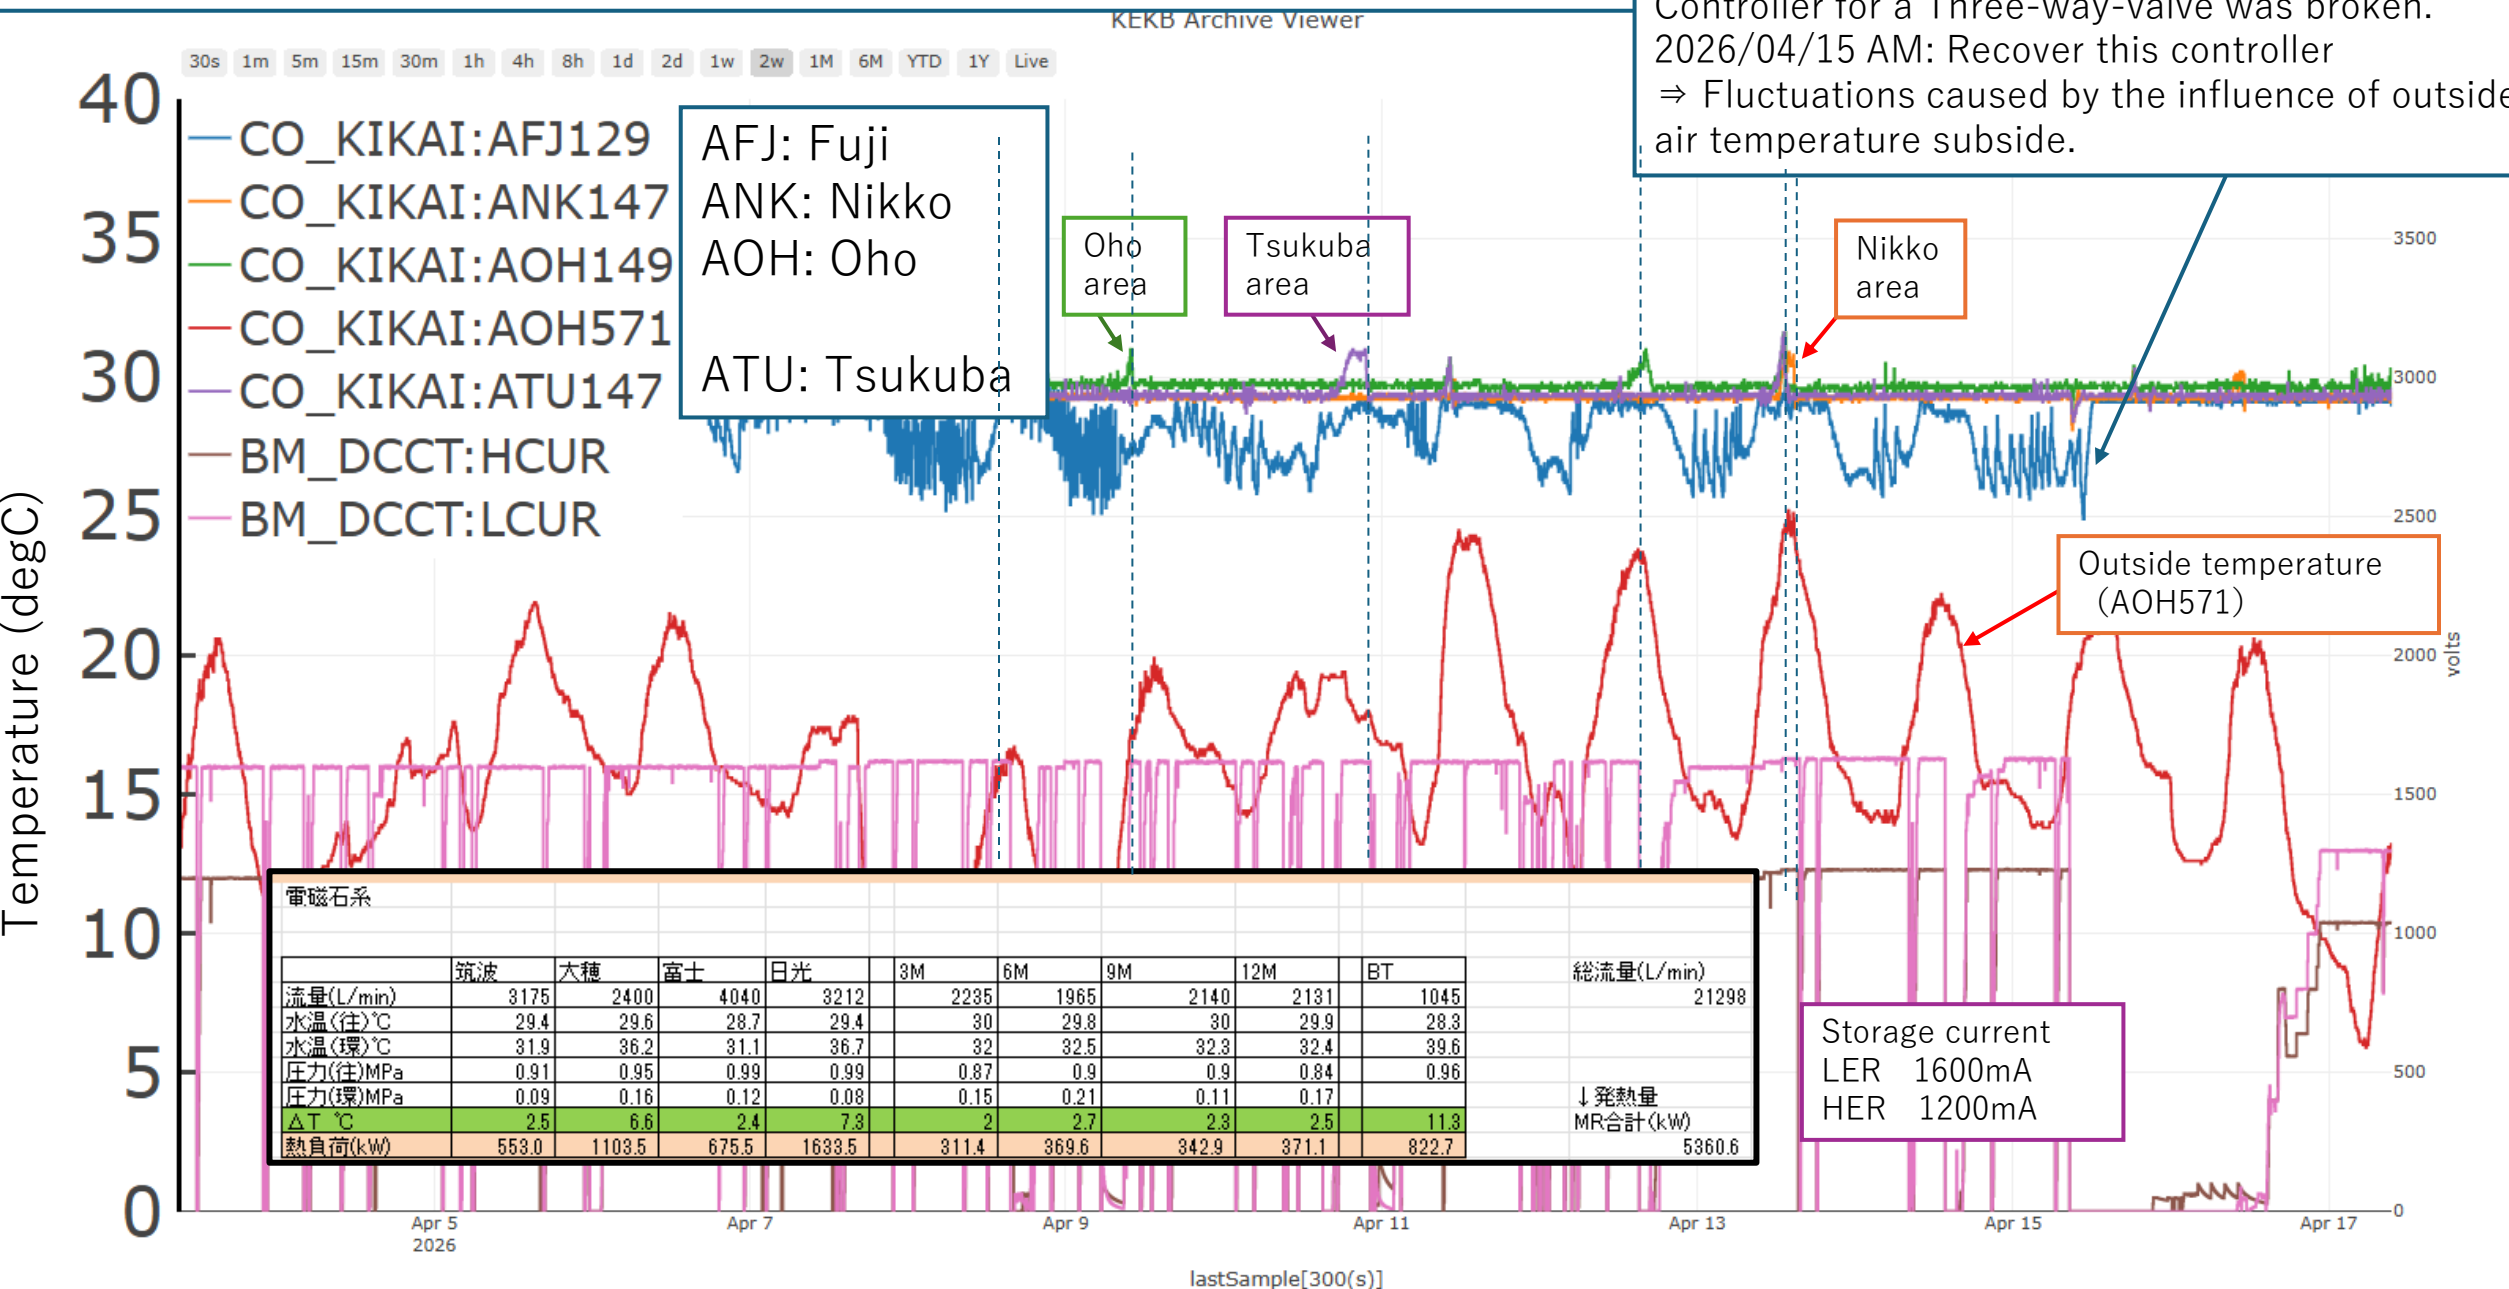
Temperature fluctuations of Magnet cooling waters, 2026/04/03~04/17

Fuji area, Magnet cooling water (Bule: AFJ129)  
Controller for a Three-way-valve was broken.  
2026/04/15 AM: Recover this controller  
⇒ Fluctuations caused by the influence of outside air temperature subside.

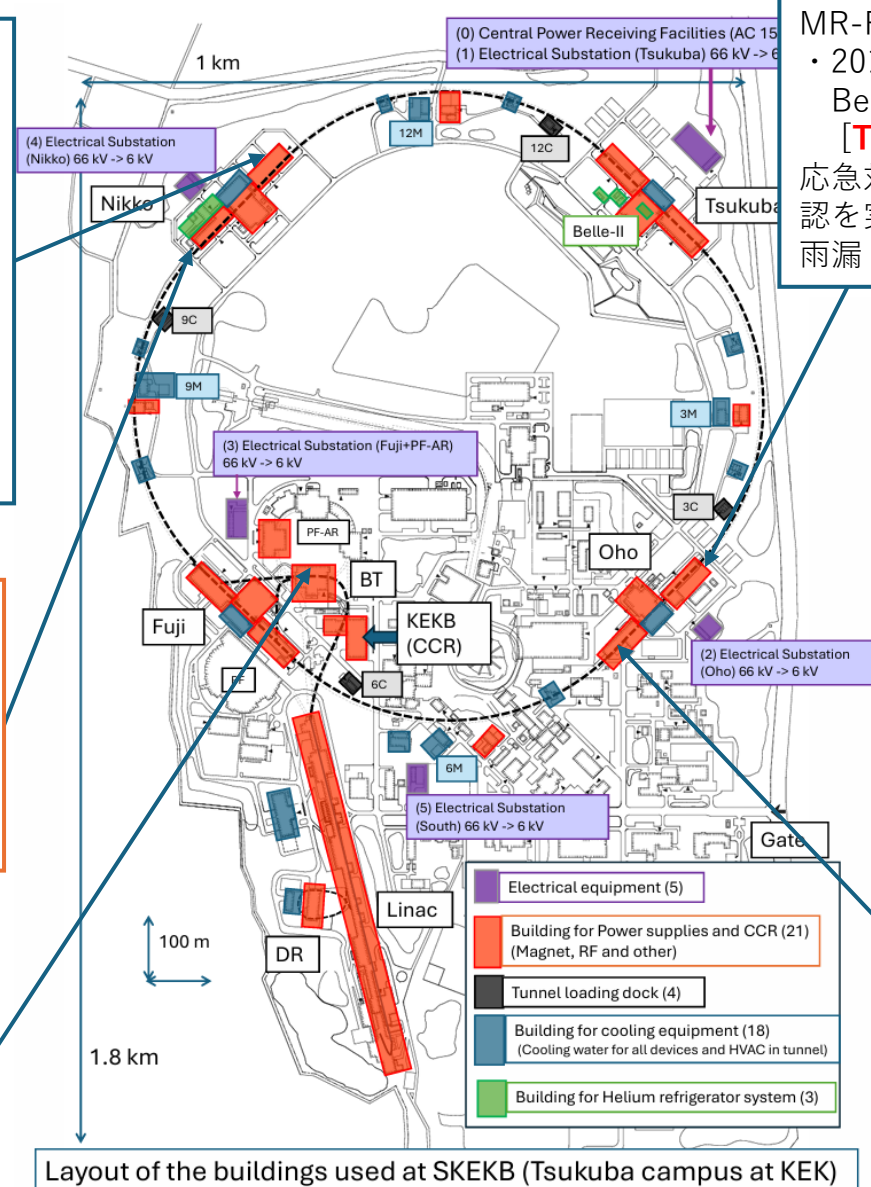
The circuit breaker tripped due to a roof leak,  
then BT magnet was downed.  
-> Operation was stopped for half day.

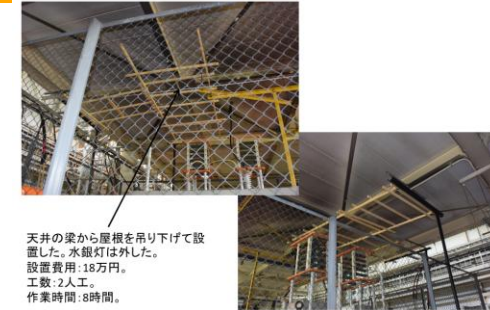
[Two cavities] have been taken out of operation.  
応急対応として電源上方に雨樋を設置、3日後の5月16日に動作確認を実施、そのあとで運転再開した。  
雨漏りによるKPSの耐圧劣化により電源がトリップした例

天井の梁から屋根を吊り下げて設置した。水銀灯は外した。  
設置費用: 18万円。  
工数: 2人工。  
作業時間: 8時間。
