MR Magnets

Shu Nakamura, Ryuichi Ueki, Masashi Furusawa,
Yasunobu Ohsawa, Mika Masuzawa

Skew sextupole magnets for non-linear collimator

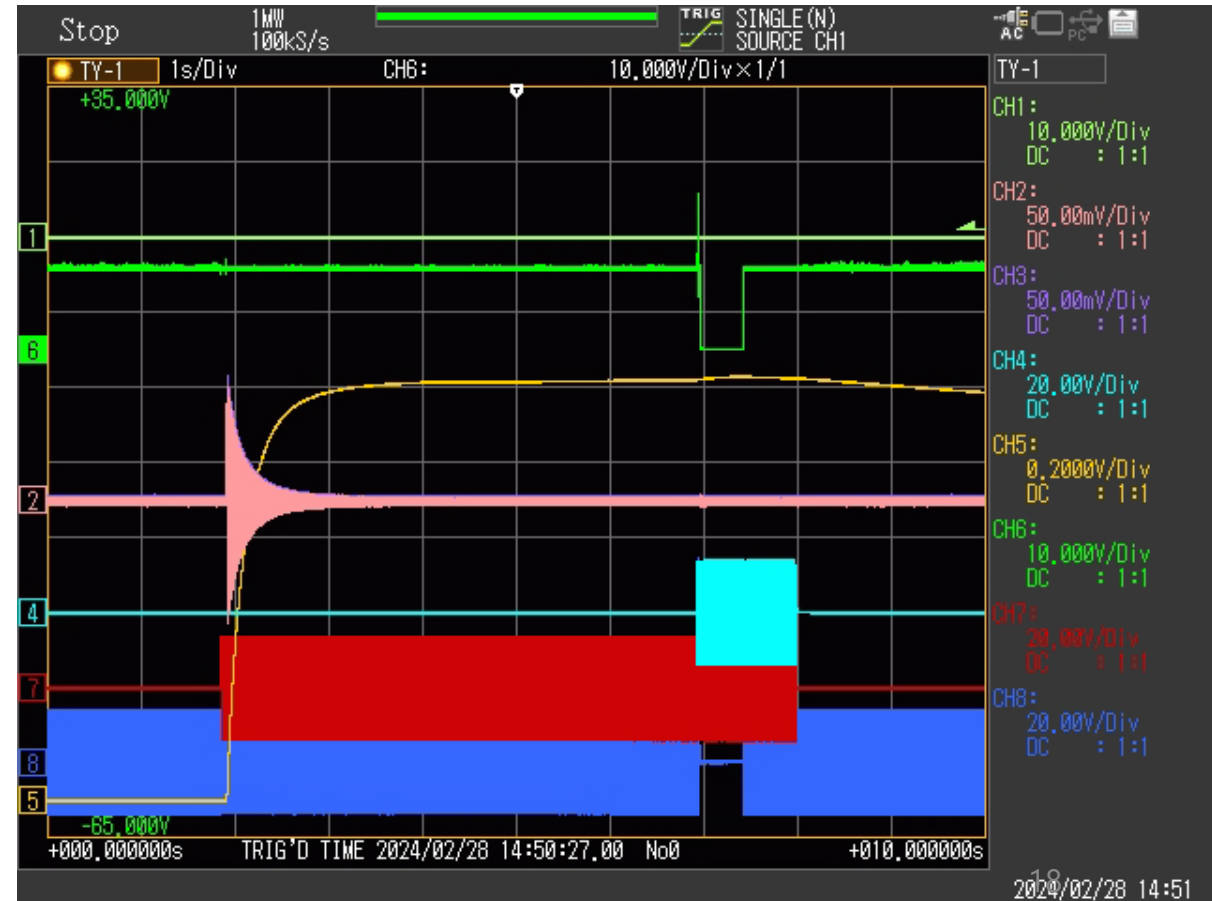
2024/02/28 14:51

Unintended current reduction

The power supply(QFROE_4) sometimes unintentionally reduces the output current.
 The only interlock the power supply displays is "Tracking", but the output current is zero A.
 A malfunction due to noise in the control circuit is suspected.
 The control power supply was replaced, but the problem recurred.
 Other measures are under consideration.
