The 27th KEKB Accelerator Review Committee
26th March 2024

Kyo Shibata
On behalf of KEKB Vacuum Group

Major vacuum works during LS1 (MR) #1

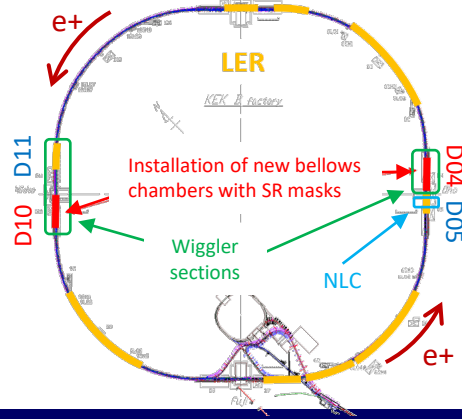
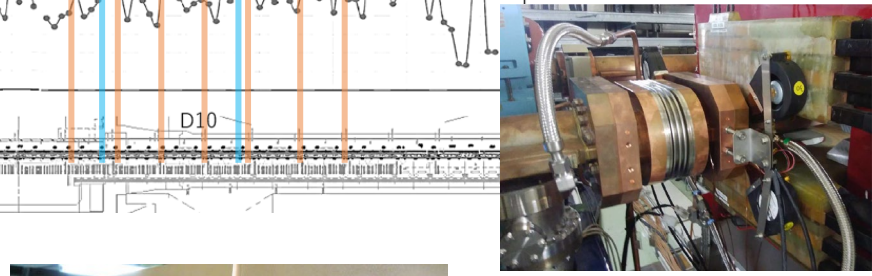
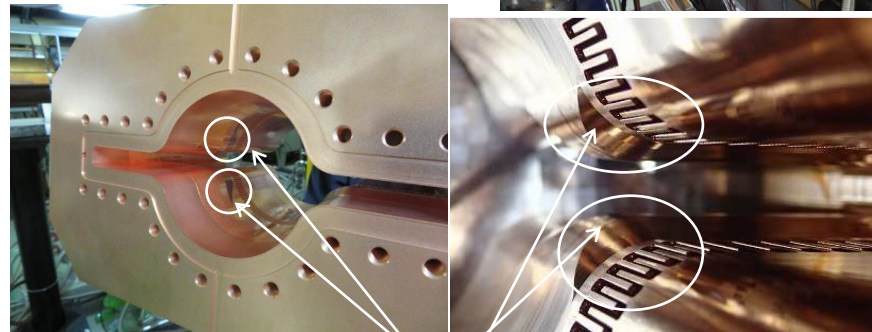
- Countermeasure against temperature rise of beam pipes downstream of Wiggler Sections
 - Beam current will be increased after LS1.
 - Magnetic field of wiggler magnets might be increased to compensate the reduction due to removed wiggler magnets for NLC system construction.
 - Strong SR should be absorbed by SR masks in the bellows chambers.
 - Locations of SR masks were optimized.
- Rearrangement of bellows chambers
 - Larger SR power locations: From bellows chamber w/o SR masks to w/ SR masks (9 chambers)
 - Smaller SR power locations: From bellows chamber w/ SR masks to w/o SR masks (8 chambers)
- Air and water cooling of the bellows chamber with SR masks were also enforced.

SR masks in bellow chamber

Bellows chamber replacement

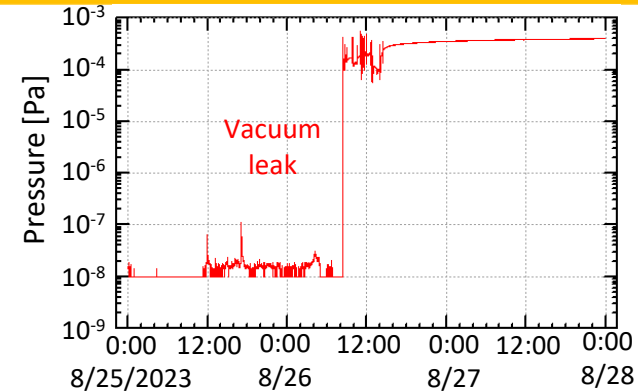
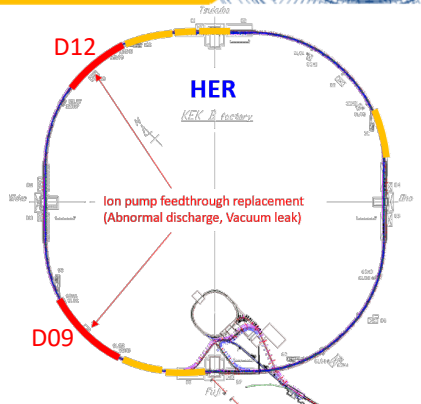
- It was found that abnormal discharge occurred in HV connector of an ion pump.
 - There was abnormal sound from it and abnormal high temperature on it.

- **Discharge in the connector resulted in vacuum leak.**
 - Replacement of HV feedthrough and investigation of other feedthroughs
 - Faulty feedthrough was replaced with new one. (Vacuum work)

- Feedthroughs and connectors of other ion pumps were checked.
 - **It was found that abnormal discharge occurred in some connectors at D09 & D12 Arc Sections.**

Ion pump feedthrough (discharged)

- **Three feedthroughs in D09 & D12 Arc Sections were replaced with new ones. (Vacuum work)**
 - **Others were reused after cleaning. (Not vacuum work)**

- They may be due to an increase in humidity due to the air conditioner stopping.
 - Further countermeasures:
 - R&D of humidity-resistant HV feedthrough and connector was started.

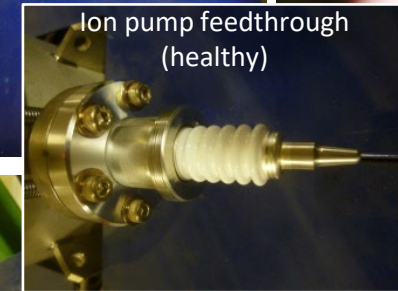
Ion pump feedthrough (healthy)

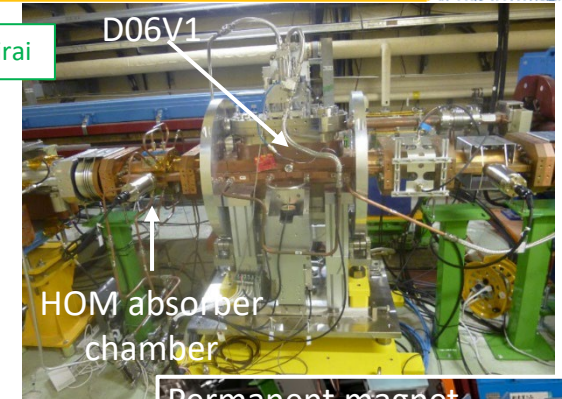
Permanent magnet

- For suppression of electron cloud which may be the cause of SBL.
- All SuperKEKB-type horizontal collimators have permanent magnets on it.

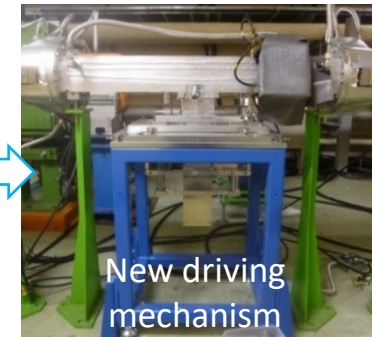
New driving mechanism

- For more precise and stable position control
 - HER : D09V1, D12V3

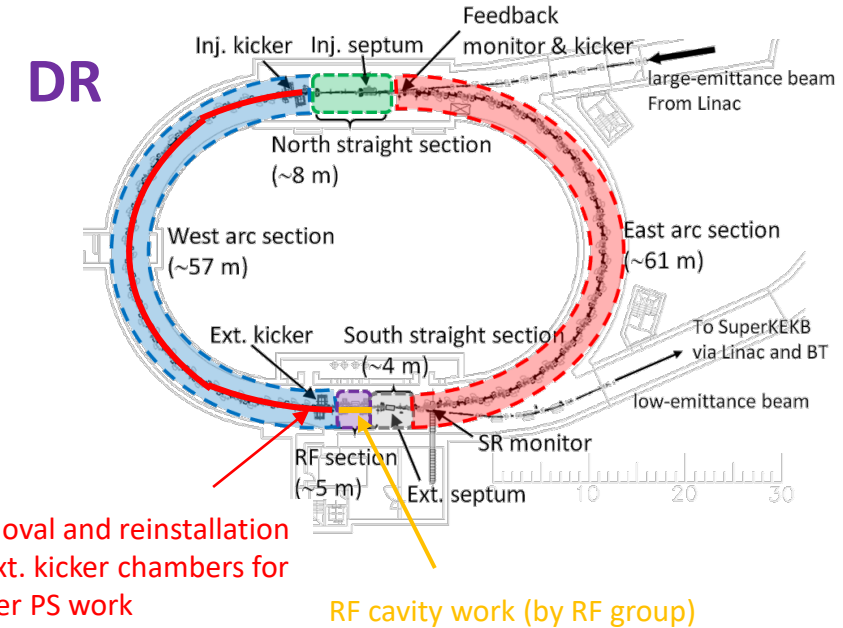
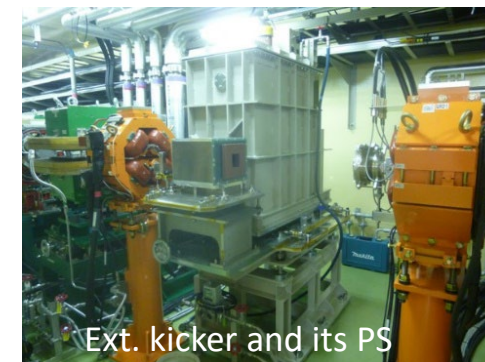
Ext. kicker and its PS

- Two beam pipes were disassembled and reinstalled for Ext. Kicker PS work.
 - First vacuum work after DR construction
 - West Arc Section was filled with dry nitrogen.
 - Ceramic beam pipe for Ext. kicker and a beam pipe next to it were disassembled to remove Kicker PS.
 - These two beam pipes were filled with dry nitrogen and reinstalled into DR about 10 months later.
 - Remaining area of West Arc Section was also filled with dry nitrogen for about 10 months.
 - Other sections covered by Vacuum Group were kept in vacuum.
 - East Arc Section
 - North Straight Section
 - Sought Straight Section
 - RF Group also performed vacuum work at RF section during LS1
 - Vacuum system of RF section is covered by RF Group.
 - Pressure of RF section was improved by this work.
 - Pressures of West Arc Section and Sought Straight Section were also improved by this work.

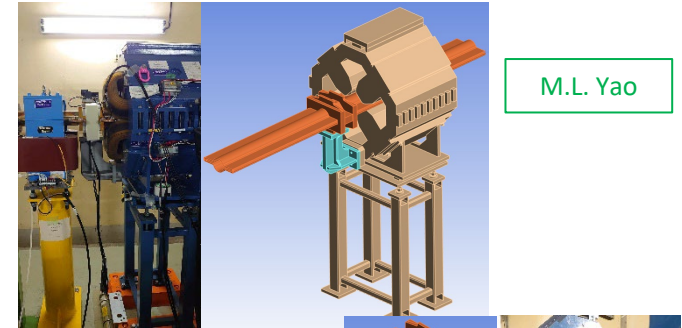
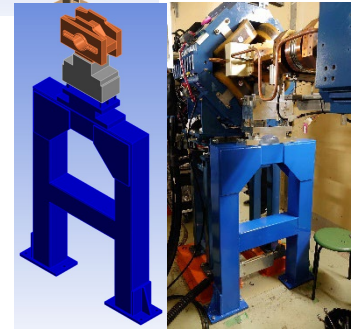
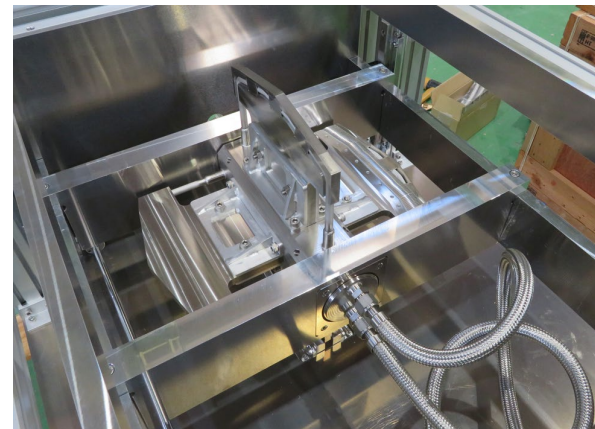
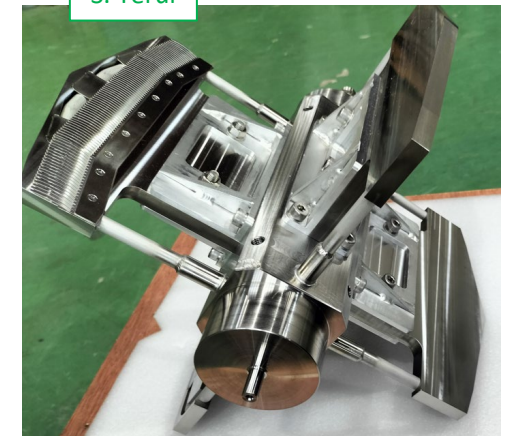
- Investigation on beam pipe deformation due to SR heating in SLY section.
 - Measurement of deformation of beam pipes due and displacement of BPM and Q-magnet in SLY section
 - Simulation of deformation of beam pipes and displacement of BPM and Q-magnet in SLY section
 - Fabrication of new BPM supports to isolate BPM block from Q-mag.
 - They will be installed near future.
- Development of pressure anomaly detection method applying machine learning
 - Trial operation of pressure anomaly detection program from this month (March 2024).
- Collimator R&D
 - R&D of more robust head material such as MoGr
 - R&D of collimator with revolver heads
- And so on.
