# Magnet

MR and BT/DR

Shu Nakamura  
On behalf of the Magnet Group

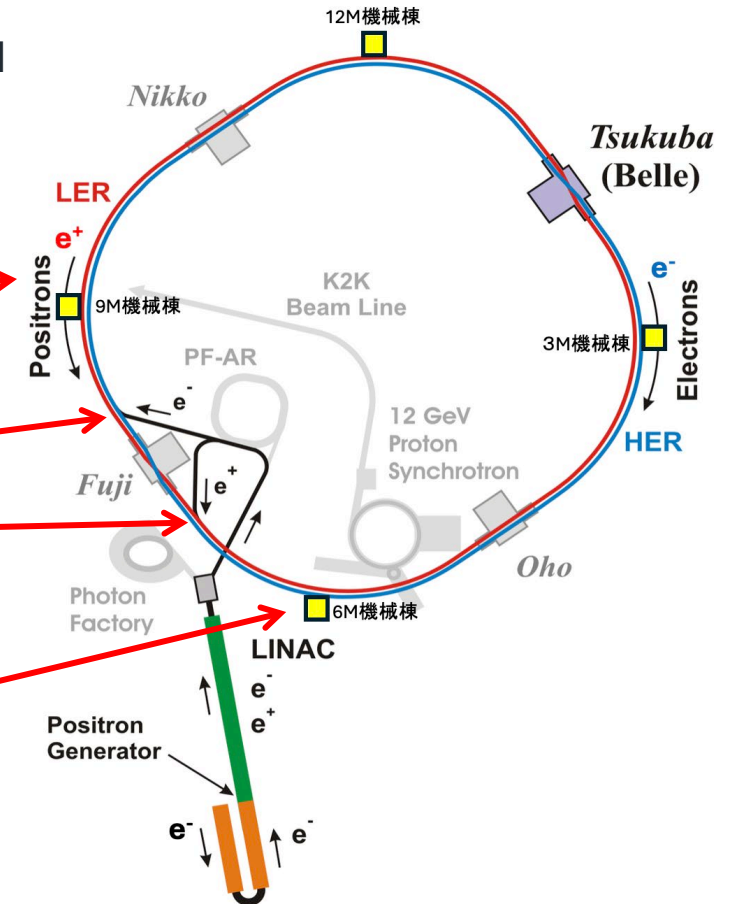
D06V1 collimator area: **QT4FOP.1**

Following beam operation, residual radioactivity tends to be higher near the injection points of both rings and downstream of the collimators just after the injection point. It is estimated that, between the 2025c and 2026b runs, some magnets accumulated radiation doses exceeding 10% of their design-specified radiation tolerance.

LER, south tunnel

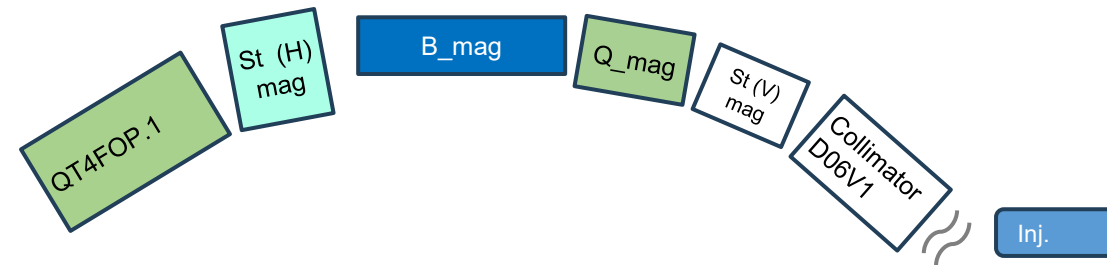
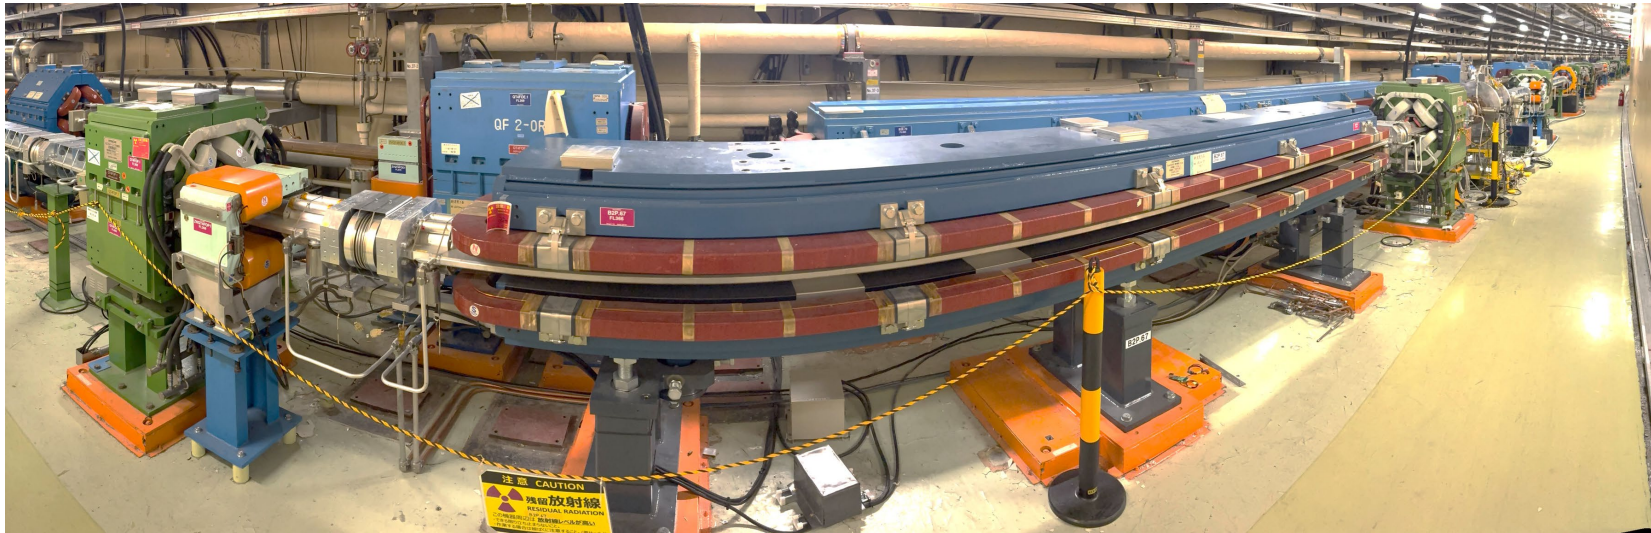
On 8 October 2025, we installed RADCOLOR film and replaced hardened, cracked cable protection with new EPDM rubber.

Quadrupoles:  $5 \times 10^8$  rad

Steering magnets: about  $10^8$  rad

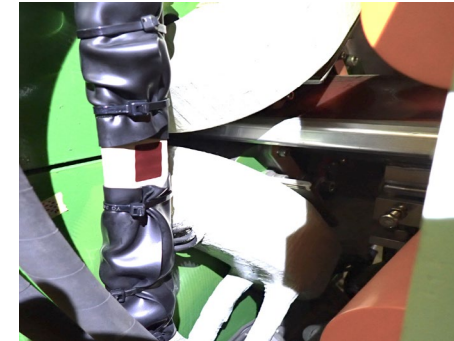
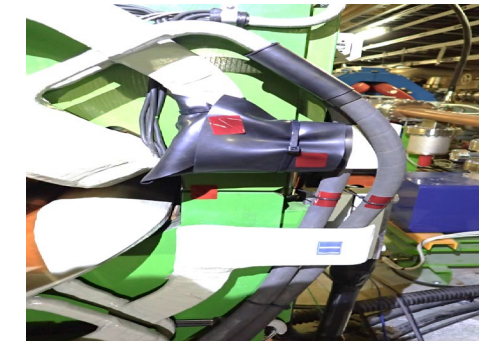
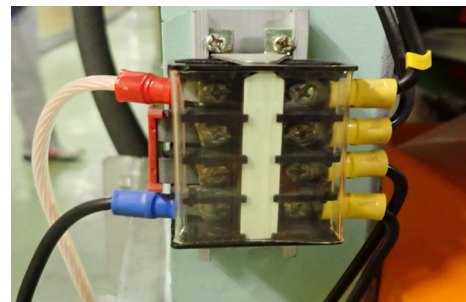
At the upstream magnet ZHQT4FOP.1, the connector showed discoloration and the cable sheath had cracked.

RADCOLOR film  
Dark red:  $10^7$  rad =  $10^5$  Gy  
Dark blue-green: Unused

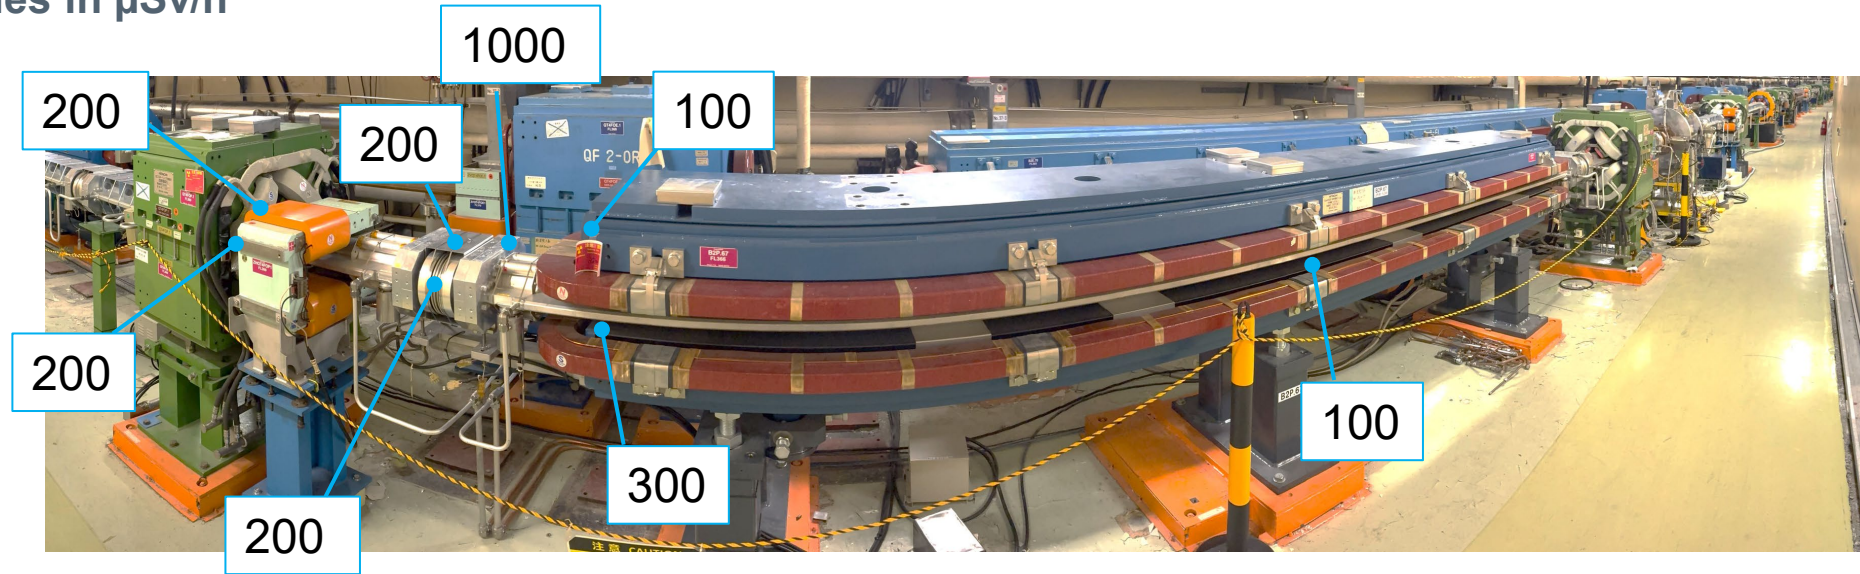
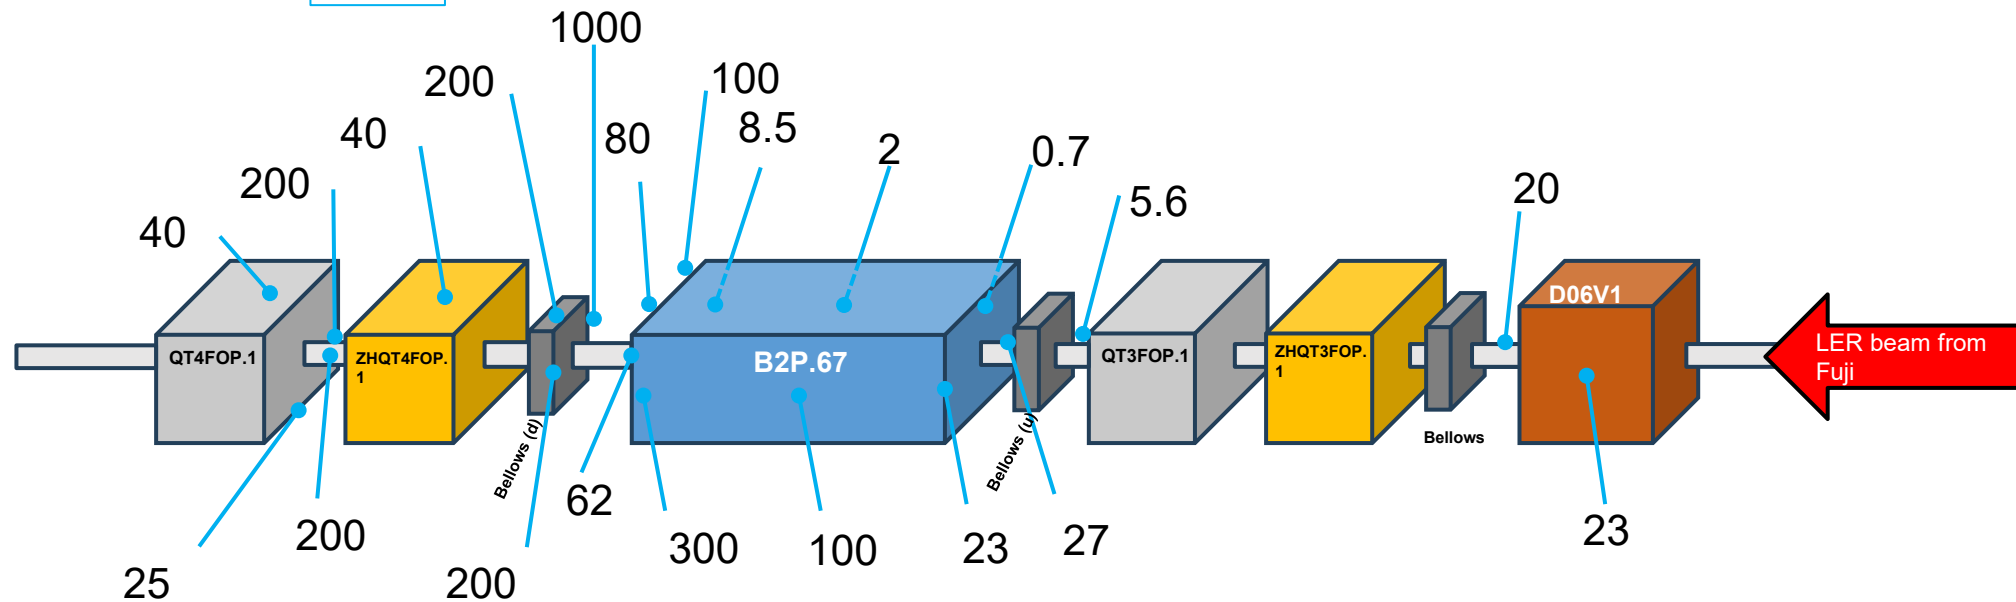
# QT4FOP.1 area: residual dose-rate survey (Oct. 2026)

Point values in  $\mu\text{Sv/h}$

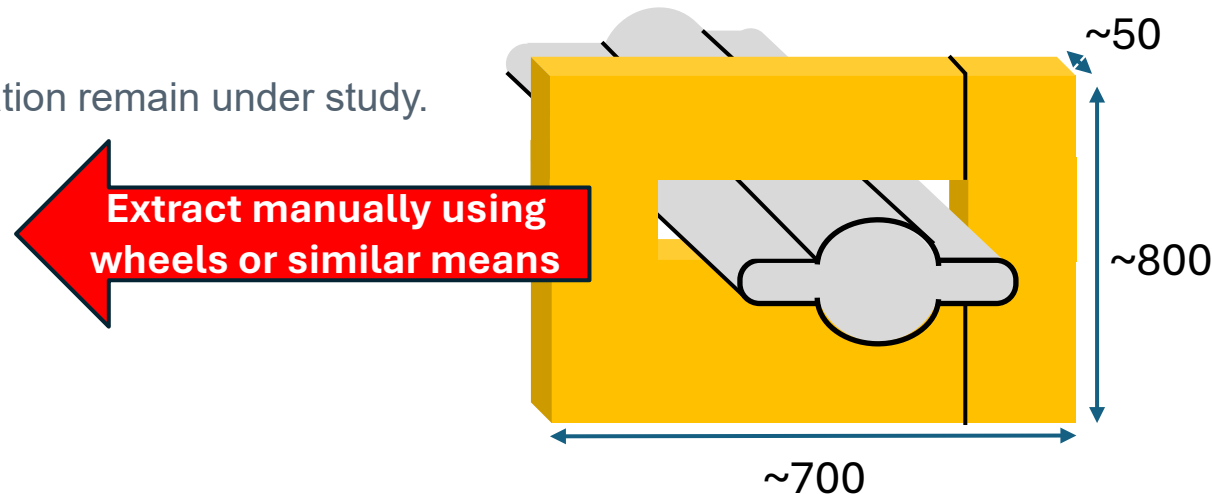
We are considering a detailed radiation survey and lead shielding at one affected location. In the future, it may be necessary to install localized shielding at approximately four additional locations.

Preliminary concept.  
Shield geometry and installation remain under study.

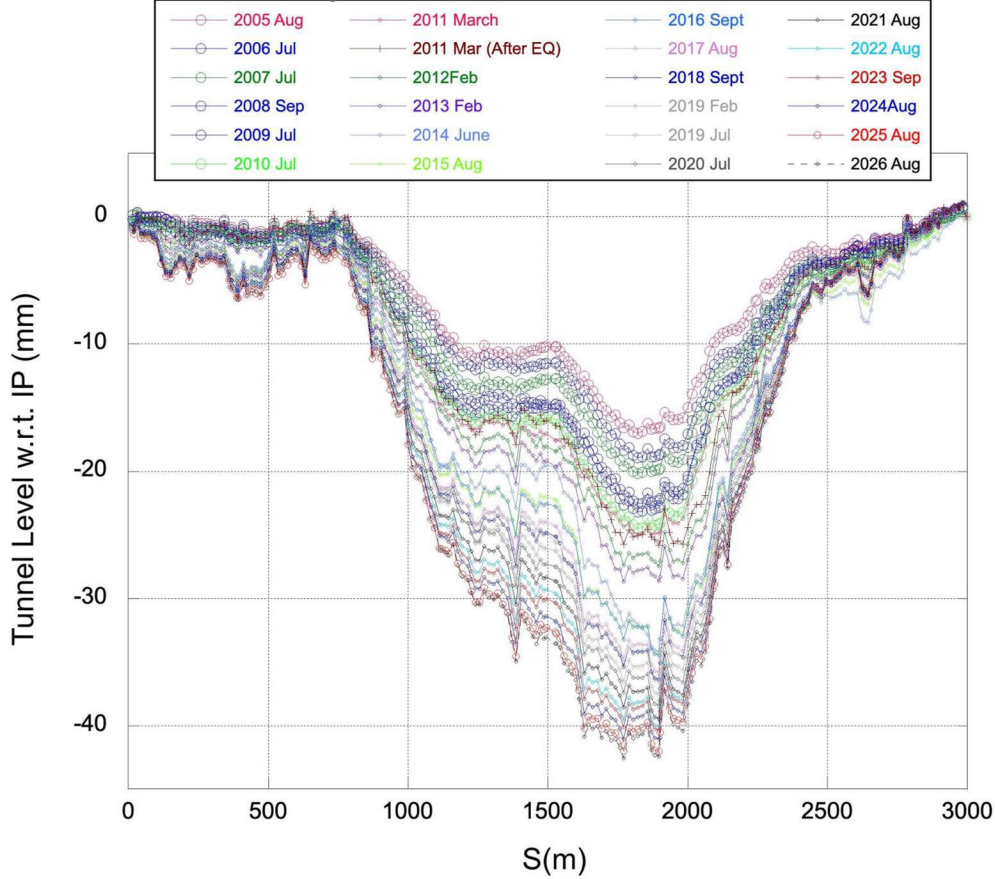
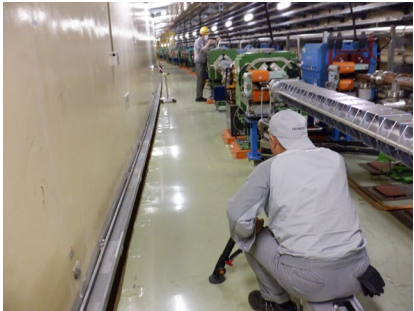
Tunnel-level history, 2005–2026

Preliminary tunnel-level data are available.  
Constrained SAD simulations show no indication of emittance growth under the some assumptions.  
Need to conduct various assessments to consider more realistic situations.

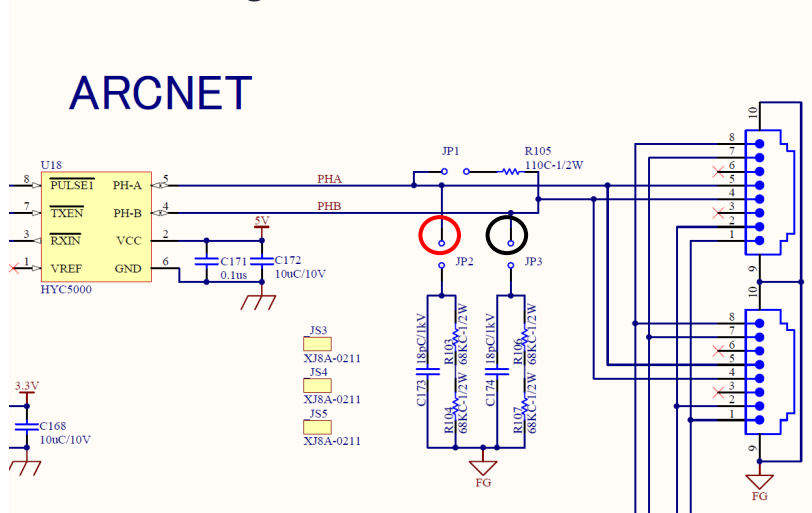
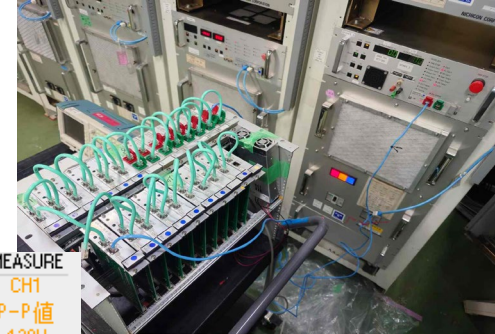
- **ARCNET Communication**
  - Power converters use ARCNET for remote control.
  - Intermittent communication failures can prevent proper orbit or tune corrections.
- **Signal-Level Inspection**
  - Check communication signal levels for all power converters.
- **Address significantly attenuated links through:**
  - PSICM-board replacement.
  - Cable replacement.
  - Reconfiguration of network branches.

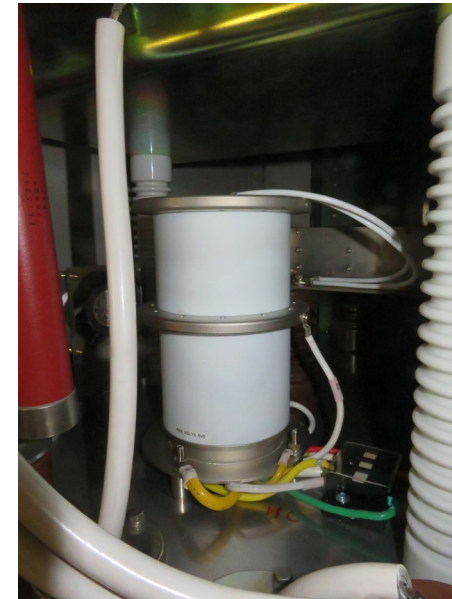
**CX1174**

K1-3 events continued after some replacements.  
(#4274 → #4314 → #1984)

The possibility of the cause lying elsewhere-outside of the thyatron-is considered low, given that measures such as duplicating the trigger have been implemented.

**We decided to replace the thyatron in the LER kicker power supply K1-3, CX1174, with the type used in the HER kicker power supply, CX1826A.**
