# Vacuum

The 29<sup>th</sup> KEKB Accelerator Review Committee  
26<sup>th</sup> October 2026

Mu-Lee Yao  
On behalf of KEKB Vacuum Group

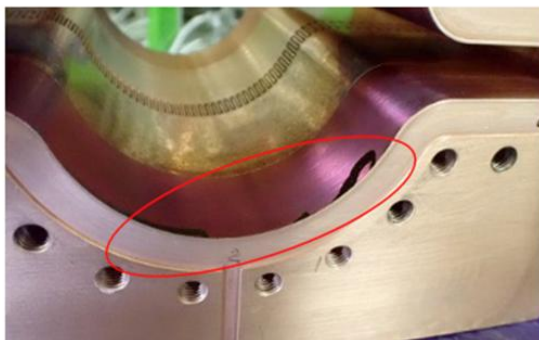
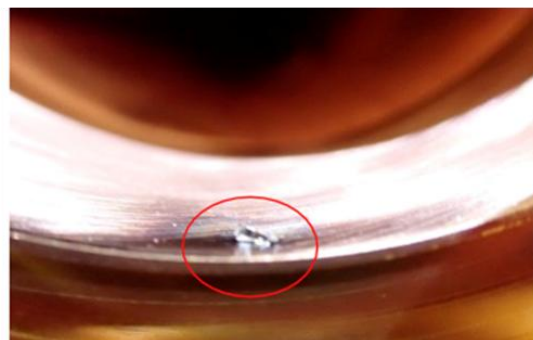
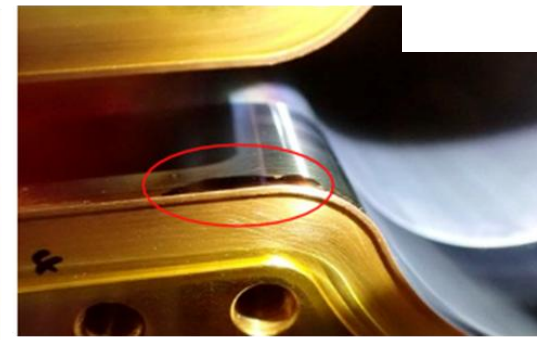
### Example D04

#### Inside of bellows chamber and beam pipe in the Oho Wiggler Section

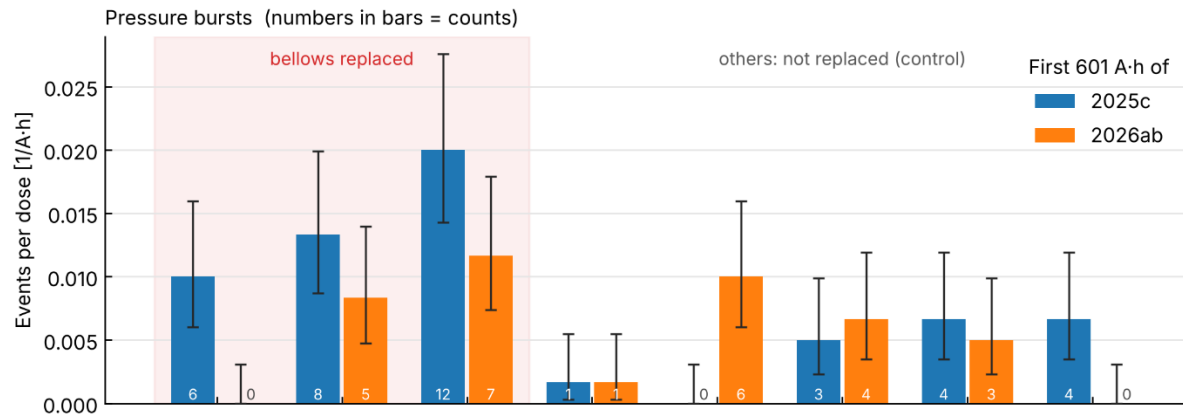
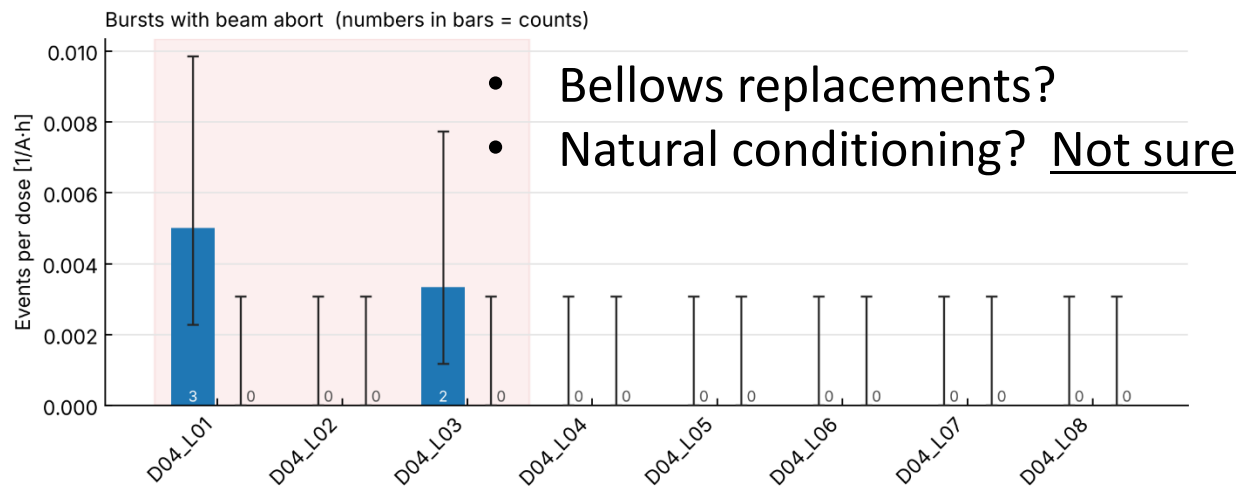
## Effect of Bellows Replacement at LER D04 L01-L03

- Pressure bursts during SBL were still observed at D11 and D04
  - The interior of the bellows was checked, and both bellows were replaced — 4 units in total.
- Verification during 2026ab run: Pressure bursts frequency reduced (see following pages)
  - Bellows replacements?
  - Natural conditioning? Not sure
- The event frequency remains higher than before LS1, although the beam current is also higher.
- Beam losses accompanied by pressure bursts also occur in regions where Vacuum Sealant has not been used, suggesting that factors other than Vacuum Sealant also contribute to beam losses.

D04 WIG: burst frequency at equal integrated dose (0-601 A-h from run start)  
error bars: Poisson 68% (Garwood)

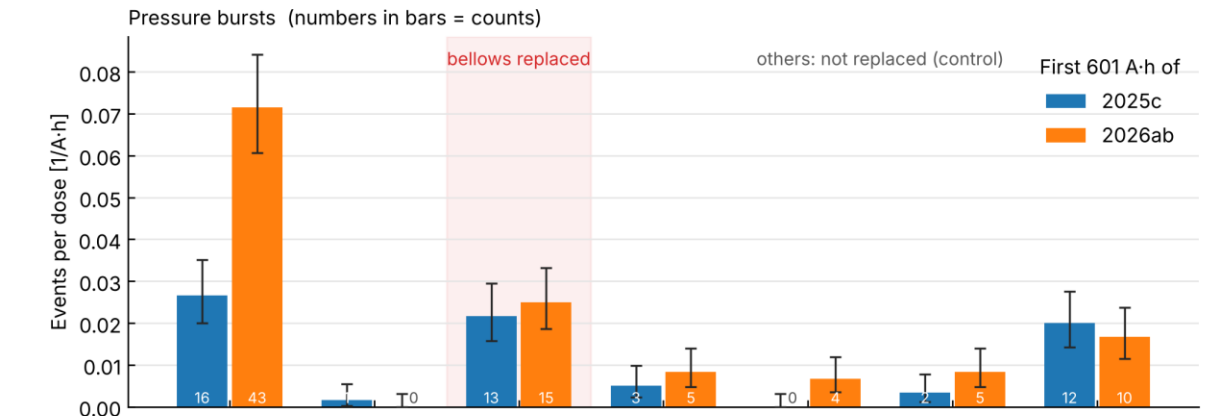
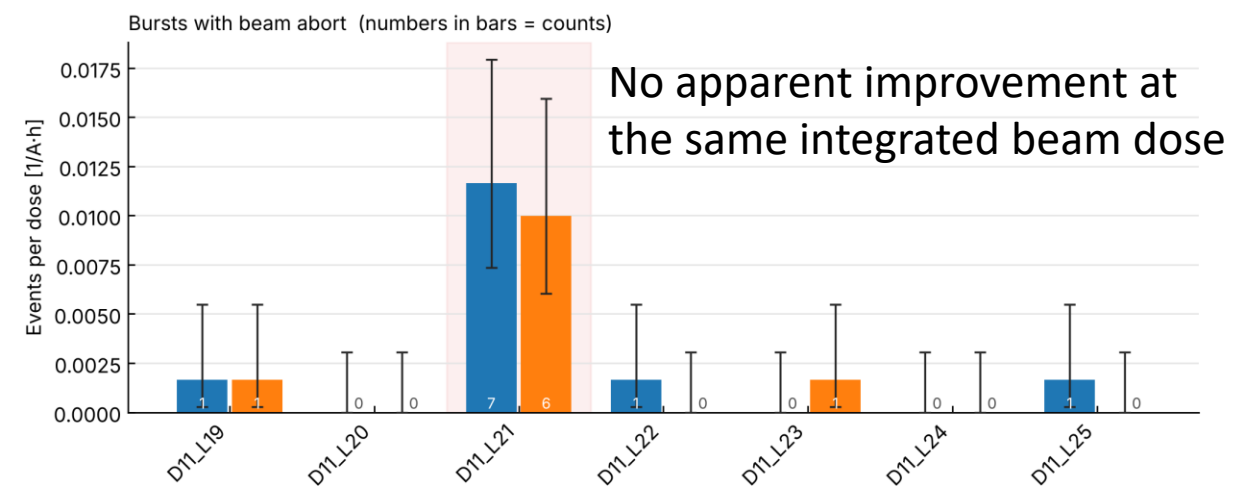
## Effect of Bellows Replacement at LER D11 L21

D11 WIG: burst frequency at equal integrated dose (0-601 A-h from run start)  
error bars: Poisson 68% (Garwood)

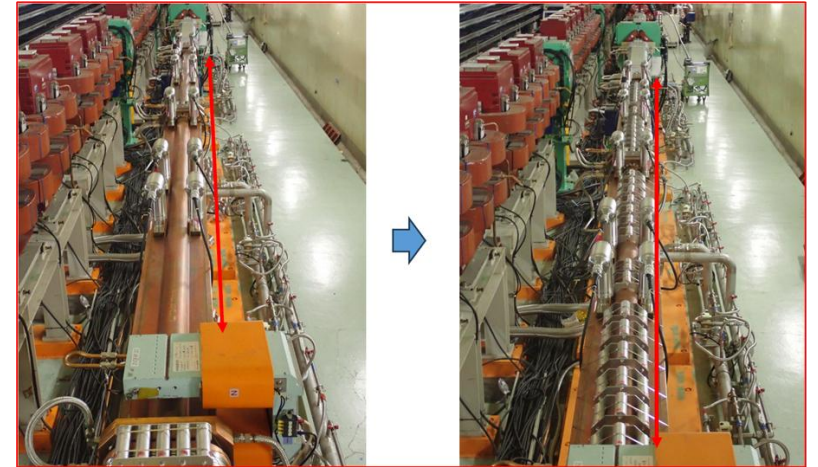
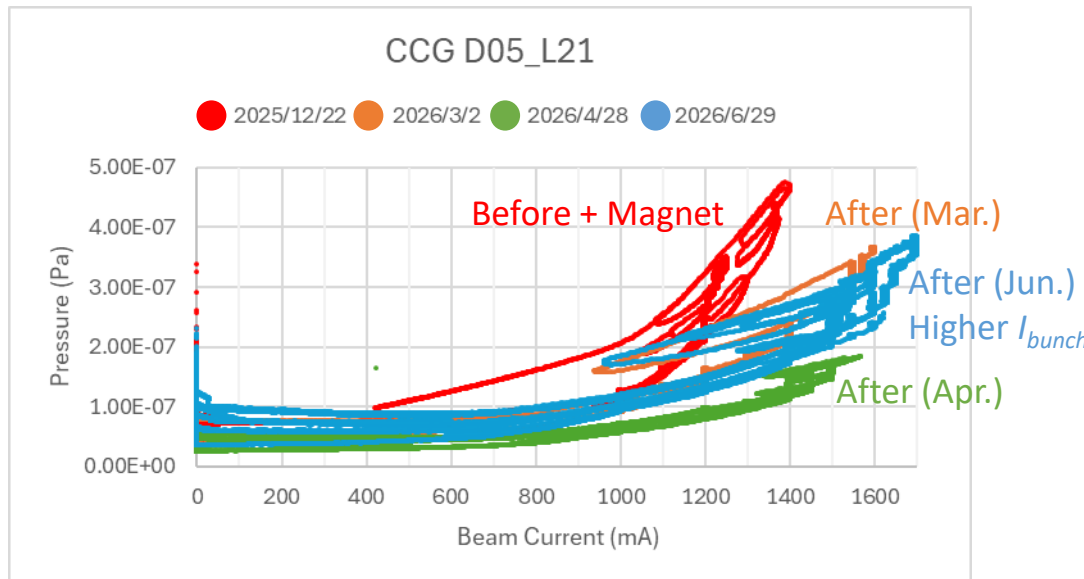
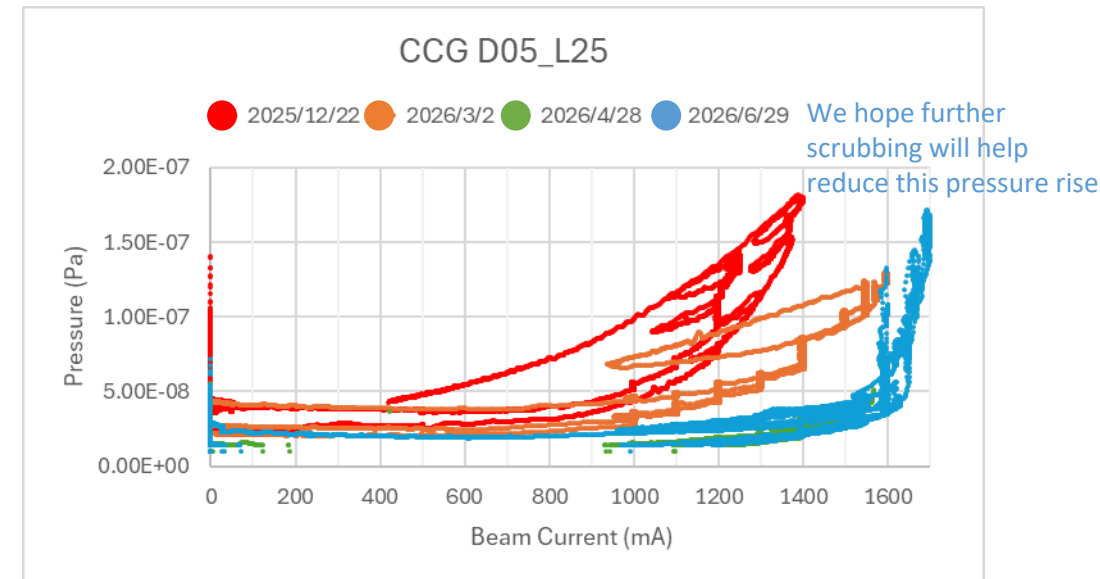
- Permanent magnets were added to sections where no permanent magnets had previously been installed
- 02/16 and 03/18 NEG activation
- 2025c → 2026a An improvement was observed
- 03/18 The permanent magnets at D05\_L25 and D05\_L26 were replaced with stronger ones: ● → ●
- Effective: stronger magnets? or beam conditioning?
- The pressure rise at D05\_L25 becomes pronounced above 1650 mA
- → ● Bunch number decreased (2346 → 2026), bunch current increased

+ More permanent magnet sets

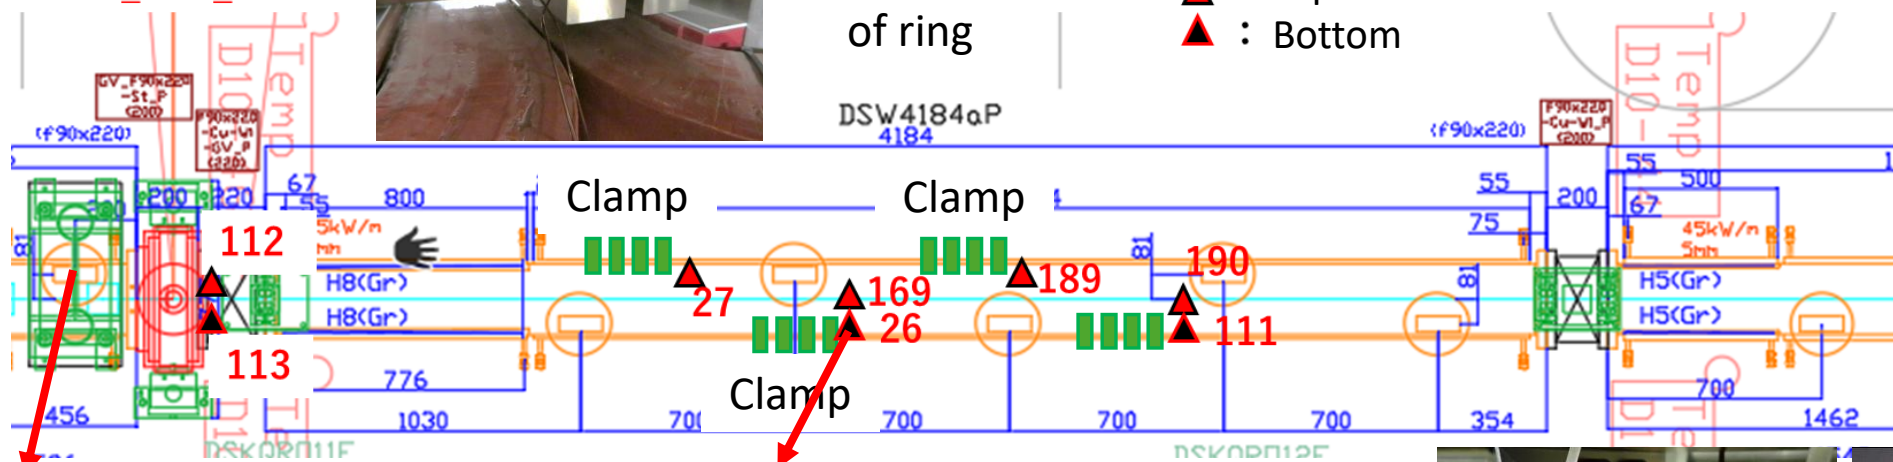
IP/CCG  
D10\_L09

- Pressure rise at CCG D10\_L09 - associated with upstream beam pipe heating
  - Black copper oxide was observed (#169: 280°C/ #27:180 °C @1600 mA)
  - Before 2027ab: 1. Replace the upstream bellows with an SR-mask-equipped unit, 2. reverse the chamber orientation, and 3. fabricate a spare
  - Clamping is effective, but the amount of deformation must be controlled

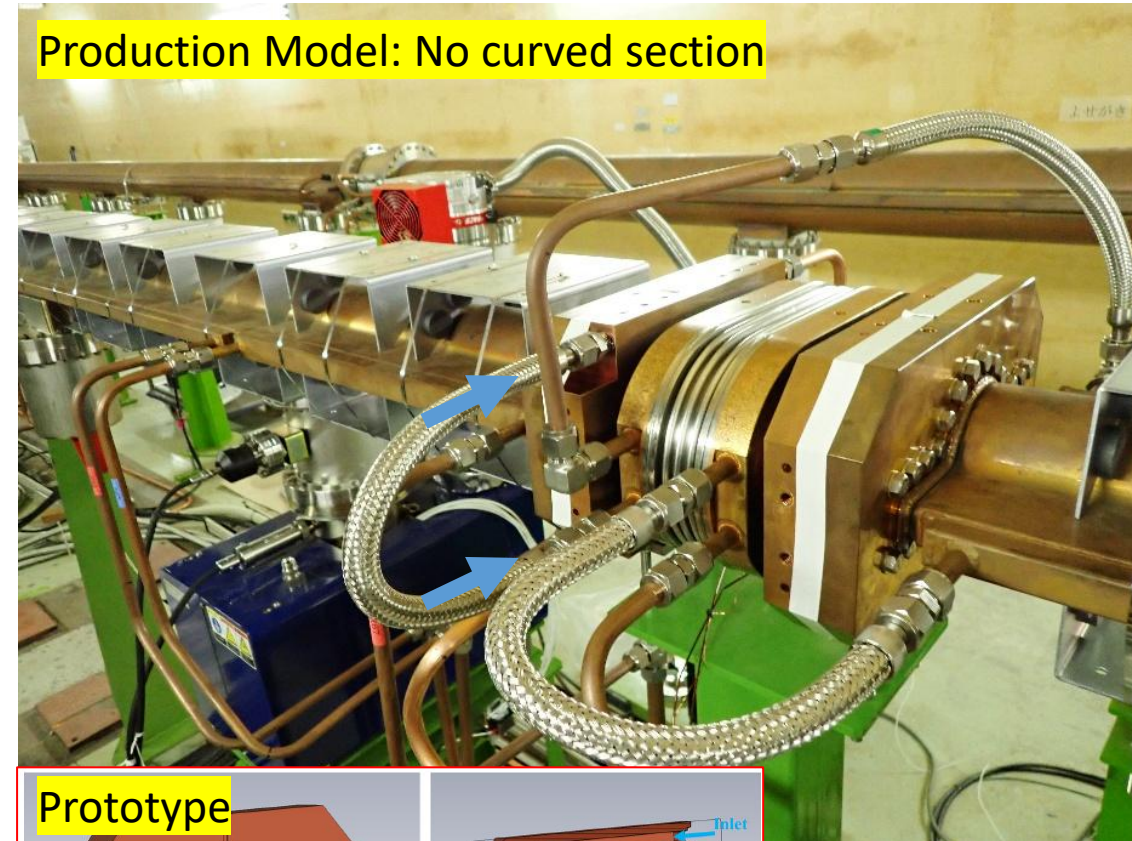
#### Production Model: No curved section

- Without water cooling: chamber temperature reached 100°C
- Cooling water: 20°C, 3 L/min
- Flange temperature: below 35°C

- Prioritize locations with high leak risk (clamshell sites)
  - D04: 3 units/ D10: 13 units/ D11: 10 units (All Completed)

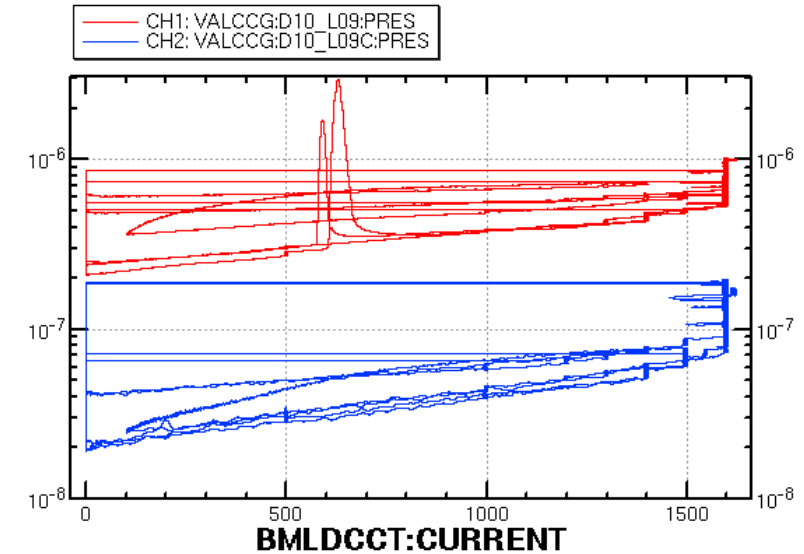
NEG Pump near CCG D10\_L09C

- Pressure rise was observed at CCG D10\_L09C in LER wiggler section
- Chamber opened for inspection on 7/3; only slight gasket discoloration was observed
- RF-screen gaskets were installed at the NEG pumps near CCG D10\_L09C and also CCG D04\_L09C

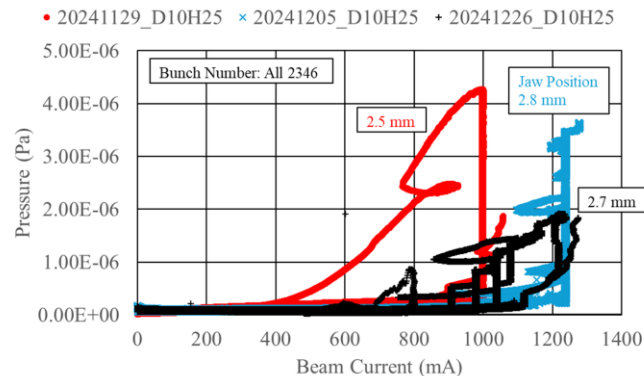
Before: original collimator (2024)

- Nonlinear pressure rises were observed at several HER collimators
- Suspected mechanism: SR heating causes head deformation, reducing thermal contact with the chamber and cooling efficiency, leading to sharp temperature and pressure rises
- A water-cooled KEKB-type collimator was installed at D09V3 before the 2025c run to suppress nonlinear pressure rise
- The removed head showed pronounced blackening, suggesting possible overheating to 200–300°C, although discoloration alone cannot establish the temperature

Clear nonlinear rise above ~1000 mA  
(jaw position 2.5 mm)

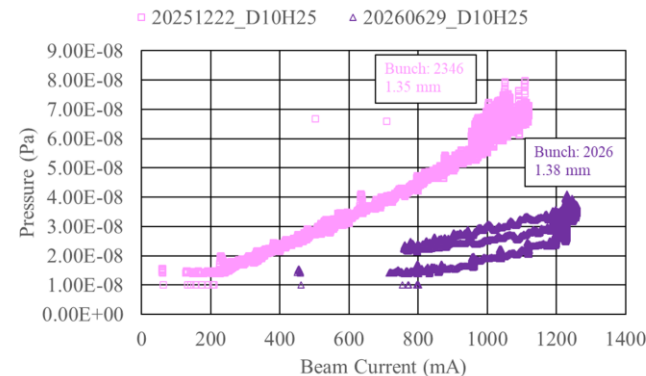
After: water-cooled collimator (2025–2026)

- No nonlinear pressure rise was observed in 2025–2026, despite narrower gaps than in 2024
- In 2026, fewer bunches (2026 bunches vs. 2346 bunches) may have increased wakefield heating at the same total current, but still no nonlinear pressure rise was observed
- Similar nonlinear pressure rise was observed at D09V1; replacement with a water-cooled unit is scheduled for Oct. 2026, before the next run (Yao's Report: PASJ2026 FRP084)

Stable up to ~1300 mA  
(jaw positions 1.35–1.38 mm)

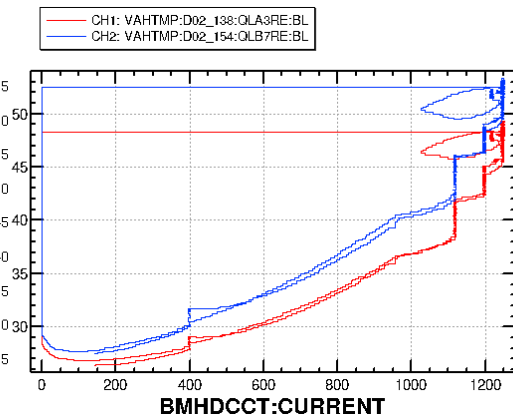
- 2026/05/30 A leak developed at a weld in the stainless-steel beam pipe for ZVF4RE (iBump steering), near CCG D02\_H16.
- Temporarily sealed with General Sealants and Vacuum Sealant during operation
- Suspected cause: Thermal fatigue cracking due to SR from BLA2RE striking the weld

6/11 Before rotation: The D02\_154 thermometer had detached

6/11 After rotation: The D02\_154 thermometer was resecured

Move the leak location into the shadow of the SR mask.

- Repair: On-site welding was successful (2026/10)
- A new chamber will be fabricated and installed (2027/02)
- Rotation of another similar chamber on the upstream side of D02 is also planned

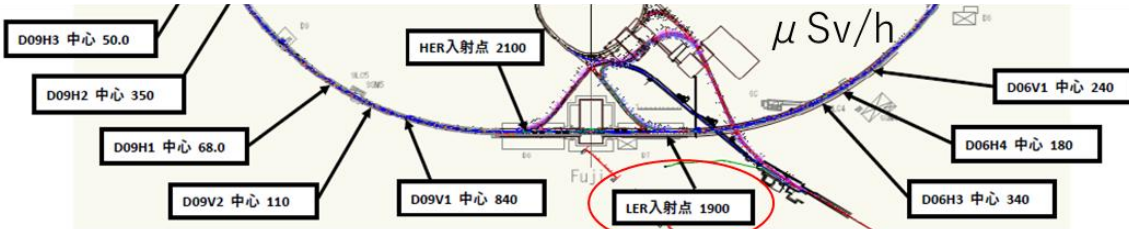
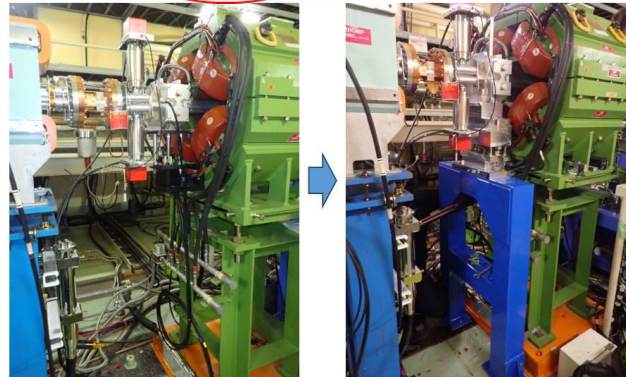
## LER Injection beam pipe QI6P alignment

- An offset of approximately 3–3.6 mm was observed at the LER injection-point BPM
- 2024 single-beam studies confirmed improved injection efficiency by reducing 2Jx
- During the 2025 shutdown, alignment adjustments using an independent BPM support and shims reduced the offset to approximately 2.8 mm (July 2025)

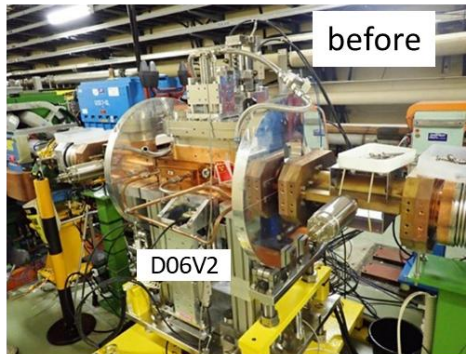
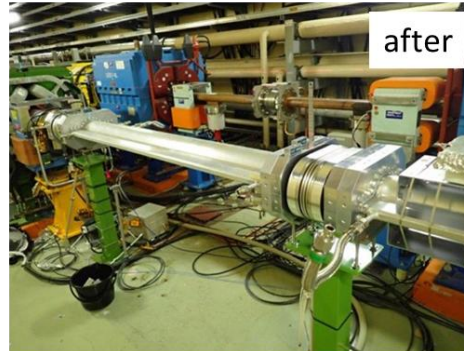
Location of D06V2

- The D06V2 collimator was relocated to D03V4 as a countermeasure against SBLs to reduce losses at the IR and D02V1 regions.

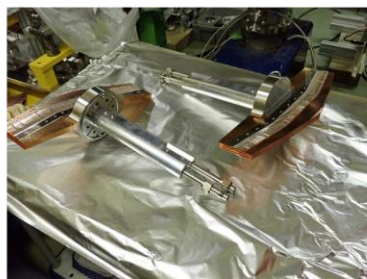
上側ヘッドの放電痕

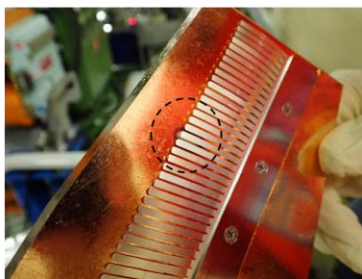
下側ヘッドの放電痕

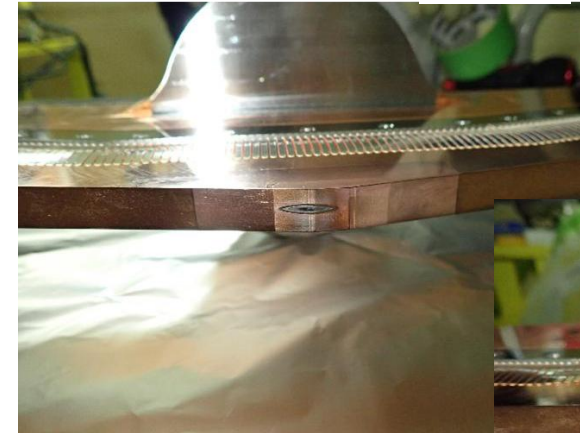
- D01V1 and D12V4 were damaged during 2026ab.

- Plan to replace
  - LER D03V4
    - It is also highly likely that this has a significant impact on LER's tune shift.
- Considering the replacement
  - HER D01V1
  - LER D05V1 Top or Bottom
    - We haven't used the top jaw (Ti) because of the high radiation level around Oho experimental hall, so another option would be to replace the top one with Ta.
    - If only the top jaw is being replaced, there is no need to rotate the chamber, and the radiation shield does not need to be dismantled to any great extent, so the amount of work required is relatively minimal.
  - HER D12V4
    - With the jaw width of 40 mm, we can avoid the damaged region by shifting the collimator horizontally.
    - For example, the D12V1 is used in a position shifted 2.5 mm outward from the ring.

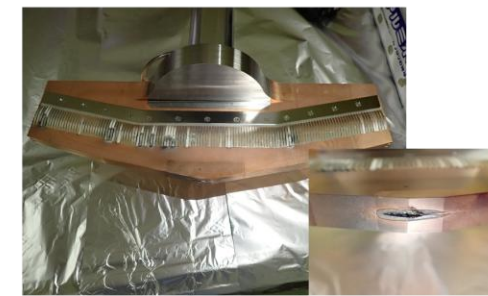
D05V1

下側ヘッド (RFコンタクトに放電痕を多数確認)

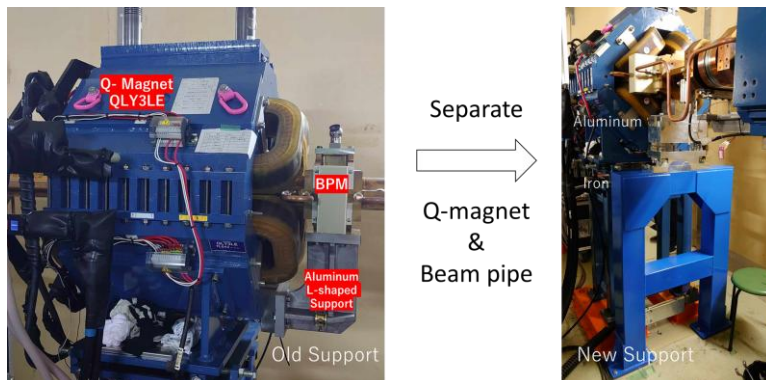
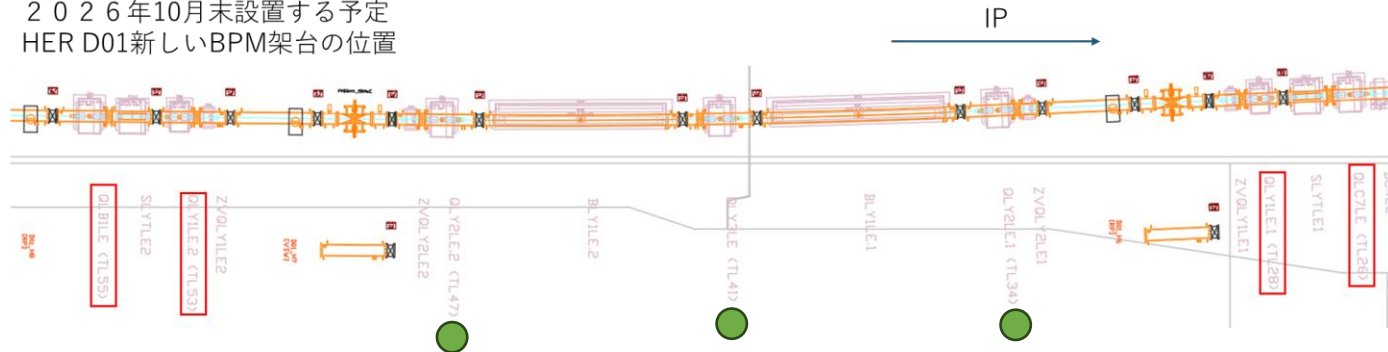
2. More SLY independent supports in HER D01 (2026/11)

- Yao's Report: PASJ2024 FRP083
- Add 4 more independent BPM supports

2026年10月末設置する予定  
HER D01新しいBPM架台の位置

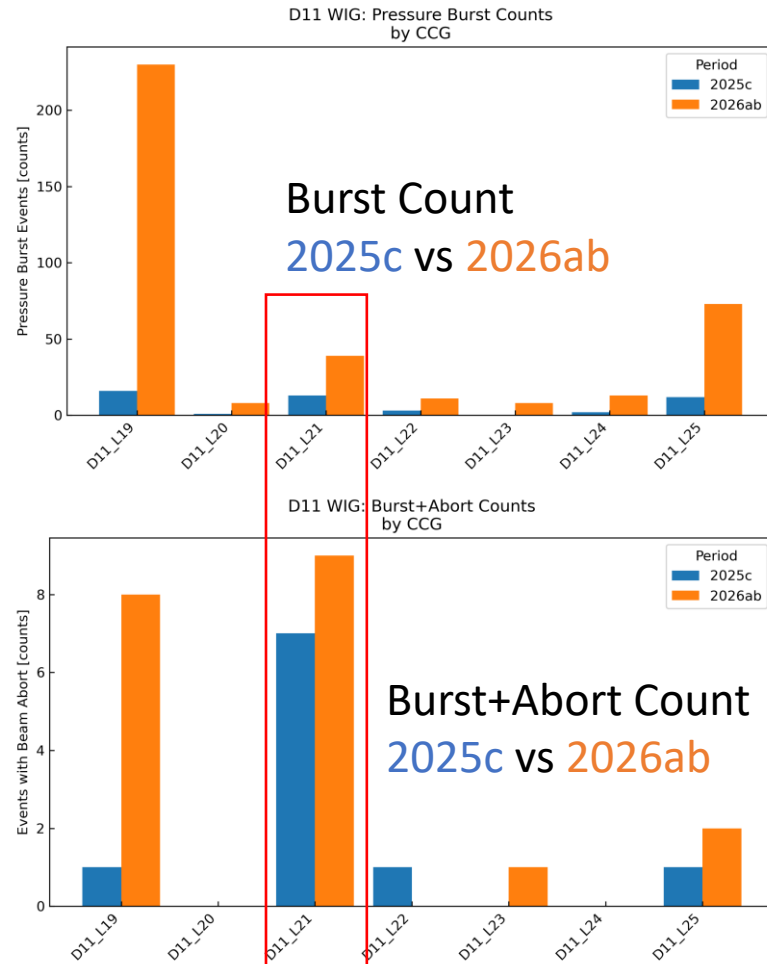
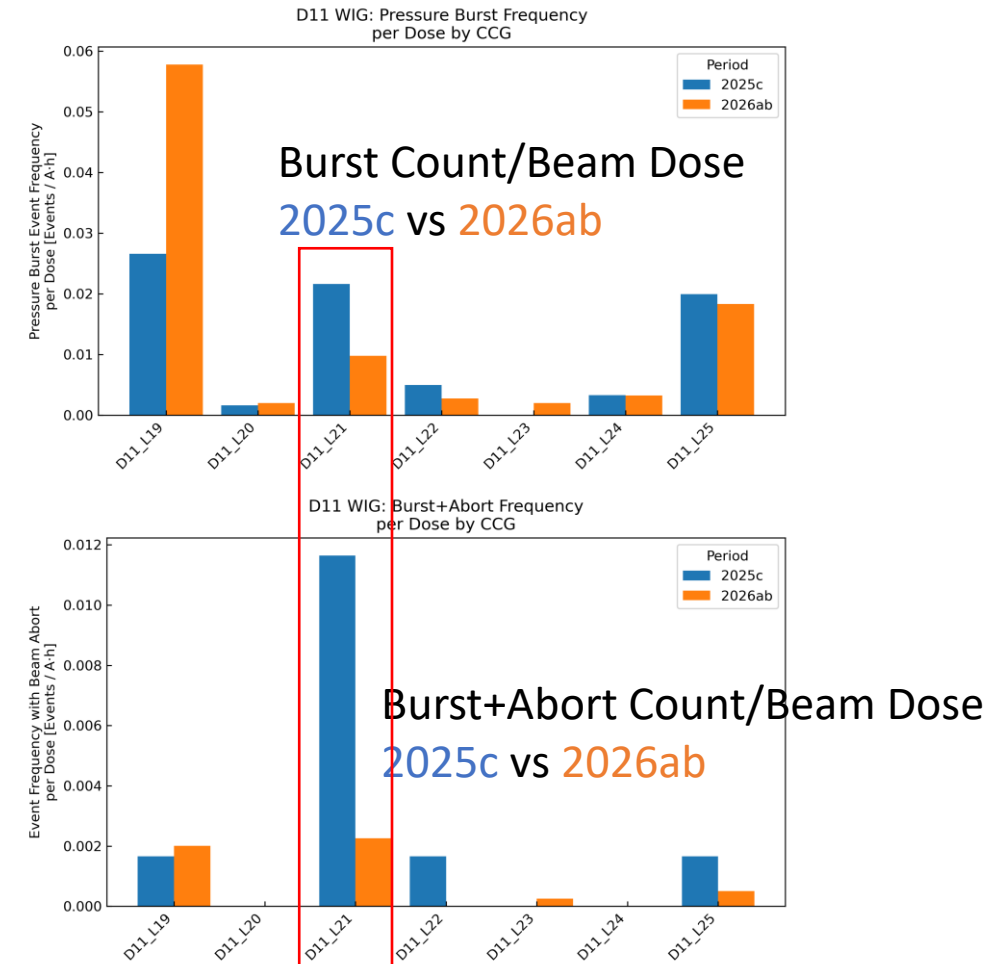
## Effect of Bellows Replacement at LER D11 L21

- Bellows replacements?
- Natural conditioning? Not sure

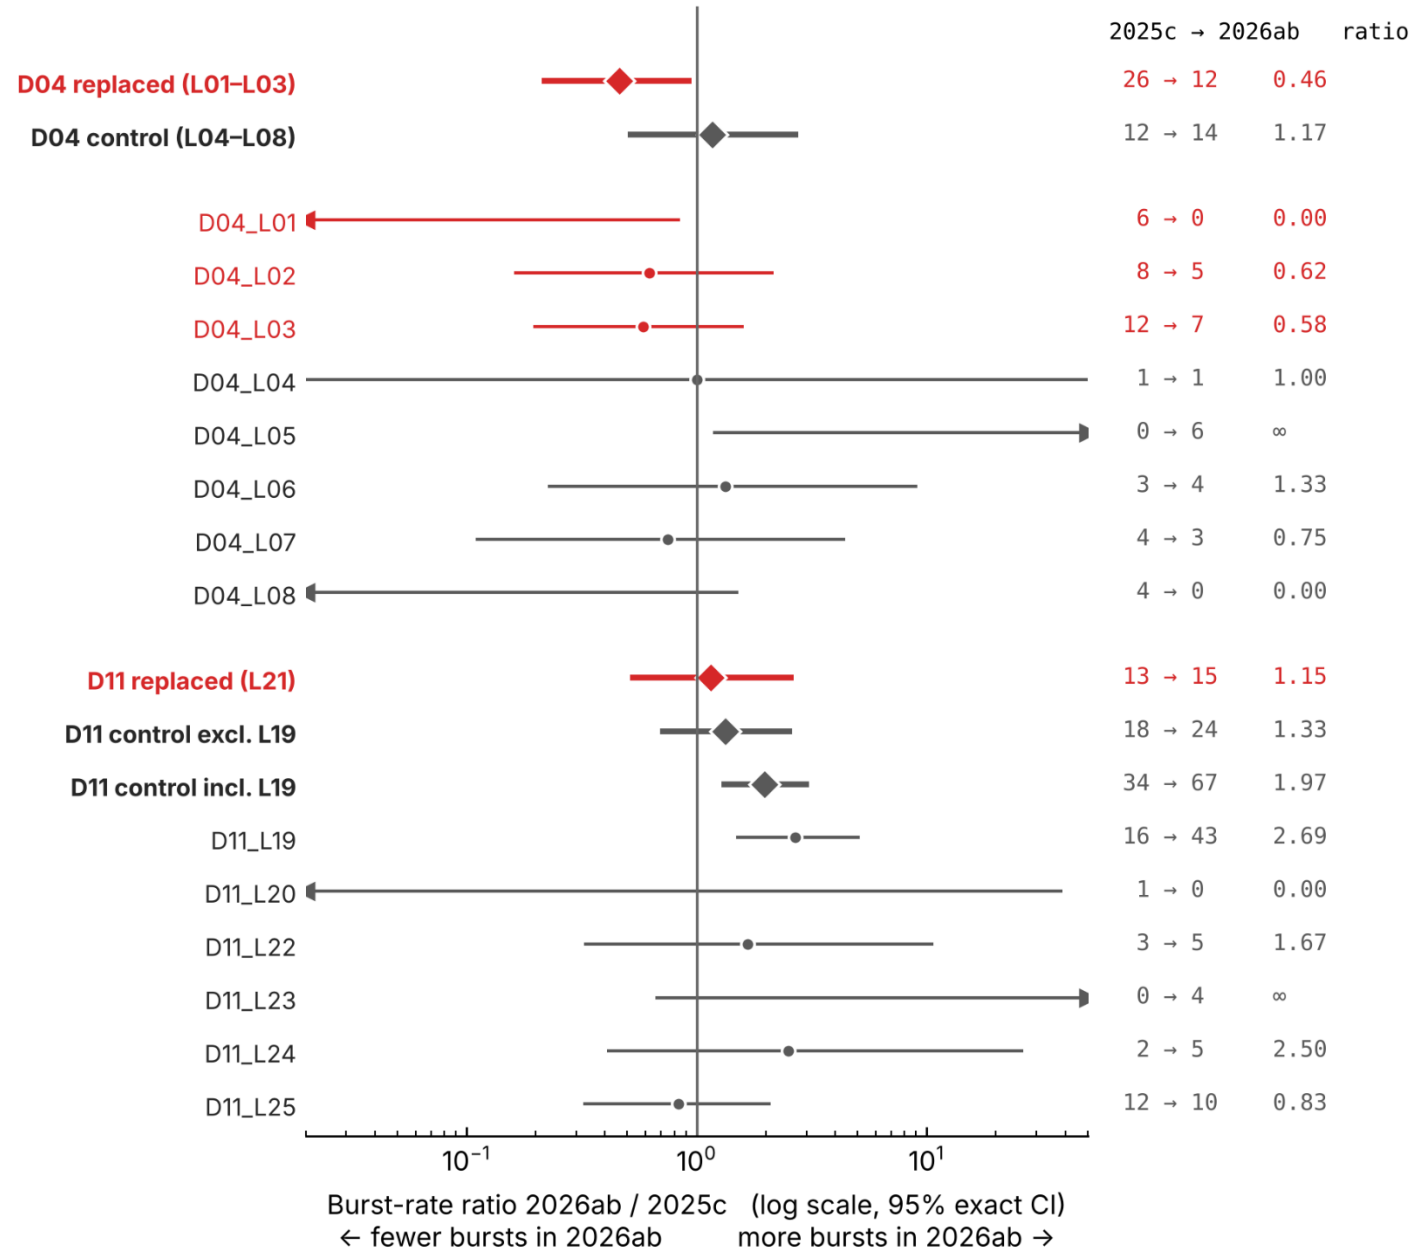
Effect at equal dose (first 601 A·h of each run)

D04: replaced/control = 0.40 [0.12, 1.25], Fisher p = 0.119

D11 (excl. L19): replaced/control = 0.87 [0.30, 2.53], Fisher p = 0.810

D11 (incl. L19): replaced/control = 0.59 [0.23, 1.51], Fisher p = 0.268
