# Facility and Safety

27 Oct 2026

The 29th KEKB Accelerator Review Committee

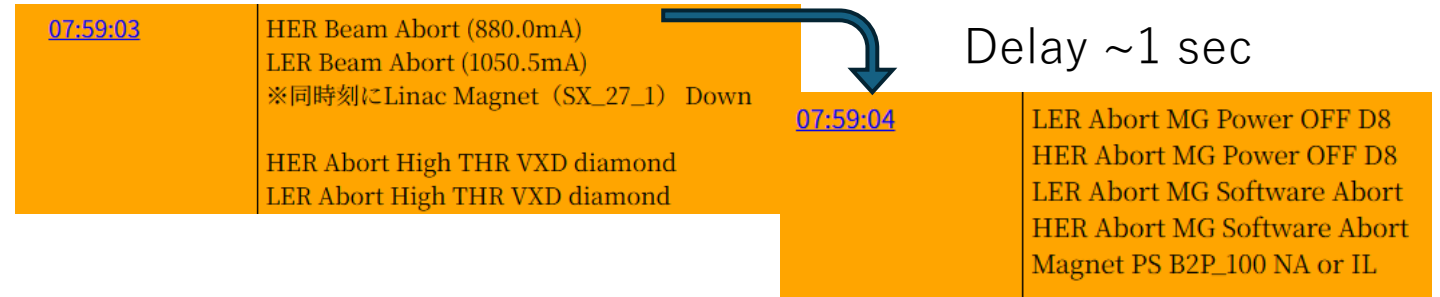
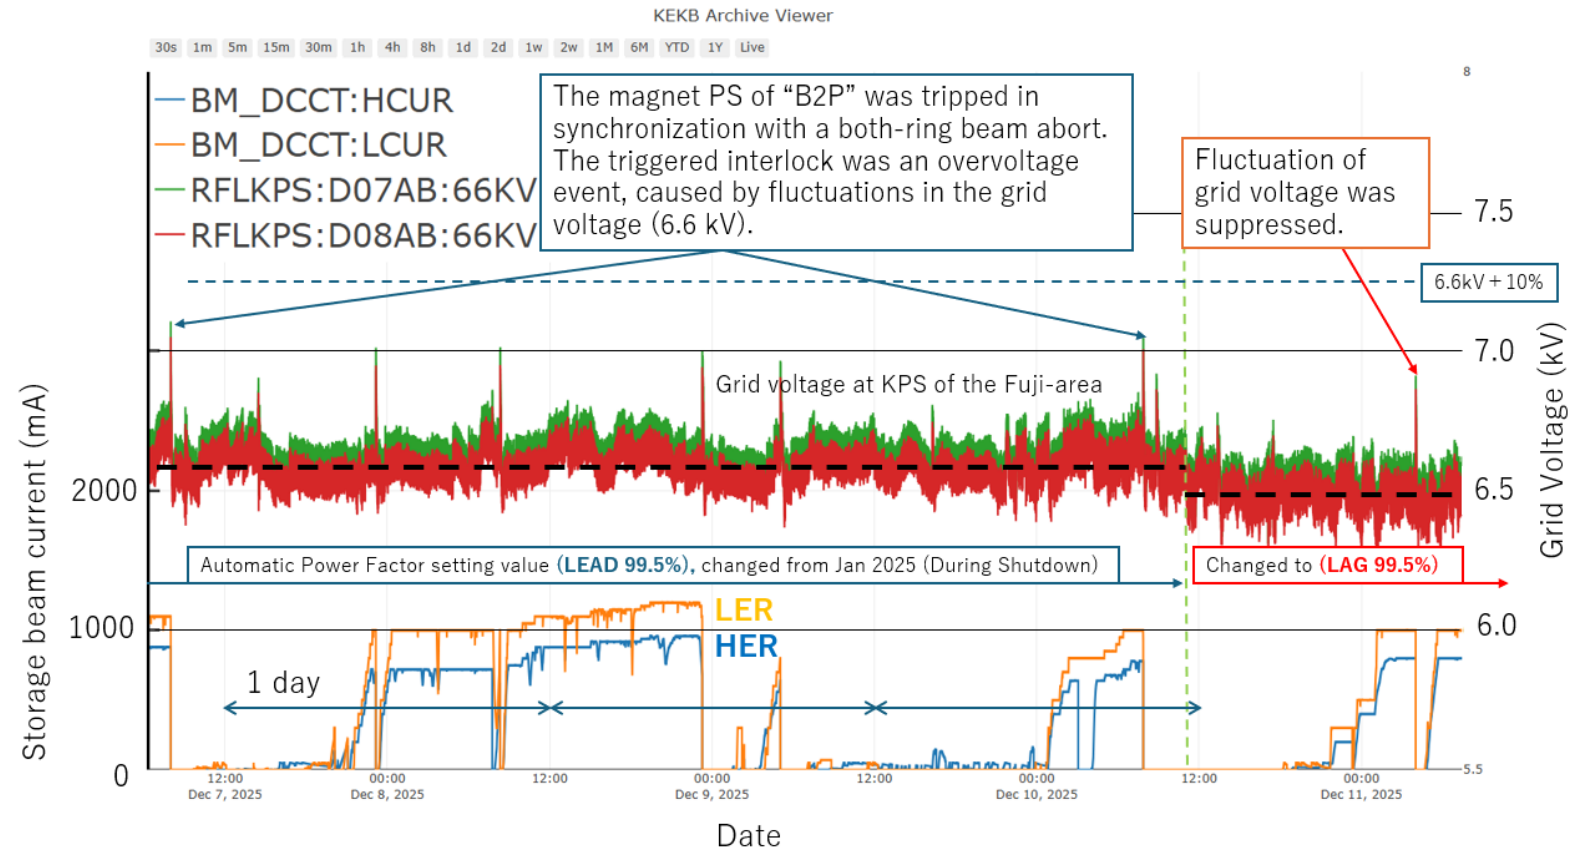
# Tipped B2P in synchronization with both ring beam aborts

- Initially, the B2P (Bending magnet in LER) tripped in synchronization with a beam abort (Dec 7, 2025).
- This is the first time such an event has occurred since operations began.
- The triggered interlock was an “overvoltage”, resulting from a spike in the grid voltage.
- Further investigation revealed that the excessive grid voltage spike was caused by the automatic power factor regulator being set to a **"leading"** state during the shutdown period (from Jan 2025).
- The setting was not returned to a **"lagging"** state in preparation for the 2025c operational run. The cause was a lack of communication with the facilities department.
- The only circuit that experienced an extremely large spike in grid voltage was this bank (EHV substation in Fuji-area, No. 4), where RF (10 MW) and magnet (1.4 MW) coexist.

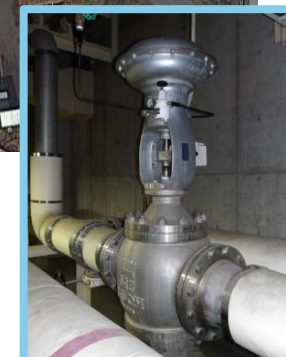
Three-way valve

- ・ 1980年代に設置された三方弁：軸受けのシール性が劣化したことによる水漏れが原因で各所が腐食。  
軸の固着による動作不良、漏水拡大による冷却系の停止が懸念される状況。

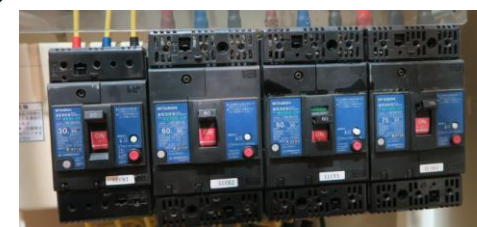
Before

Manufactured in 1997

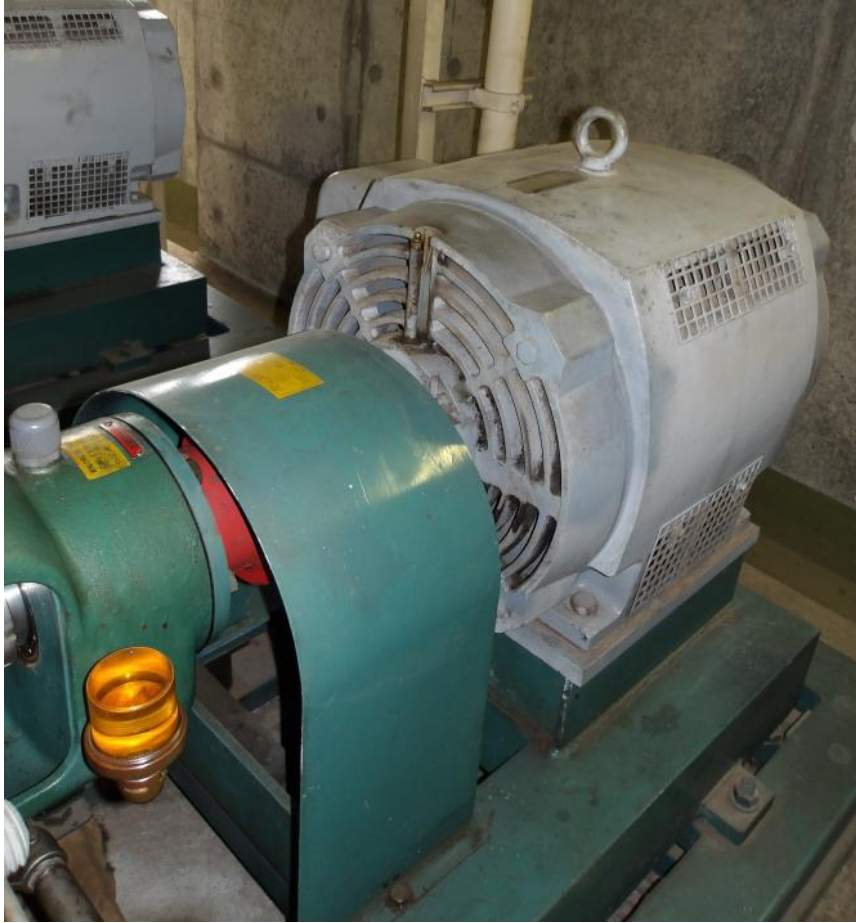
High power pump (1980s)

Although infrequent, there have been instances where electric motors have suddenly developed ground faults; consequently, the risk of operational shutdowns or performance limitations due to pump failure is on the rise.

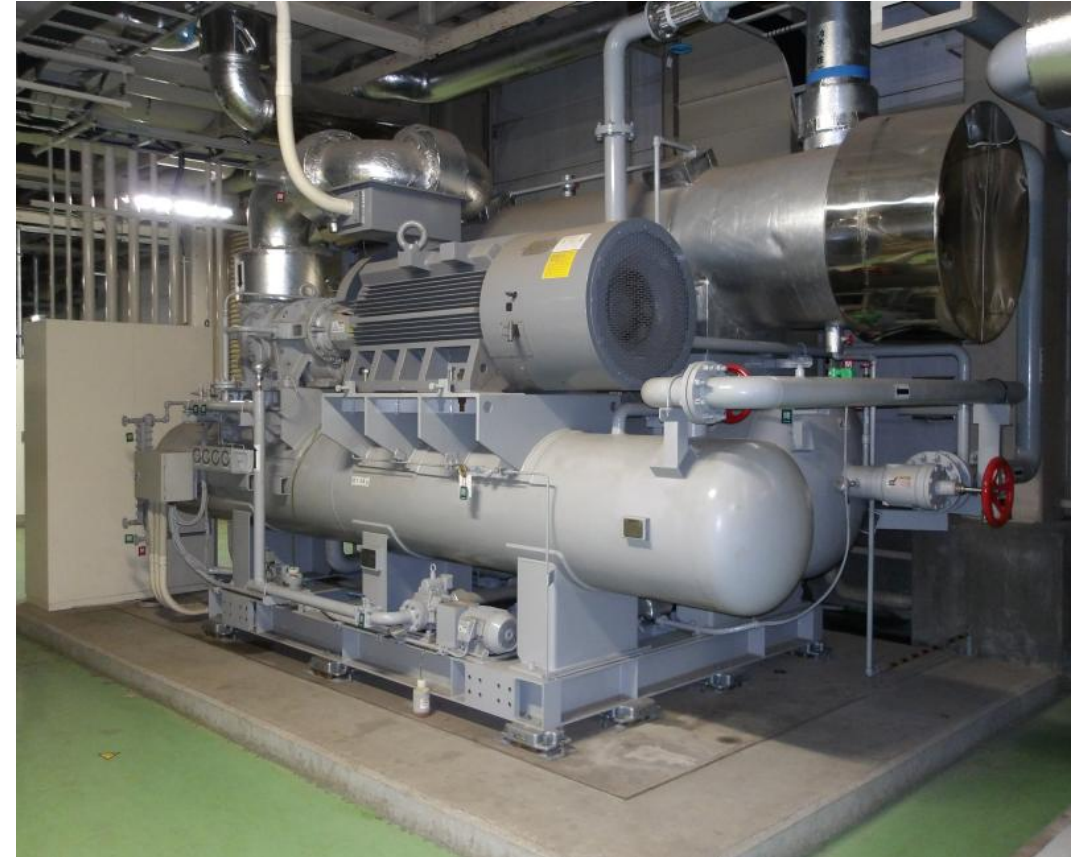
Screw chiller (~400kW)

冷媒の冷却が追いつかず、冷凍機の性能に制限がかかる。負荷大（圧力異常）により冷凍機の急停止、一時的にはあるが加速器運転も停止する。

冷媒冷却用の空冷塔（粗熱取り）  
老朽化により6台中2台のファンが停止している。  
（電動機の地絡が原因）

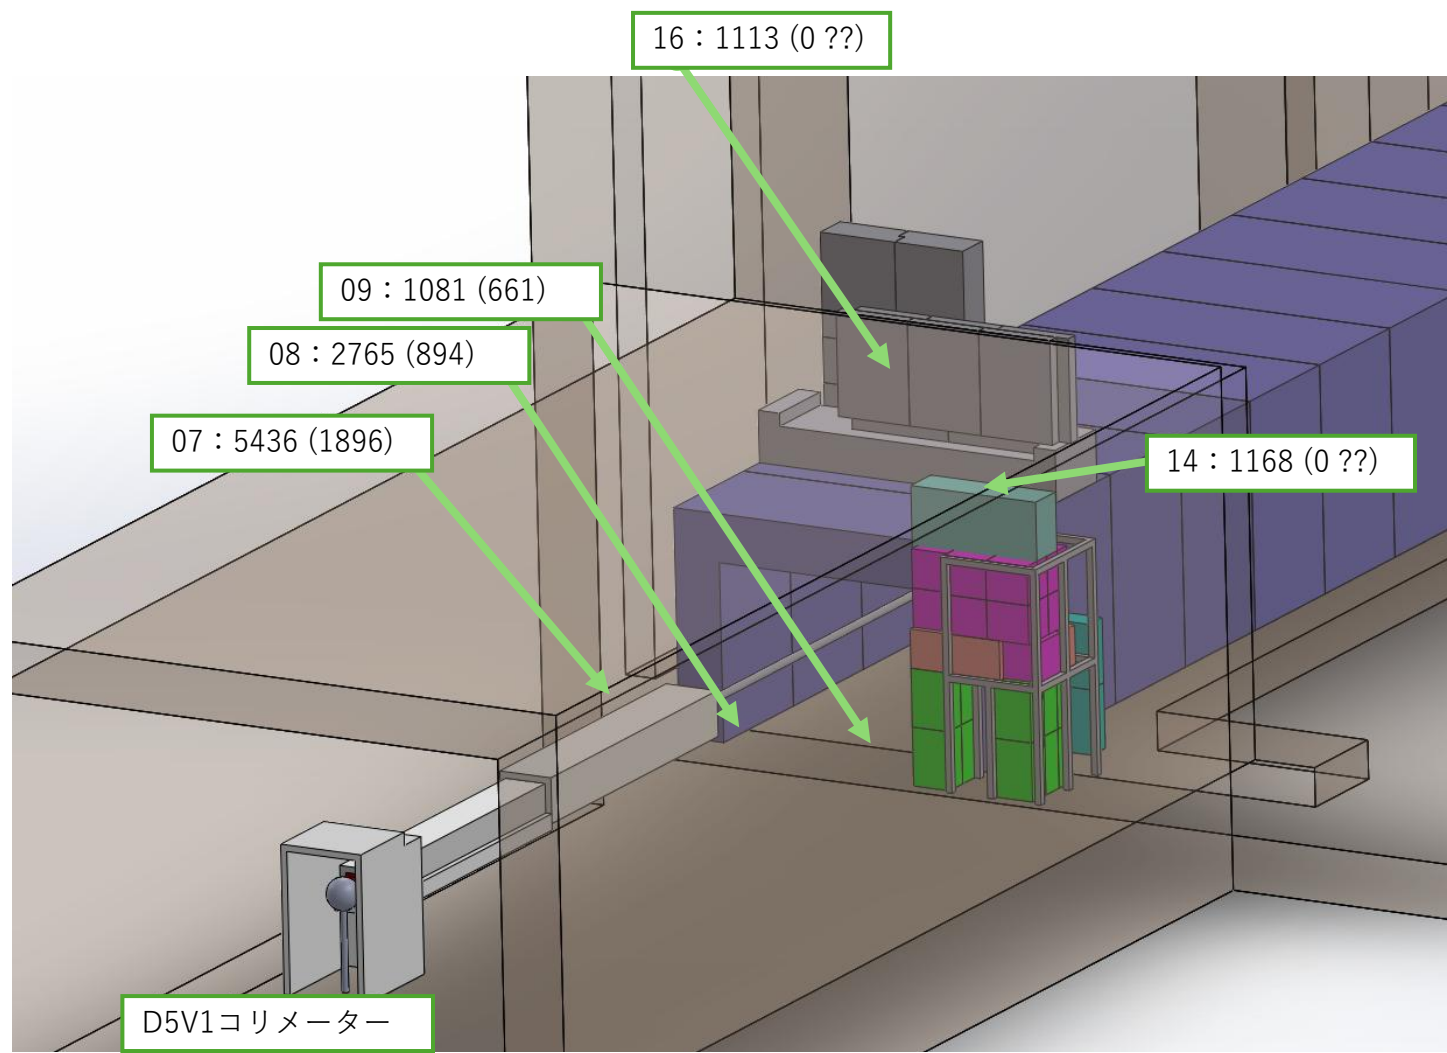
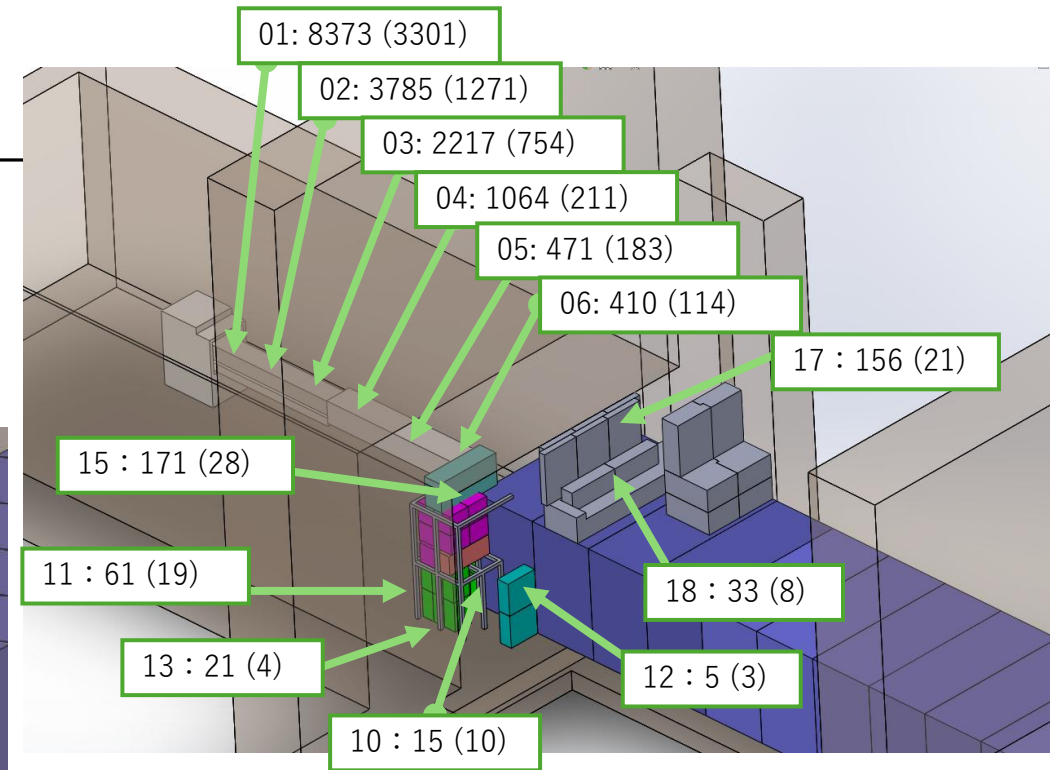
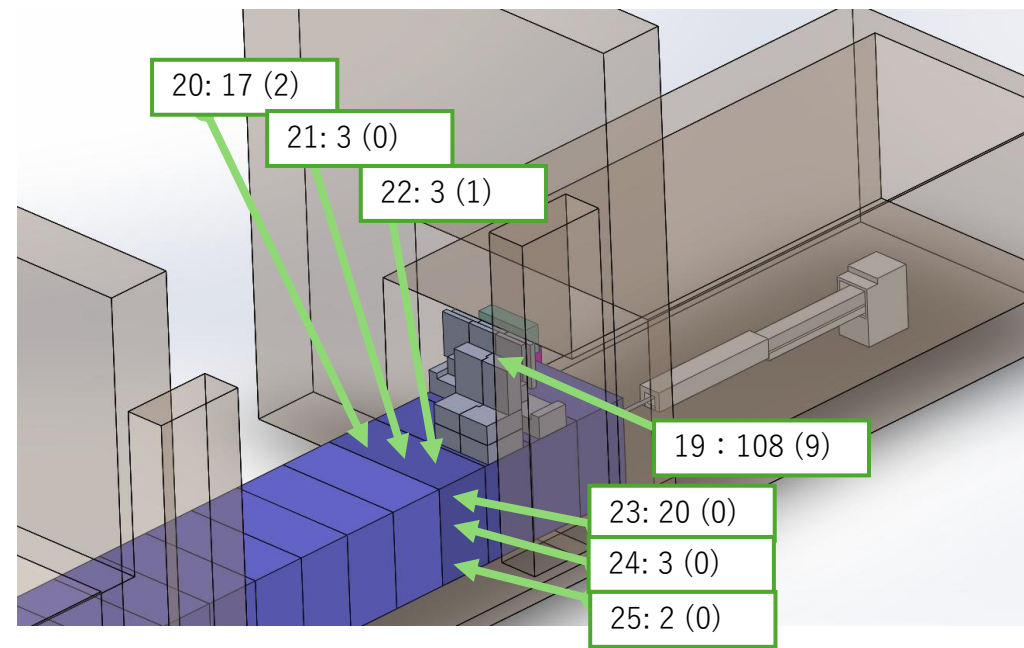
# 観測結果：DeepDose [mSv] (NeutronDose [mSv])

測定期間：2026年1月26～2月18日 (24日：576時間)

大穂直線部に構築した放射線シールドの遮蔽効果と漏洩箇所の探索のため、2026a運転開始前にフィルムバッジ（計25個）を各所に設置した。1月26日の運転開始から2月18日の保守日までの計24日間の暴露状況をまとめる。この結果より、今後行うべき遮蔽体増強の方針を検討、必要なビームスタディについて相談する。

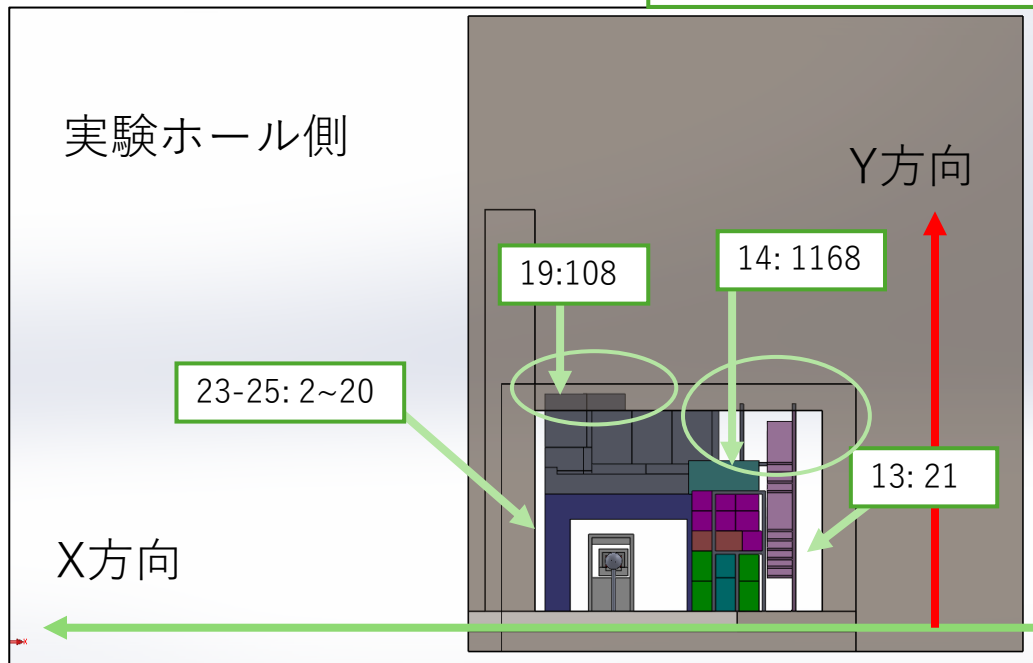
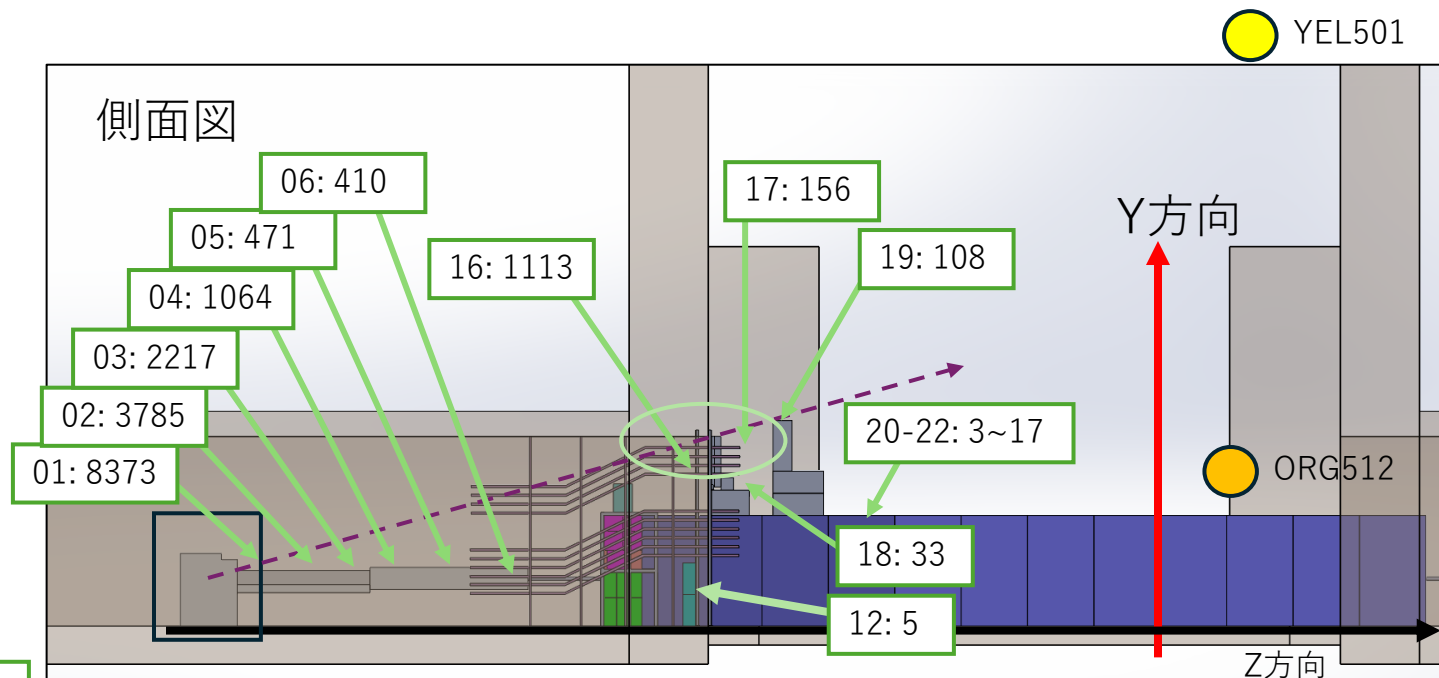
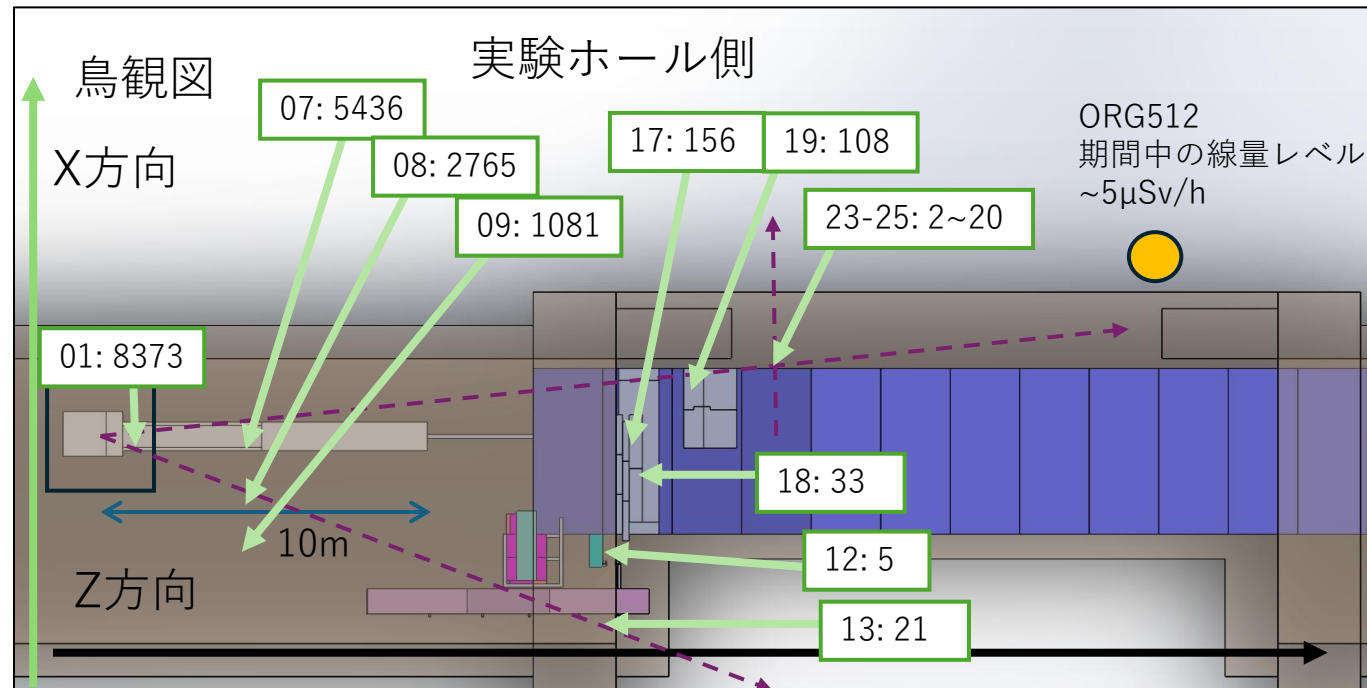
### コリメータ正面より

- ・実験ホールへ漏れ出る線量分布より、「高さ3.5m以上」のエリアからの漏洩が多い状況であることが確認された。
- ・今後の対策として
  - ①トンネル-実験棟境界の右上方の部分の遮蔽体構築
  - ②既設門型シールド上方の遮蔽強化
  - ③コリメータ直下+1~5m区間の遮蔽強化を行い、大元の線量を減らす（1~5mは10cm厚と薄いまま）。
