# Monitor

2026/10/26 KEKB Review

H.Ikeda

on behalf of beam monitor group

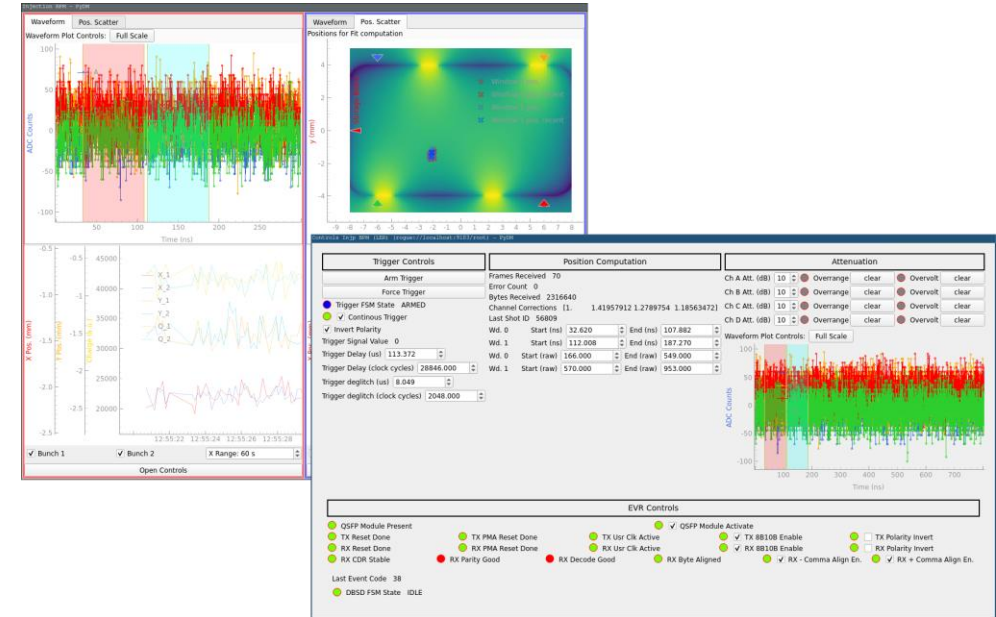
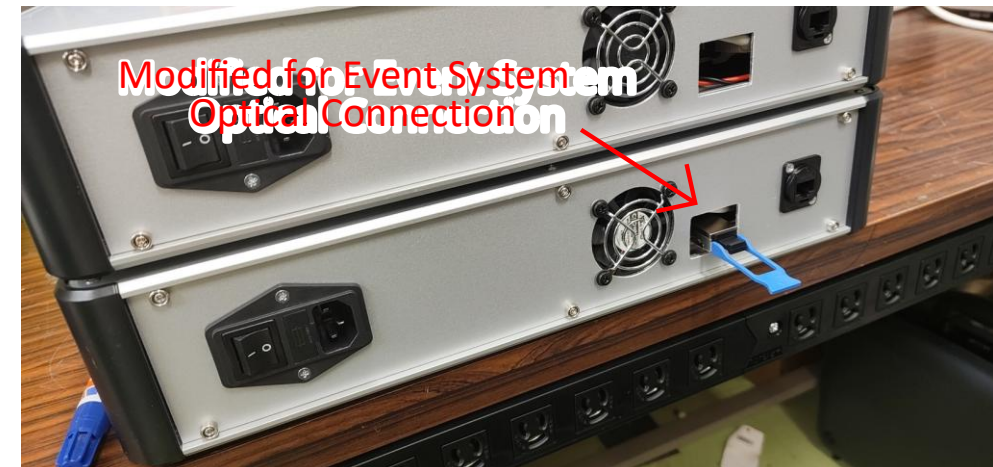
- RFSoc-based readout independently measures both injected bunches in HER and LER, supporting injection tuning.

- New firmware supports a direct optical link to the Linac event timing system, providing timing and shot IDs.
- Updated control room interfaces.
- Channel gains were calibrated using measured signals and simulated electrode responses to improve position consistency.

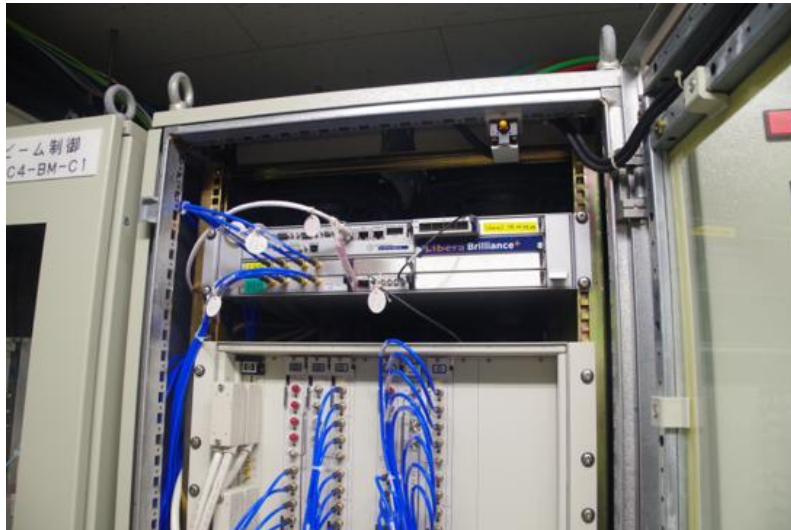
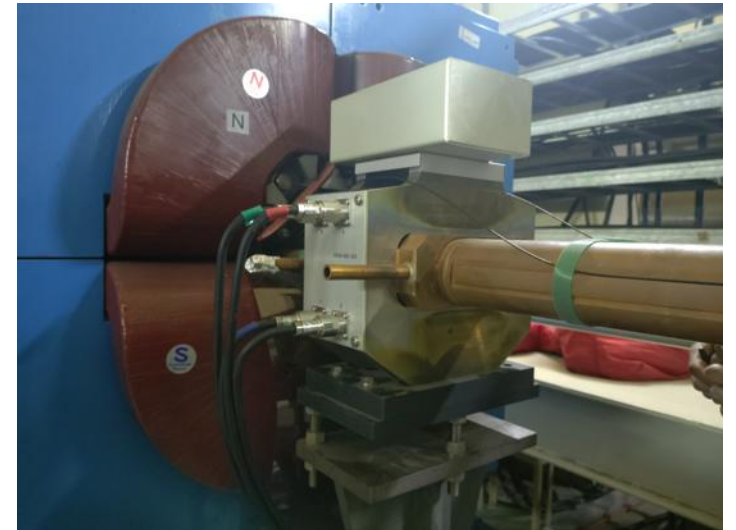
508MHz detector

- Generally operated reliably, but faults appear to be increasing.
- Aging cables, MUX switches and VXI hardware have failed; VXI startup errors are also increasing.
- A poorly fixed BPM block was found, apparently dating back to the start of SuperKEKB.

- They worked properly, but the frequency of glitches seems to be increasing slightly.
  - FT-panel cables (used KEKB time)
  - Panel to 4 in one coax cables
  - VXI 1GHz narrowband detector (4:1 MUX switch failure)
  - 4:1 MUX unit failure
  - VXI main frame (Fan failure)
    - Also, an increasing number of units are displaying errors when VXI starts up.
- Found a BPM block with poor fixation
  - It appears this has been the case since SuperKEKB began.

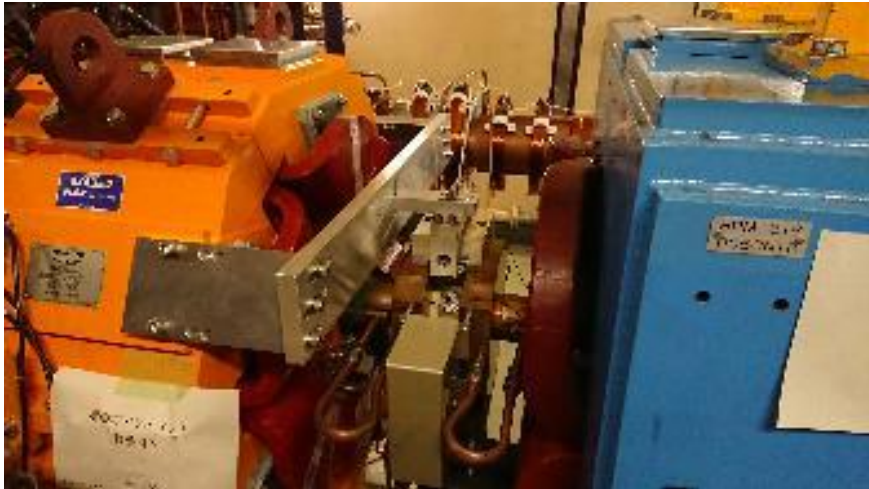
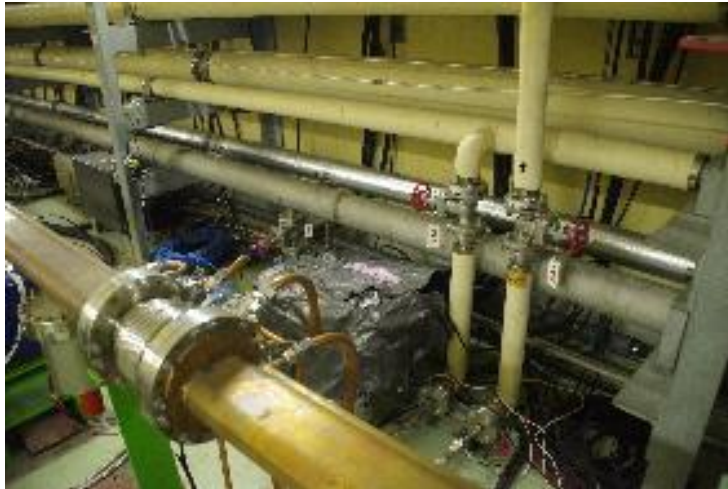
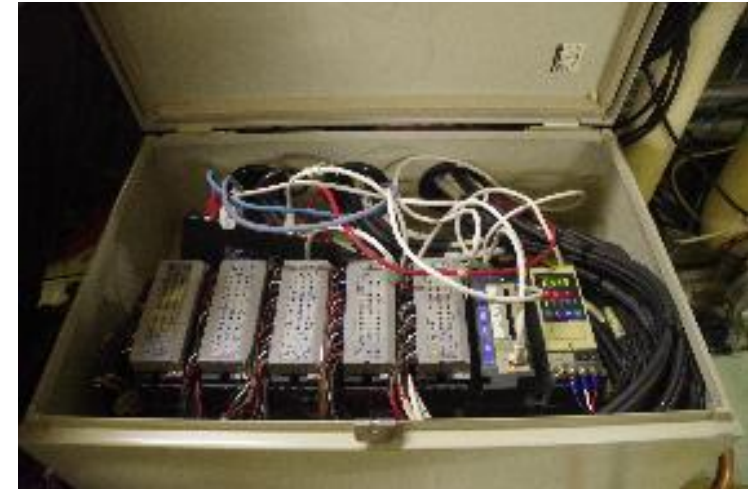
- **Function:** Capacitive sensors measure BPM block displacement relative to nearby sextupole or quadrupole magnets (range:  $\pm 1$  mm or  $\pm 5$  mm, resolution:  $<1$   $\mu\text{m}$ ). Measurements are automatically incorporated into COD corrections.
- **Issue:** Sensors operate reliably, but loggers in high-radiation areas experience hang-ups and ADC failures. Lead shielding provided limited improvement.
- **Measures:** Automatic recovery, alarms, power resets and spare-module replacement.
- **Plan:** Develop EPICS support and conduct in-tunnel radiation tests for a successor logger before the current model is discontinued.

- Some data acquisition slots (ADC module) that frequently hung up experienced a failure that could not be resolved by a power-on reset, so they were replaced with spares. All the failed modules had high residual radiation levels and could not be removed from the tunnel.
  - Even when enclosed in a 5-cm-thick lead block, the hang-up rate did not decrease significantly.
- The logger used will be discontinued within a year. We plan to develop EPICS device support for the successor system and conduct radiation resistance tests inside the tunnel.

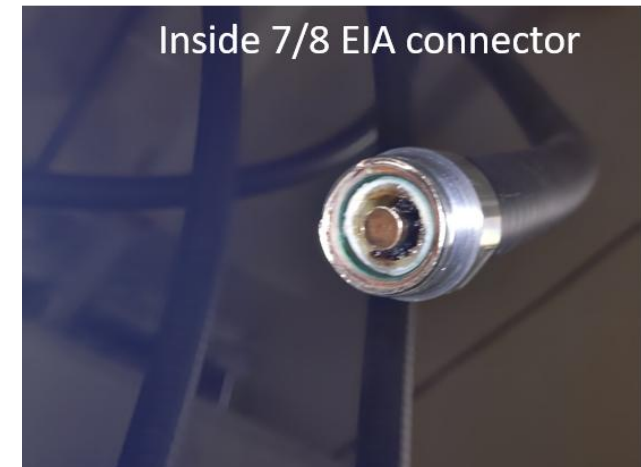
- **Performance:** Generally operated reliably and stabilized the beam up to the maximum current under non-collision conditions.
- **Noise reduction:** Replacing the 2 GHz filter improved the noise figure by  $\sim 20$  dB and reduced ADC RMS noise from 15 to 3 counts. Using the cleaner HER reference RF eliminated the large LER noise component.

- **Hardware issues:** Attenuator failures, amplifier trips, communication errors and logger hang-ups occurred. Two attenuators and the damaged LK2 cable were repaired, and input timing was adjusted.

- Several failures
  - High-power attenuators for transverse feedback kickers
    - 5 units failed; all due to input section malfunctions (burnout of the first resistor).

- Inspection following a gradual temperature rise at the No. 1 input feedthrough of LK2 revealed damage to the 7/8-inch EIA anchor contact.

- The cable was also damaged, so the entire cable from the absorptive LPF to the feedthrough was repaired, and the signal timing between the two inputs was adjusted.

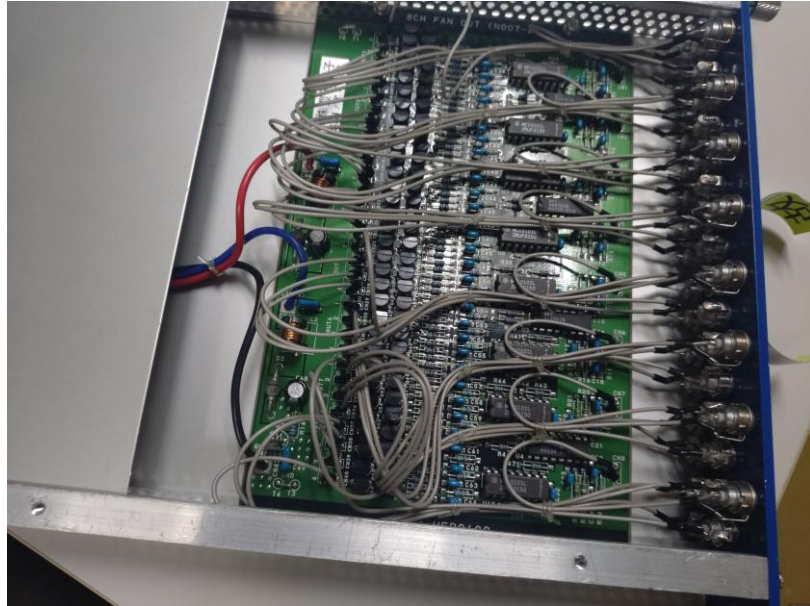
# Suspected source of the unstable voltage of NIM PS

- NIM fan-out module (old technology, not used for current operation).
- Removing unused NIM module from the NIM PS
- Checked all the NIM power supplies using the oscilloscope. No other suspicious power supply has been found up to now.
